Microstructure and In-Service Degradation of Baffle-Former Bolts – In-Core Components of Light-Water Reactors

ORNL/TM-2023/3118
M3LW-23OR0402027

**MICROSTRUCTURE AND IN-SERVICE DEGRADATION OF BAFFLE-FORMER
BOLTS – IN-CORE COMPONENTS OF LIGHT-WATER REACTORS**

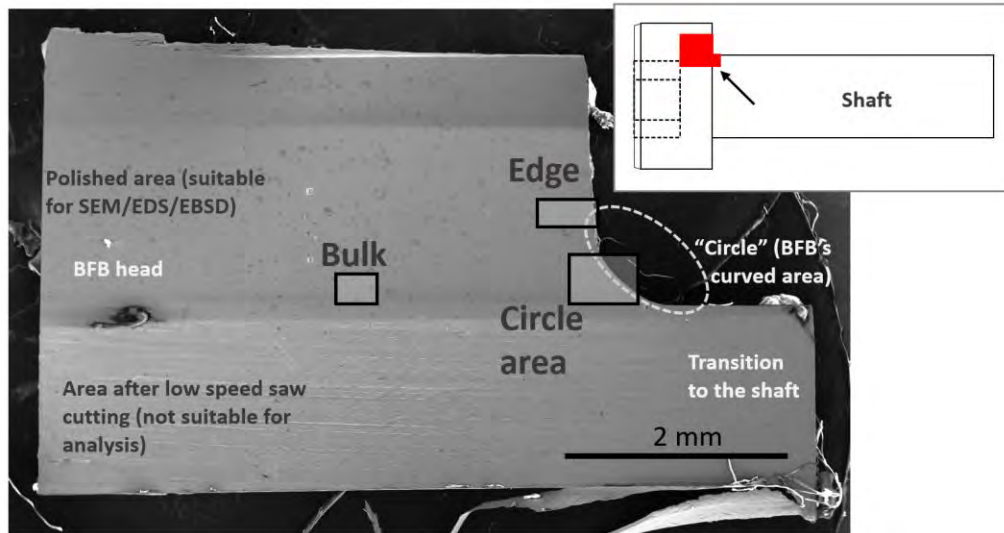
Figure 3 shows the general view of the 4412-CS-1-1 specimen; an insert in the right corner demonstrates specimen origin and orientation concerning the baffle bolt axis. It can be observed that most of the as-prepared specimen surface had a high-quality EBSD-suitable surface. Approximately $\frac{1}{3}$ of the surface (shown in the bottom portion of Figure 4) still had an as-cut surface with low-speed saw marks. EBSD scans were performed at several locations (Figure 3) to investigate microstructure conditions and to target future focused ion beam (FIB) liftouts.

Figure 3. General view of the 4412-CS-1-1 specimen from the BFB head portion. *Bulk*, *Edge*, and *Circle area* labels show the locations of EBSD scans discussed herein. The inset at the right top shows the geometry and orientation of the specimen within the source bolt.

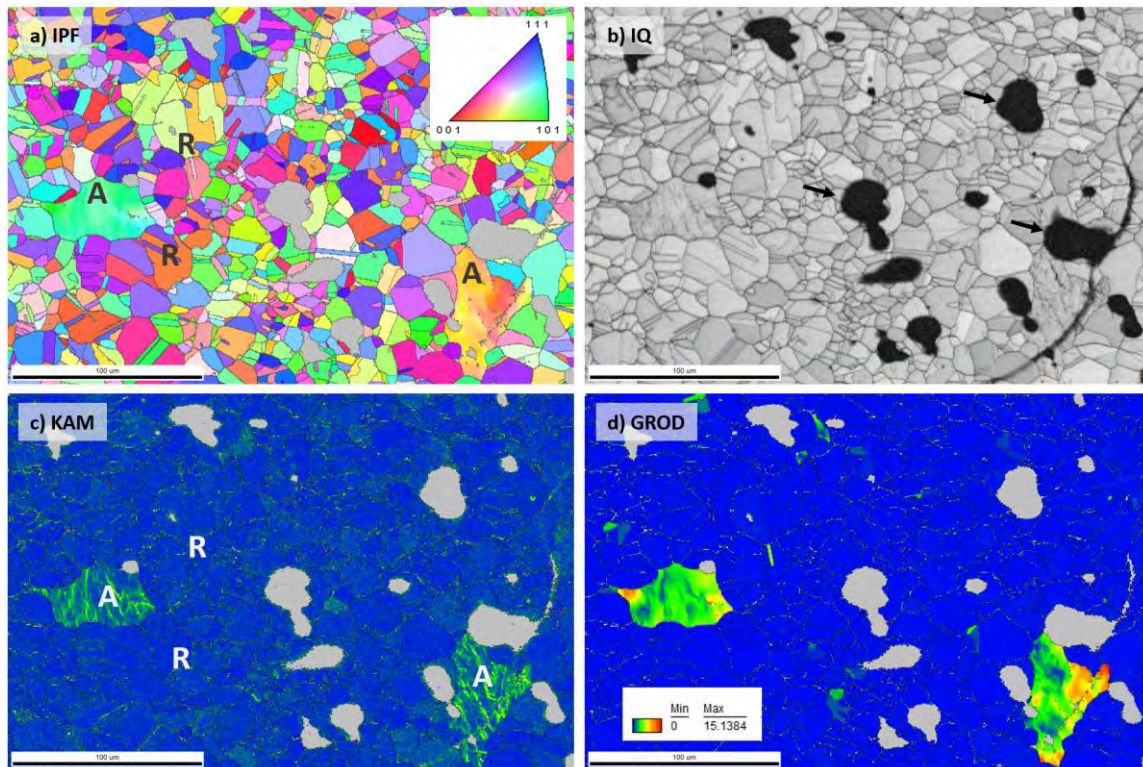
Figure 4. Microstructure of the BFB head (bulk area, ~2 mm from the edge; see Figure 3 for specimen location and orientation). A dominating recrystallized microstructure (several typical recrystallized grains are marked with an *R* label) can be observed, with a few grains with high in-grain misorientation levels (marked as *A* for *abnormal*). Carbon contamination spots are marked with arrows in the image quality (IQ) map. The inverse pole figure (IPF) color key is the same for all images in the document. All IPFs are colored in the horizontal direction.

Figure 4 shows the typical microstructure for the BFB material in the 4412-CS-1-1 specimen. Typical equiaxial austenite grains dominate in the structure; such grains (some are marked as *R*, indicating *recrystallized*; see an enlarged grain view in Figure 5a) have no in-grain color variations, indicating minor misorientation gradients. No or negligible in-grain orientation gradients are present for such grains in kernel average misorientation (KAM) and grain reference orientation deviation (GROD) maps. No retained ferrite was observed in the structure.

Some grains show pronounced in-grain misorientation variations (see IPF map; grains are marked as *A*, indicating *abnormal*, an example is given in Figure 5b). The KAM map for such grains clearly shows in-grain low-angle boundaries (LABs) most likely from dislocation. The GROD maps reveal in-grain misorientation levels up to 15°, suggesting elevated dislocation densities. A population of recrystallized grain fully surrounds such abnormal grains, ruling out the possibility that cold work (occasional or intentional deformation) was a possible source of the elevated in-grain misorientation levels. KAM distribution inside such abnormal grains is also not typical for cold or warm deformation in reference (non-irradiated) steel or strain localization processes in irradiated steel.

These abnormal grains are much larger than the surrounding fully recrystallized grains. The specific shape of grain boundaries (arcs or semicircles) suggests that these grains may be a result of abnormal grain growth (AGG) [7] (sometimes termed also as “anomalous grain growth”). The AGG usually occurs if the material has experienced some threshold deformation level and remained at higher temperatures longer than necessary to complete recrystallization. The presence of some texture components may be a factor influencing AGG. Although there is limited literature evidence, elevated levels of in-grain misorientation may be connected to the AGG phenomenon, such as through the consumption of neighboring grains. An additional focused study may be necessary to understand these aspects.

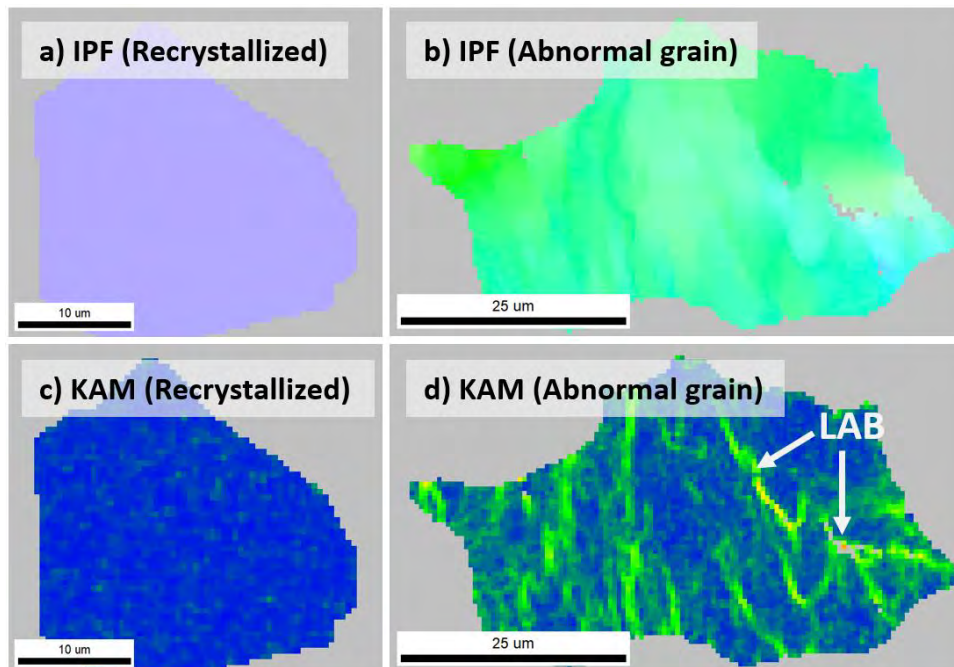
Figure 5. Typical recrystallized (a) and abnormal (b) grains for BFB bulk microstructure shown in Figure 4.(c, d) KAM maps showing in-grain misorientation. LAB: in-grain low-angle boundaries.

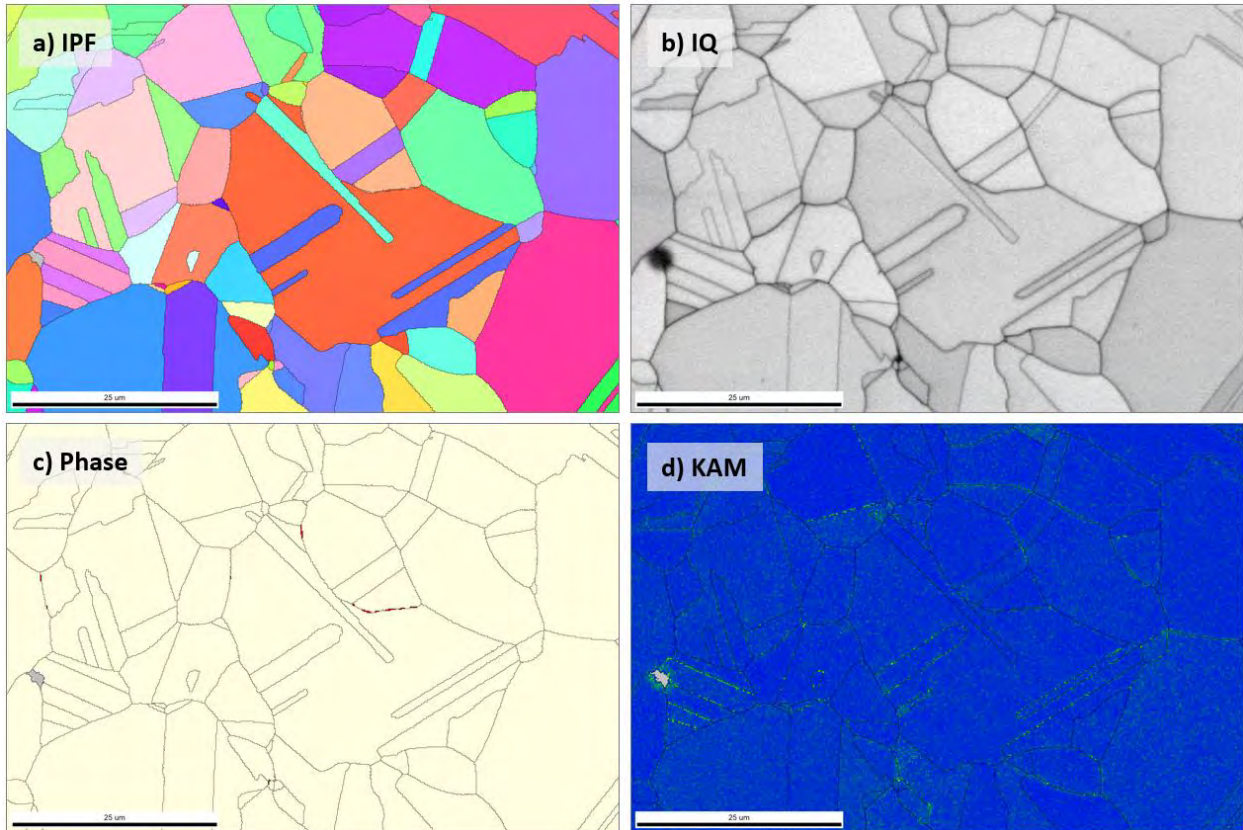
Figure 6. Subarea of bulk EBSD scan seen in Figure 4, rescanned with 125 nm step. An annealed austenite structure with equi-axial grains can be seen. Note the relatively small average grain size of $\sim 20 \mu\text{m}$.

Figure 6 shows the subarea of the bulk EBSD scan. If abnormal grains are excluded, then the remainder of the microstructure consists of typical annealed austenite with multiple annealing twins. No obvious signs of pre- or post-irradiation deformation (e.g., lattice orientation gradients along grain boundaries, fine slip lines, or coarse defect-free channels) are present in the BFB interior.

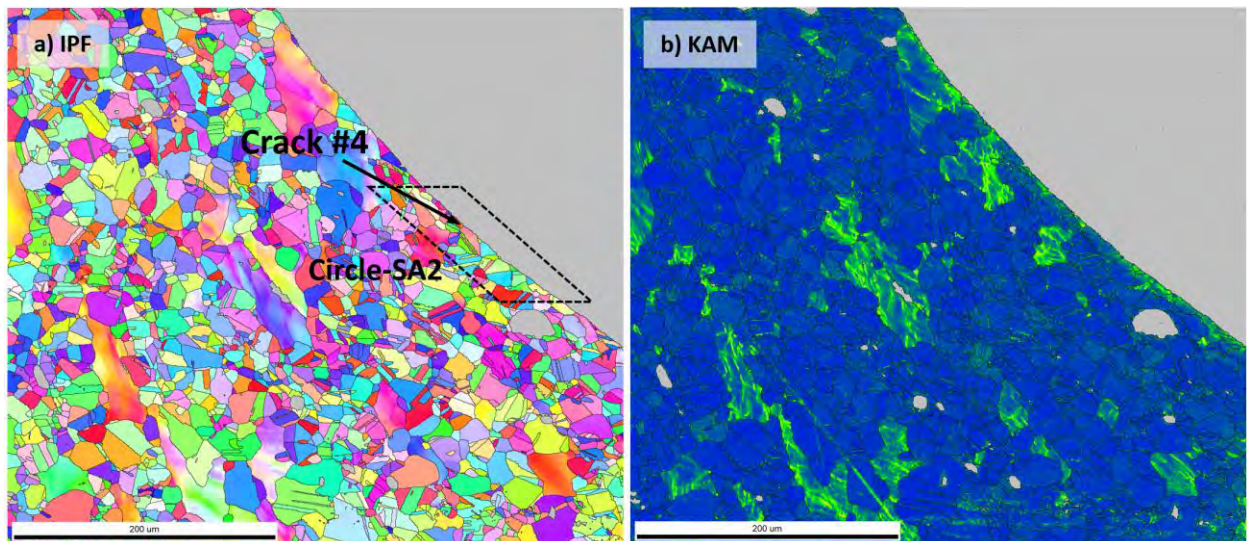
Figure 9 shows the microstructure of the *circle area* shown in Figure 3; the same pattern of dominating annealed grains mixed with abnormal grains can be seen. The abnormal grains are more abundant here, forming specific groups or lines. Such groups are elongated in the direction parallel to the edge, likely reflecting some preexisting texture or deformation structures related to BFB manufacturing. Also, there is a thin, slightly deformed layer along the edge with a thickness estimated at 10–15 μm .

Figure 9. The microstructure of the *circle area* shown in Figure 3.
