Light Water Reactor Sustainability Program

Survey of Aging and Monitoring Concerns for Cables and Splices Due to Cable Repair and Replacement

**M.P. Spencer, M. Elen, and L.S. Fifield
Pacific Northwest National Laboratory**

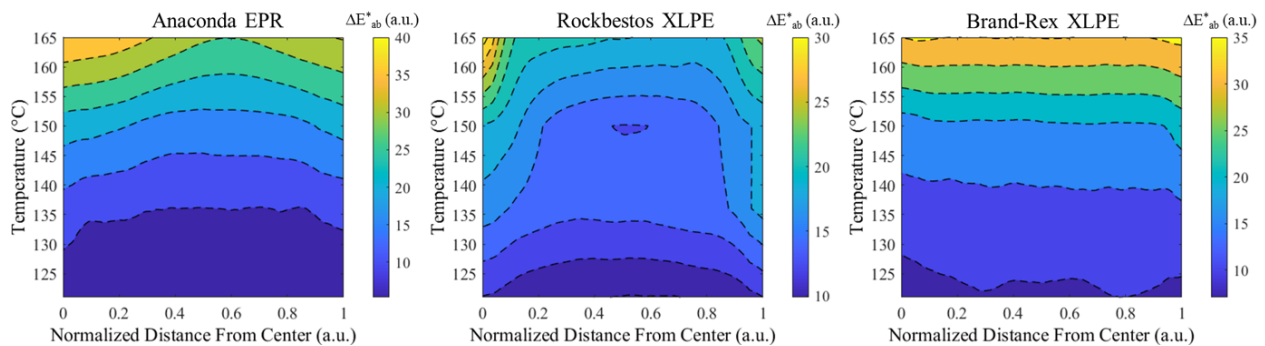
Figure 4-2. Evaluation of DLO using total color difference for three materials aged for 30 days. DLO is indicated by curvature of the contour lines (---). A normalized distance of 0 is the edge next to the conductor and a distance of 1 is the external edge (Fuchs et al. 2021).

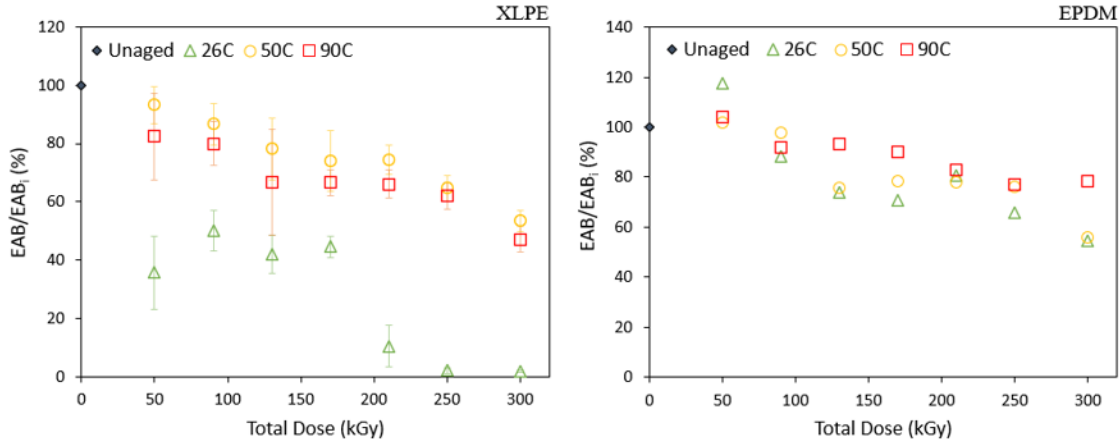
Figure 4-3. Average relative elongation at break of a (left) cross-linked polyethylene (XLPE) and (right) ethylene-propylene-diene elastomer (EPDM) cable insulation. ITE were observed with XLPE, but not EPDM (Fifield et al. 2022).

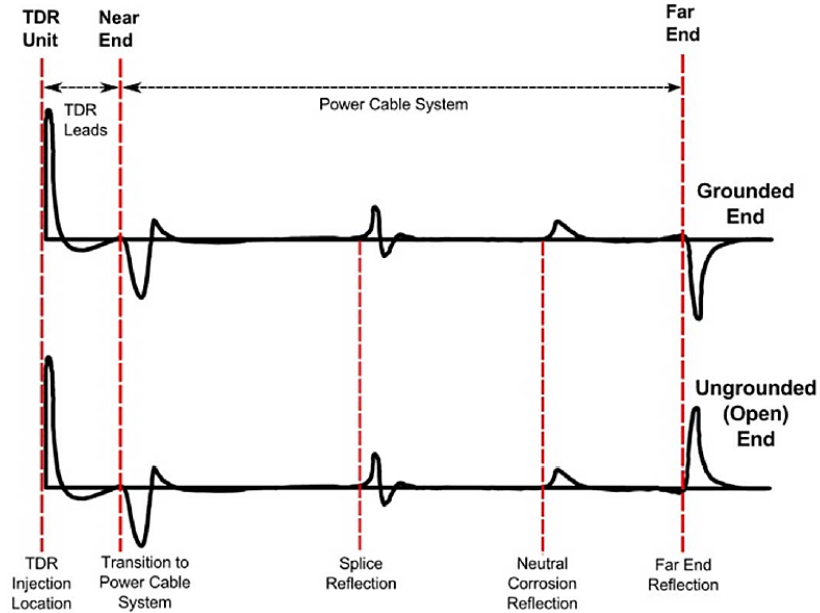
Figure 4-4. Typical test plot of TDR applied to a cable with a splice (Hernandez-Mejia 2016). The effect of grounding the cable is also shown.

TDR measures reflections of a stepped or impulse signal along a single conductor to detect and locate any changes in the conductor or insulation impedance. A TDR pulse is usually less than 10 volts and is primarily in the higher frequency range (> 1 kHz), so the pulse has little or no effect on low frequency signals or on 50/60 Hz power excitation. TDR transmits an incident signal into the conductor and listens for signal reflections. If the conductor is a uniform impedance network and is terminated to a matching impedance, then there will be no reflections and the transmitted signal will be completely absorbed at the far end by the termination. Instead, if there are impedance variations such as a short or open circuit at the cable end, a damaged or reduced cross-sectional area, or a splice with a higher resistance along the conductor, then some fraction of the incident signal will be reflected to the source. The polarity of the reflection contains information about the reflector. An open cable end will reflect “in-phase” with the excitation and a short will reflect as an inverted signal. This reflected signal is measured at a point in time on the TDR instrument that is proportional to the signal propagation velocity in the cable and the distance along the cable, thereby allowing assessment of the location of any reflector observed. The amplitude of the reflected signal coupled with the inherent cable attenuation characteristics also allows an estimate of the magnitude of the impedance change. An example TDR plot is shown in Figure 4-4.

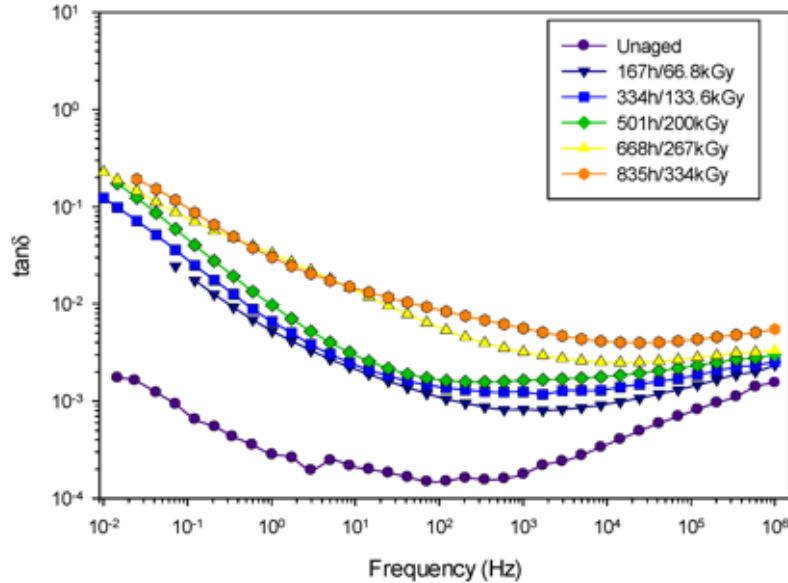
Figure 4-9. DS response for a twisted pair cable undergoing radiation aging at different aging time points (Suraci, Li, and Fabiani 2022). Note that the frequency range is generally much higher for DS compared to typical $\tan \delta$.

DS is similar to $\tan \delta$ (discussed above) where both the applied voltage and frequency are varied in the test steps. The test is applied across the conductor and a shield or between unshielded conductors in a multiconductor cable configuration. The test series is performed at different frequencies varying from 0.01 Hz to approximately 10 Hz, although much higher frequencies have been used in the laboratory as shown in Figure 4-9. At each frequency, a number of voltage steps are applied, and $\tan \delta$ is measured at each step. One embodiment of this method—the broadband impedance spectroscopy (BIS)—has been developed by Boeing for condition monitoring of aircraft wiring. Extension of this technology was further explored for nuclear applications under an NRC program (Rogovin and Lofaro 2006). This effort included claims of usage of BIS to determine location of degradation to within 10% of the overall cable length. To date, DS has not had broad acceptance within the power industry; however, it has attracted attention as a promising technique particularly for medium-voltage water-tree detection (Werelius et al. 2001). A typical DS test plot is shown in Figure 4-9.

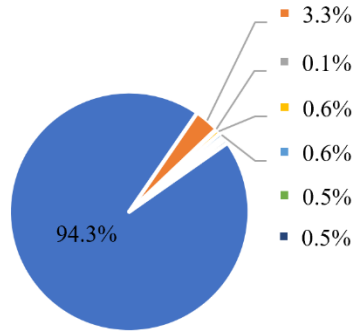
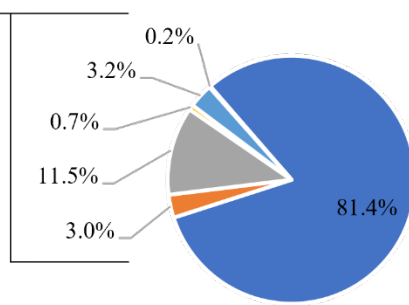
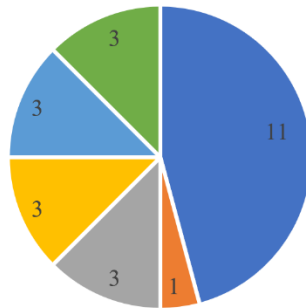
Figure 5-1. (Top) reported LER events for cables, splices, and other components and (bottom) the average number of reported issues since 2000.

All reported LER events for cables, splices, connectors, fittings, terminations, and joints are shown in Figure 5-1; the events for non-cable associated components (i.e., *cable* or *cables* was not included in the title or abstract of the event) were estimated by subtracting the combined cable and component events [e.g., *(Cable OR Cables) AND (Splice OR Splices)*] from the reported LER events for the component alone (e.g., *Splice OR Splices*). In addition, cable events including the components are also reported in Figure 5-1. From the figure, of all LER events, approximately 3.3% are cable related. In addition, most cable events (approximately 81%) were not keyword-associated with splices, connectors, fittings, terminations, or joints. Of the events that correspond to the components of interest, approximately 12% were due to connectors, 3% were due to terminations, 3% were due to splices, 1% were due to fittings, and less than 1% were due to joints.

To evaluate trending of the events, the events per year are shown in Figure 5-1 and Figure 5-2. As shown in the figures, reported events peaked shortly after recording of LER events begun. Specifically, it is hypothesized that due to new LER reporting requirements around 1980, a significant increase in reportable events occurred as NPP operators moved to ensure they were meeting regulations. Thus, to evaluate events without bias of initial reporting, and since the last published NRC report on splices was conducted in 2002 (see Table 14), reported events since 2000 are also shown. Since 2000, reported events for cable splices, connectors, fittings, terminations, and joints were nearly constant with reported splice events at approximately one per year. Interestingly, reported cable events overall seem to have reduced over the 2019 to 2022 timeframe, potentially due to COVID restrictions.

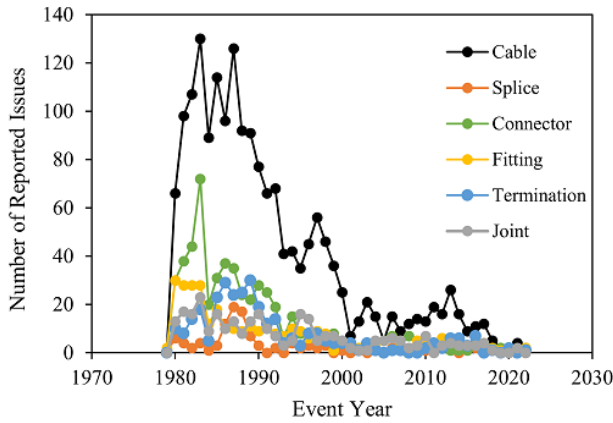
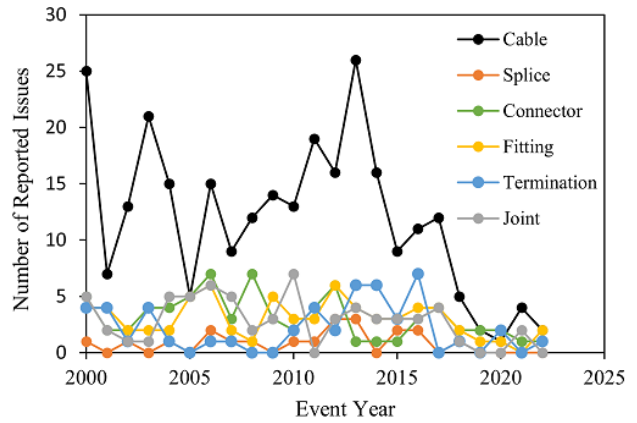
Figure 5-2. Reported LER cable events against event year.

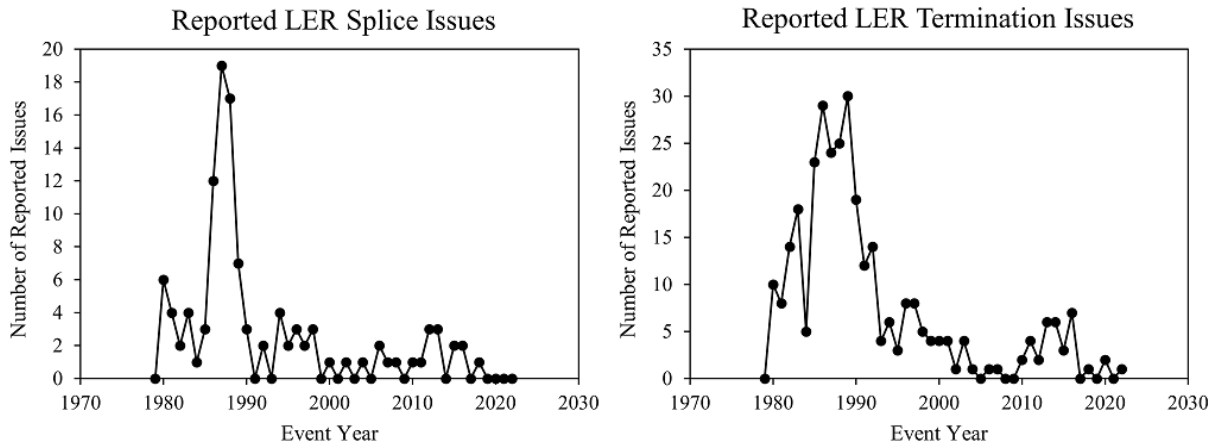
Figure 5-3. Reported LER cable (left) splice and (right) termination events against event year.

Reported splice and termination LER events are shown in Figure 5-3. Contrary to the other components shown in Figure 5-2, splice and termination events demonstrated a peak near 1988. It is hypothesized that this was due to new reporting requirements for splices (i.e., non-qualified splices were upgraded to qualified splices) (NRC 1987).

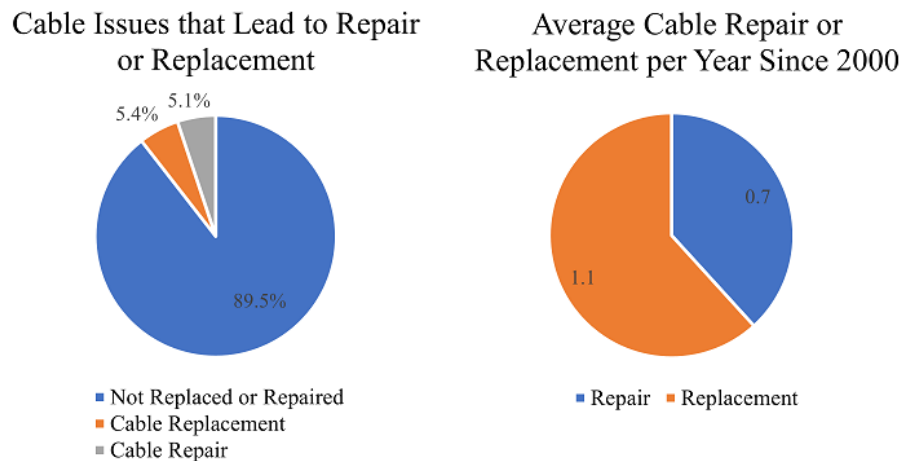
Figure 5-4. Reported LER cable events for repair and replacement.

LER events related to cable repair or replacement are shown in Figure 5-4 and Figure 5-5. From the former figure, approximately 5.4% and 5.1% of cable events are correlated to cable replacement or repair, respectively. In addition, since 2000, cable replacement has been approximately 50% more common than cable repair, which is within expectations as cables have historically been replaced, as opposed to repaired, when issues were observed (IAEA 2012). In addition, replacement can effectively assist with NPP life extension as many of the cable types of interest have been EQ tested and newer cables can supply improved performance, such as flame retardancy, halogen-free materials, and reduced degradation.

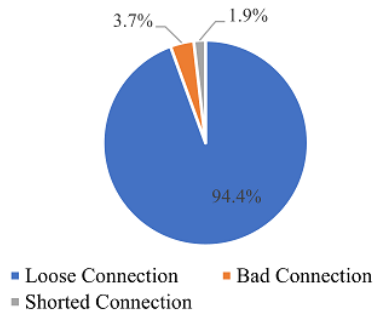
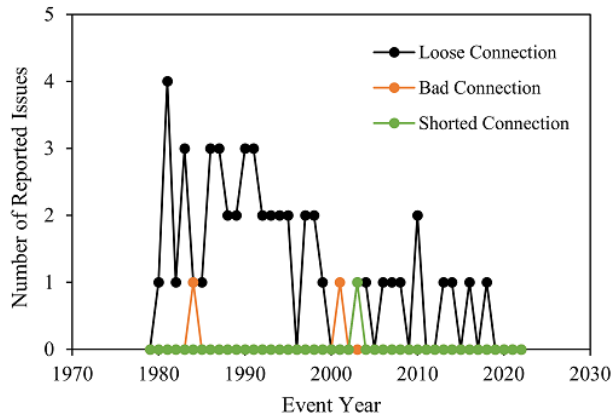
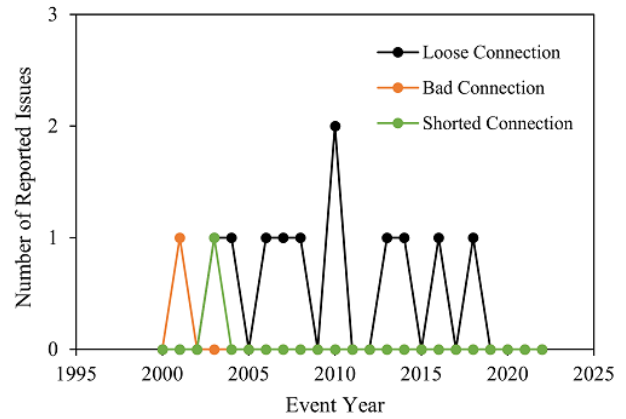
Reported Connection Events

Reported LER Cable Connection Issues

LER Cable Connection Issues Since 2000

Figure 5-6. (Top) reported LER cable connection events and (bottom) events reported against event year.

The results for the additional search terms are shown in Figure 5-6. Of the investigated events, a majority of them (approximately 94%) were related to loose connections. A loose connection may occur due to workmanship but may also occur due to thermal cycling (Gazdzinski et al. 1996). More specifically, thermal cycling will lead to expansion and contraction of the components and may lead to issues with contact pressure and correspondingly contact between interfaces. Such thermal fatigue may eventually cause failure of the splice or component through ingress of moisture, for example. In addition to thermal cycling, vibration may also lead to loosening connections and interface issues, particularly over 30 to 40 years. Based upon these events, thermal cycling fatigue and vibration are of potential concern for long-term aging of splices but are not currently considered in cable and splice EQ (IEEE 2015).

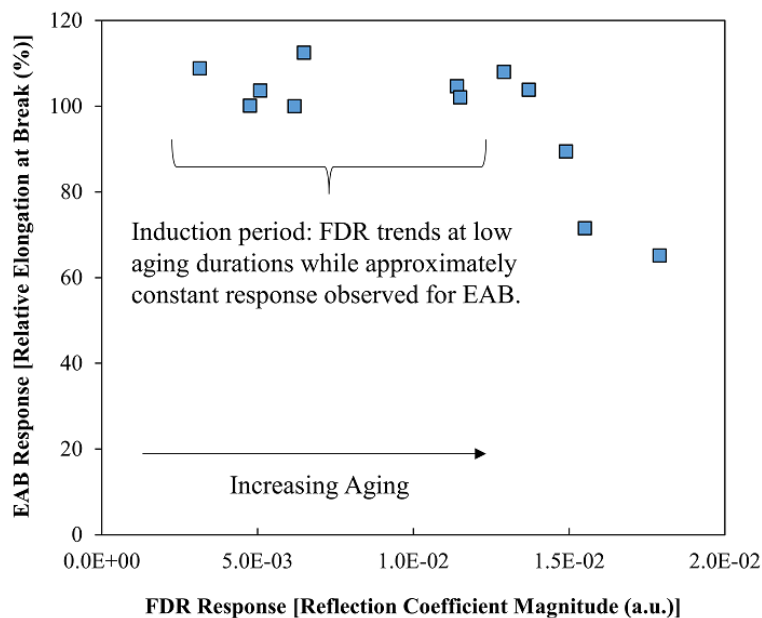
Figure 6-1. Low-voltage electrical cable aged at 140°C for up to 62-days; aging increases along the positive x-axis. EAB response approximately constant at low-to-medium aging durations (induction period < 37-days). FDR response increases for aging time points > 7-days.
