Light Water Reactor Sustainability Program

Online Monitoring of Induction Motors

January 2016

**Idaho National Laboratory
Idaho Falls, Idaho 83415**

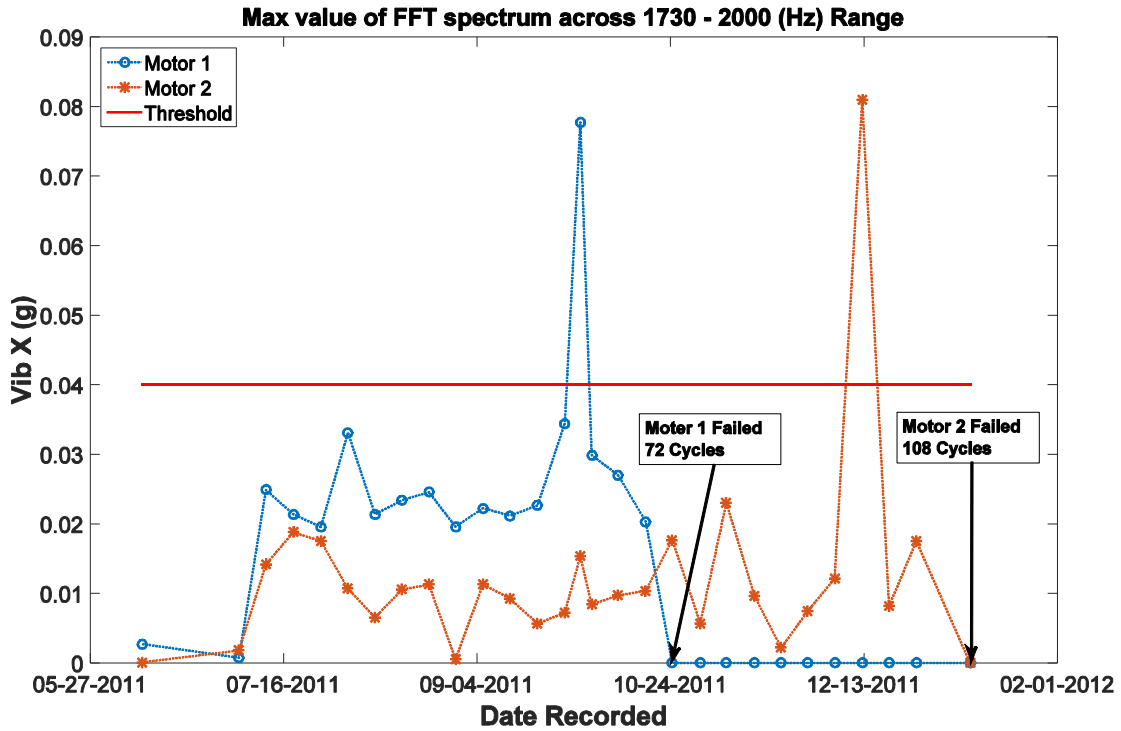
Figure 14. Trend of maximum amplitude of vibration frequency spectrum for Motors 1 and 2.

While motor failures can be produced by faults in many different motor components, five out of the ten test motors experienced failures directly related to bearings. Since this report focuses on bearing failure, the experience related to bearing failure is discussed here.

The FFT or PSD of each of the raw data signals were calculated and peaks within particular frequency ranges were tracked by a series of scalar values over the history of the motor. Figure 14 depicts the tracked peak values of the vibration signals in the X-direction for Motors 1 and 2 over the specific bandwidth of 1730–2000 Hz, with a threshold cut off value of .04 for anomaly detection. To create a RUL model based on peak value tracking would involve curve fitting the measured data and forecasting the expected time of failure when the peak value would exceed the operational threshold limit. Perhaps some conservative method of estimating the RUL based on this threshold and the current trend (e.g., value and slope) exists; however, a straightforward trend given this data set was not observed. For example in Figure 15, the signal approaches close to the threshold many times suggesting a short RUL before settling down for a long period of time prior to climbing through that threshold at the point of motor failure. These results do not provide a transparent measure of RUL that provides any high value to operational decisions based on implied longevity expectations.

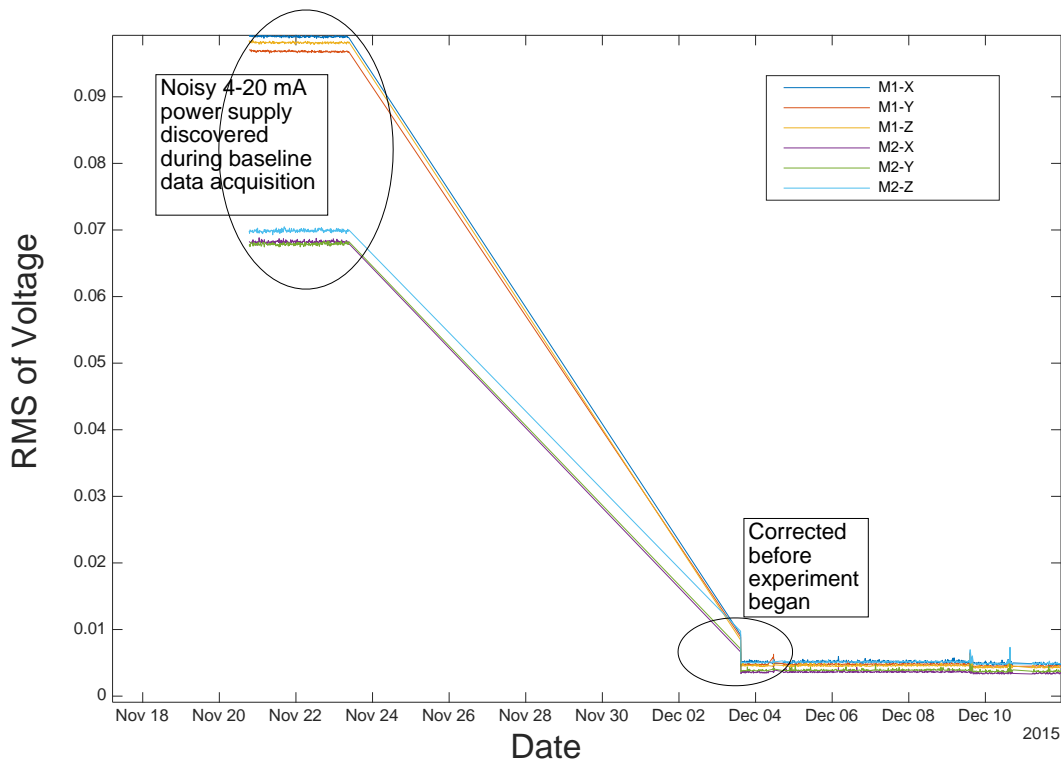
Figure 18. Baseline acquisition and beginning of test data from different motor vibration channels showing unacceptable noise that was reduced to acceptable level before experiment was initiated.

Initial data sets showed large noise variation in the 4–20 mA signals from the temperature and vibration transducers during baseline data acquisition. Figure 18 shows a measure of the noise in the RMS value of the vibration sensor and the RMS value of the signal after the noise was corrected by grounding the unused inputs to the PLC.

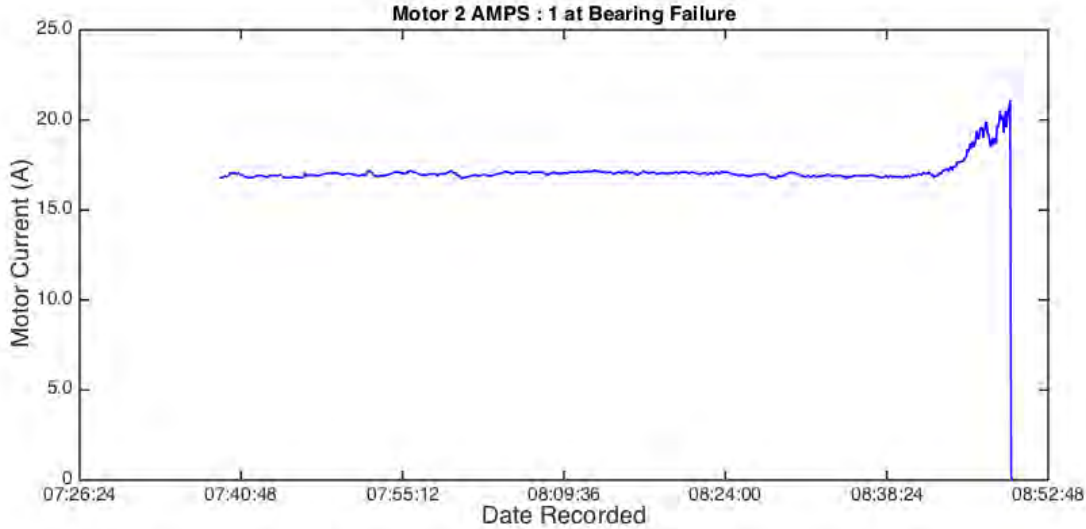
Figure 19. Phase A motor current of M2 after introduction of iron filing contaminant.

By opening the grease drain port in M2. loss of bearing lubrication experiment was initiated. Surprisingly, after 28 hours of operation, M2 bearing showed no signs of degradation. The hypothesis associated with this unexpected behavior is that the motor is unloaded and could be fully supported on the back bearing. Removal of viscous grease actually decreased the torque on the motor. but no significant wear was achieved. As a next step, to ensure grease was removed, light oil and then a solvent was applied through the bearing. The drive current still remained within the normal range for over 12 hours of operation. At this stage, 50 ml of iron fillings were introduced into the bearing. The motor was operated until a highly worn bearing finally created enough friction to cause the torque and current to spike to the trip set point. Figure 19 shows the RMS value of drive current collected by the PLC. Figure 19 illustrates a sudden spike in the RMS value of the drive current. The spike occurred after iron fillings were added to the motor bearing. At this point, the system tripped automatically. The dissembled motor is shown in Figure 20. From Figure 20, one can observe the level of damage that occurred to the rotor winding and motor internal due to the presence of contaminants in the bearing. The important lesson learned here is

that one faulty condition can (unintentionally) add to another in a relatively short period of time. Also, during the initial experiments, only current data was collected and no vibration data was available. Continuous temperature data was also not collected; however, periodic thermal images of the motor were collected using a hand-held thermal camera.

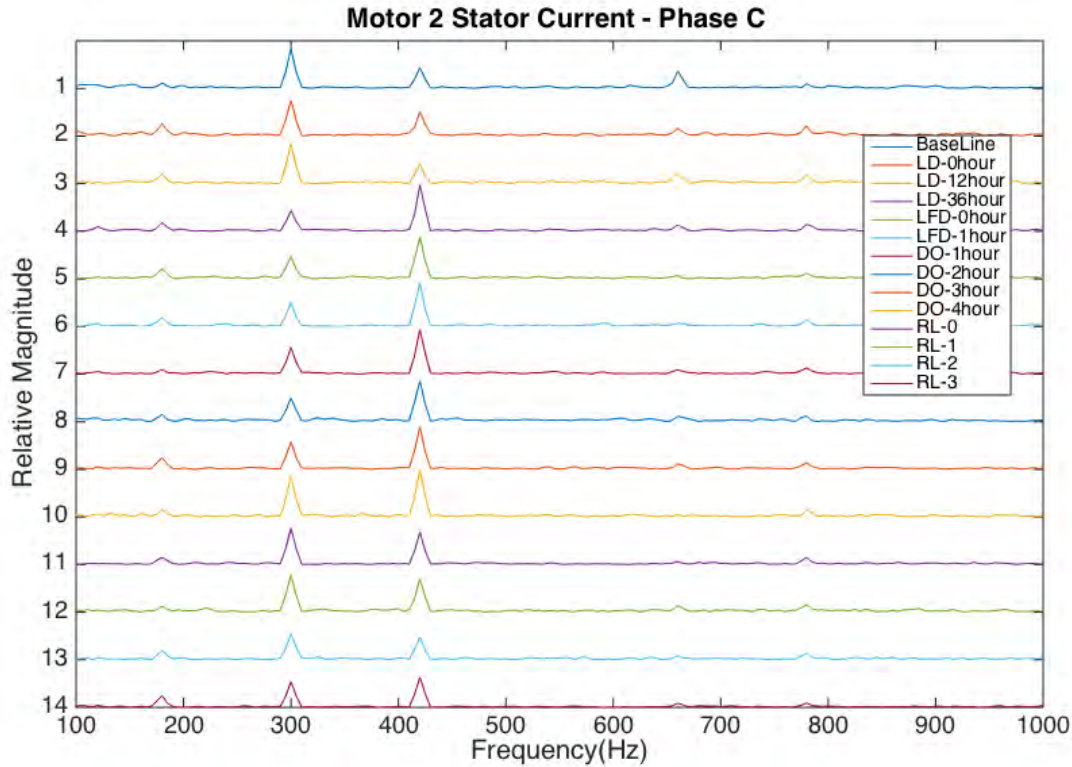
Figure 22. Frequency spectra of M2 at different steps of the second experiment.

The lubrication drain process yielded a measurable change in $7^{th}/5^{th}$ harmonic amplitude by the end of the natural drain cycle completion. However, completion of drain by forced air (i.e., LFD) did not increase this ratio further and no other obvious indicators were observed. On the other hand, the ratio decreased somewhat through the duration of the test even though acoustic from the motor increased enough that after 4 hours of operation the decision was made to shutdown the test and reintroduce lubrication through the grease port. After reintroduction of grease, the motor was restarted and the sound level decreased to pre-drain level with the harmonic amplitude ratio decreasing to below 1. The trends of the individual harmonics and the ratio are shown in Figure 23. For sake of convenience and better representation of trends, the ratio value was scaled by 100. The other two phases of current show similar trends.

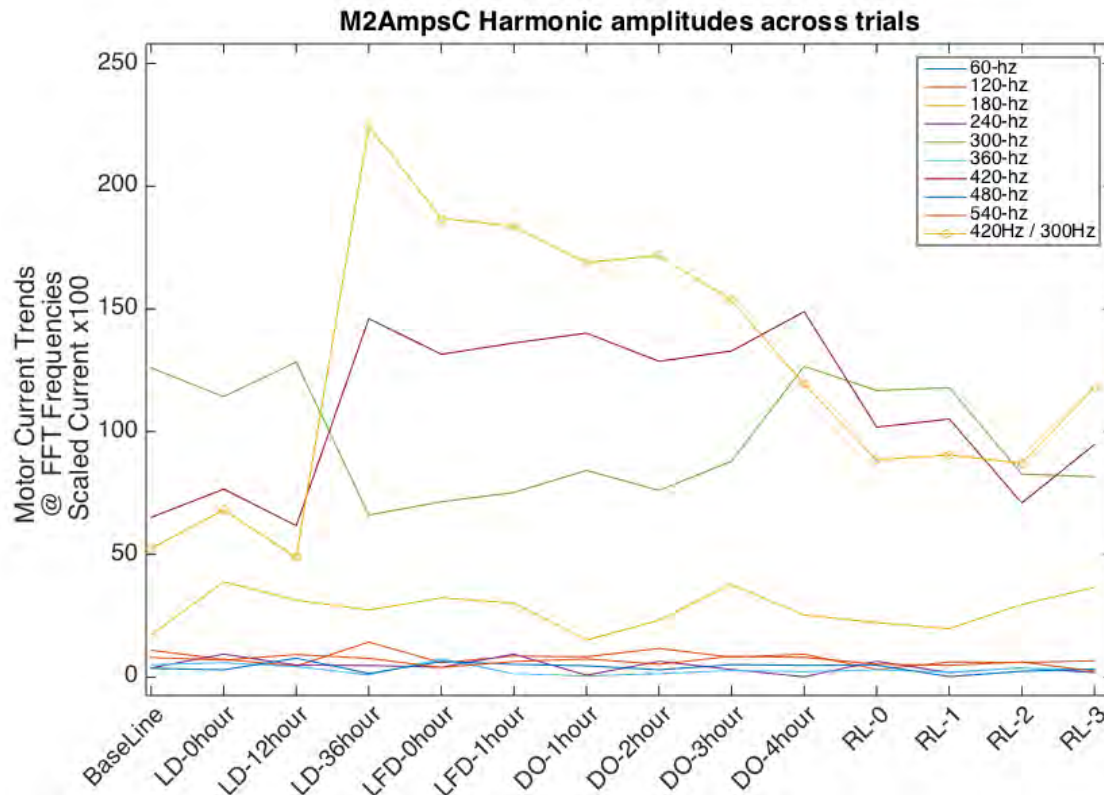
Figure 23. Trends of the drive current frequency harmonics over the duration of the removal/replacement process of the second experiment.

Unfortunately, the vibration sensors were not effective in showing the trauma that the audible noise level was indicating, and audio was not captured in a systematic method. Temperature did increase over the duration of the test but was not indicative of onset of the degradation that would be necessary for effective RUL determination. Based on these results, several instrumentation improvements were identified for the next set of tests. First, vibration sensors that are sensitive enough to provide the accelerations that were obviously occurring needed be installed, positioned, and tested for sensitivity prior to another experiment. Data collection of the sample rates adequate for frequency domain analysis needed be automated to take regular and frequent samples, with a data acquisition system that does not depend on human operation of an oscilloscope. It is possible that a clear trend between the second and third sample of lubricant drain would give clear usable information for derivation of RUL. Finally, the bandwidth of the signal collection needed to be increased to produce better resolution in the frequency domain.

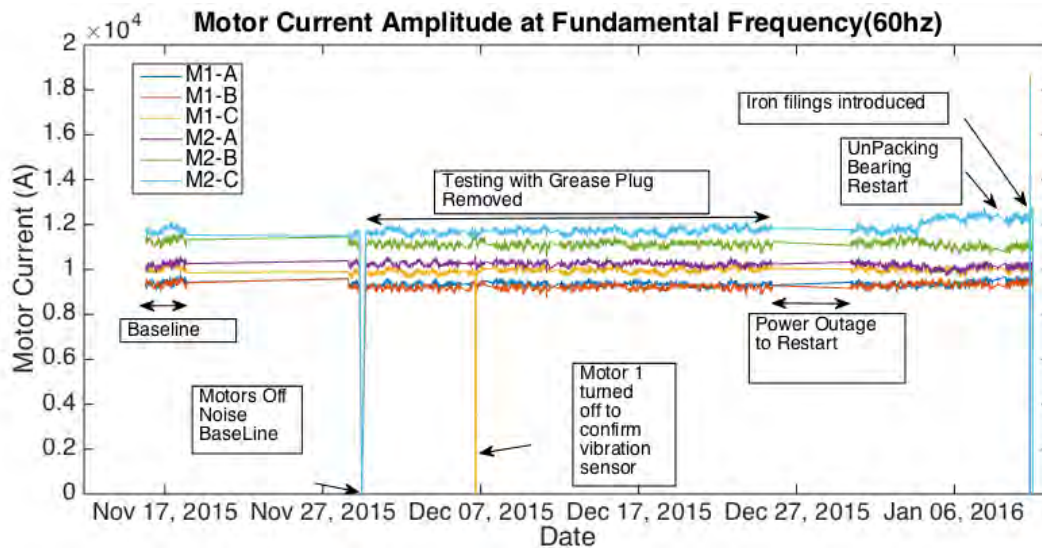
Figure 24. The timeline of the extended bearing test is summarized in the annotation for the motor current plot.

c. Operator reported very audible noise to INL

d. INL advised to discontinue test before additional damage that may result in more complicated rebuild occurred

9. Test terminated January 15 at 10:56 pm.

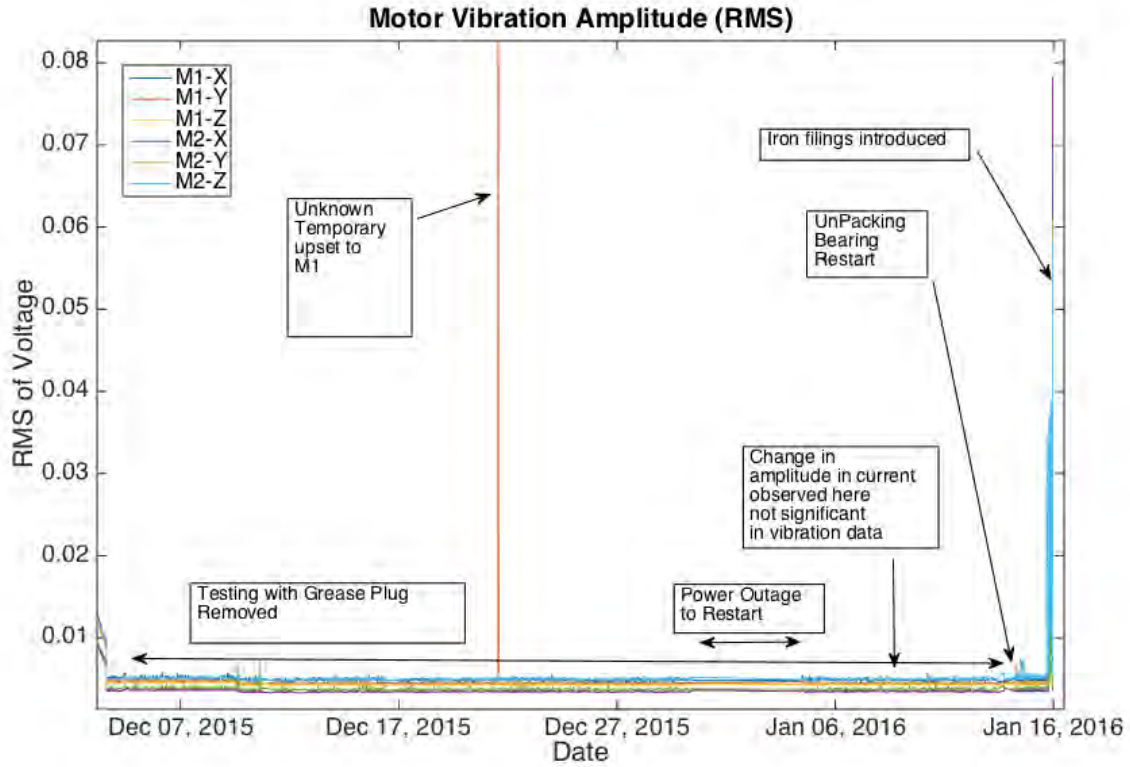
Figure 27. Overview of the vibration RMS data.

Examining the vibration RMS values as the experiment continued to the unpacking of the bearing, the amplitude of the vibrations is noticeably higher periodically for about 12 hours, followed by a settling to smaller vibrational variations from sample to sample (Figure 28). This corresponds to the 12-hour period the motor was run with the unpacked bearing before flushing with light lubricant and solvent. The motor ran more smoothly with a completely flushed bearing than with an unpacked bearing.

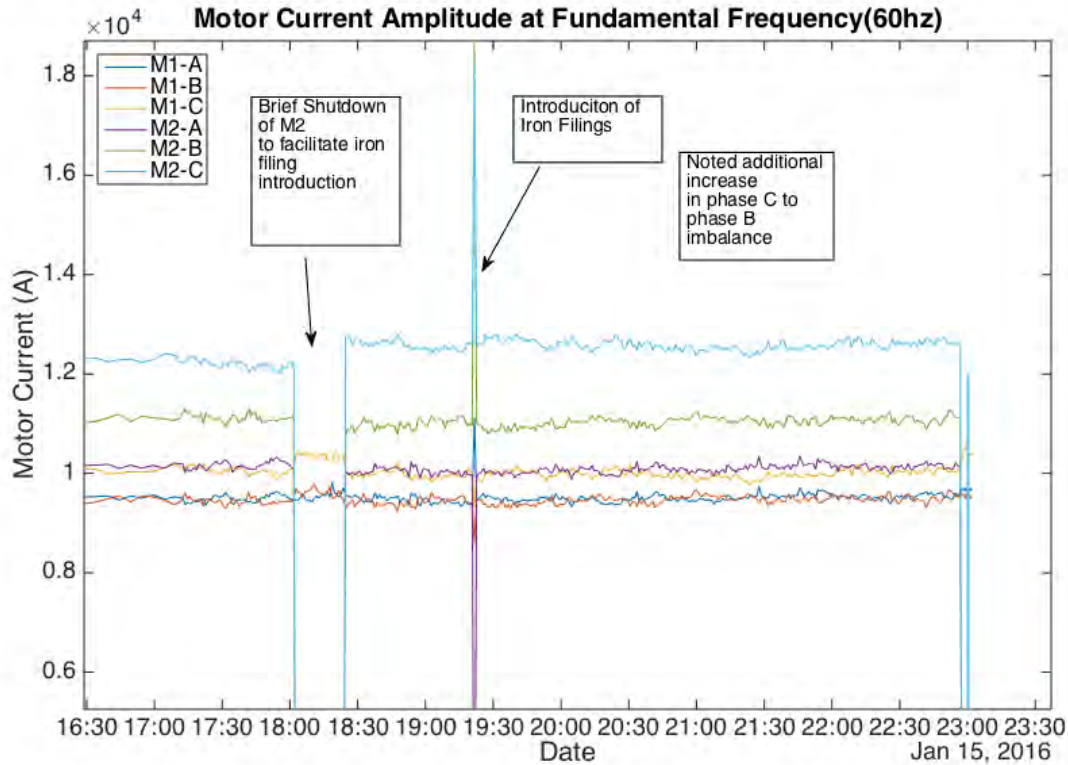
Figure 29. Detailed of iron filling introduction to completion of experiment.

The fundamental frequency amplitude of Phase C increase at the restart prior to introduction of the contaminants, as seen Figure 29, and does not decrease until the end of the experiment. The moment of the introduction of the contaminant does introduce a transient, but the current quickly settles back to that baseline, indicating the overall torque does not change at steady state for the contaminant test.

The experiments also show that for degradation that is related to the condition of the bearing, the vibration sensors provide a better feedback mechanism for diagnostics, since the current signatures do not show any changes as the bearing lubrication health degrades. For completeness, the difference in the time series of the vibration sensor between the start of the experiment and the introduction of iron fillings is displayed in Figures 30 and 31. The vibration FFT is shown for the introduction of iron filings in Figure 32 to illustrate another instrumentation finding about vibration sensors with 4–20 mA rating. The frequency response of 4-20 mA vibration sensor was not sensitive past the 2nd harmonic. To perform technical exams with frequency specific signatures, voltage-based vibration sensors should purchased to replace the 4–20 mA sensors.

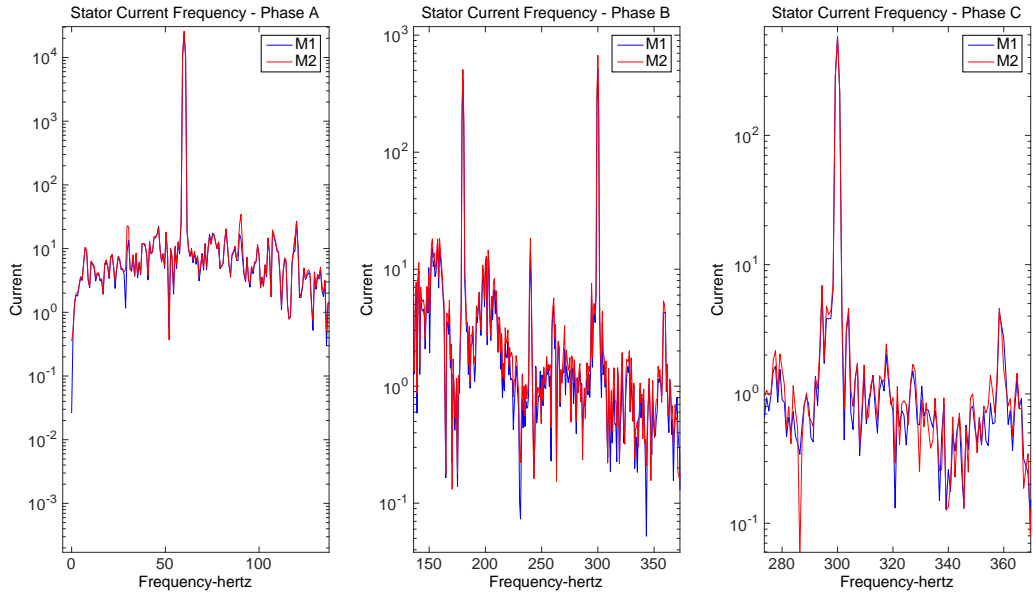
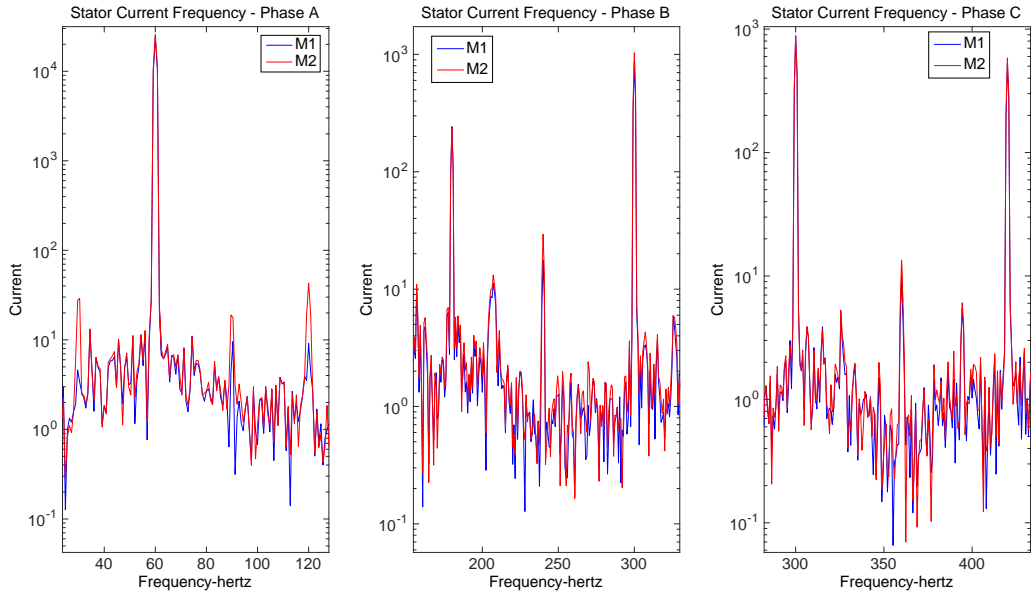
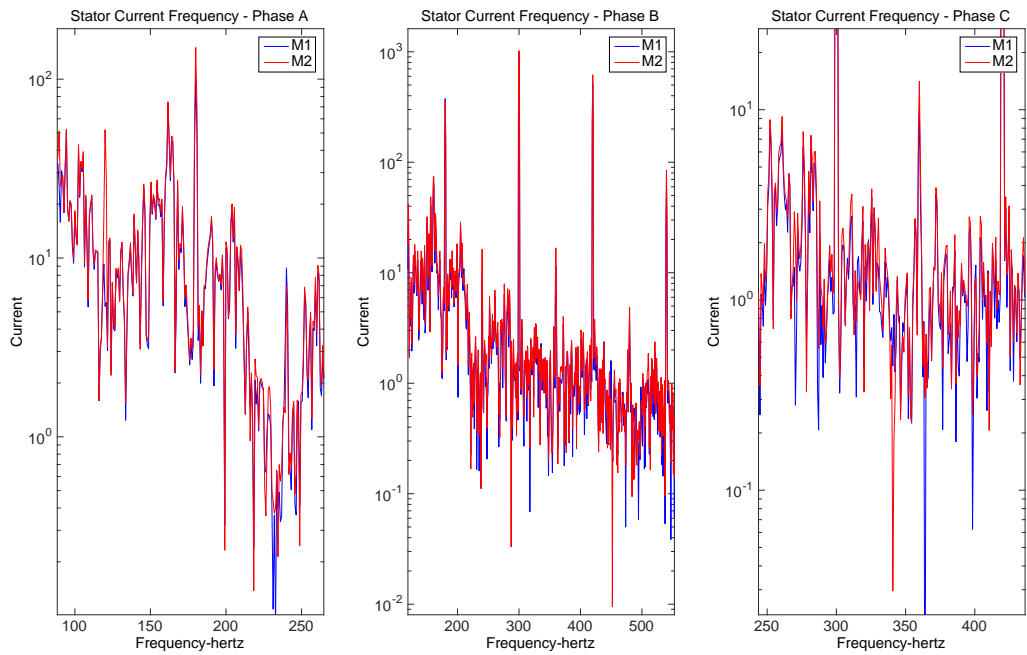
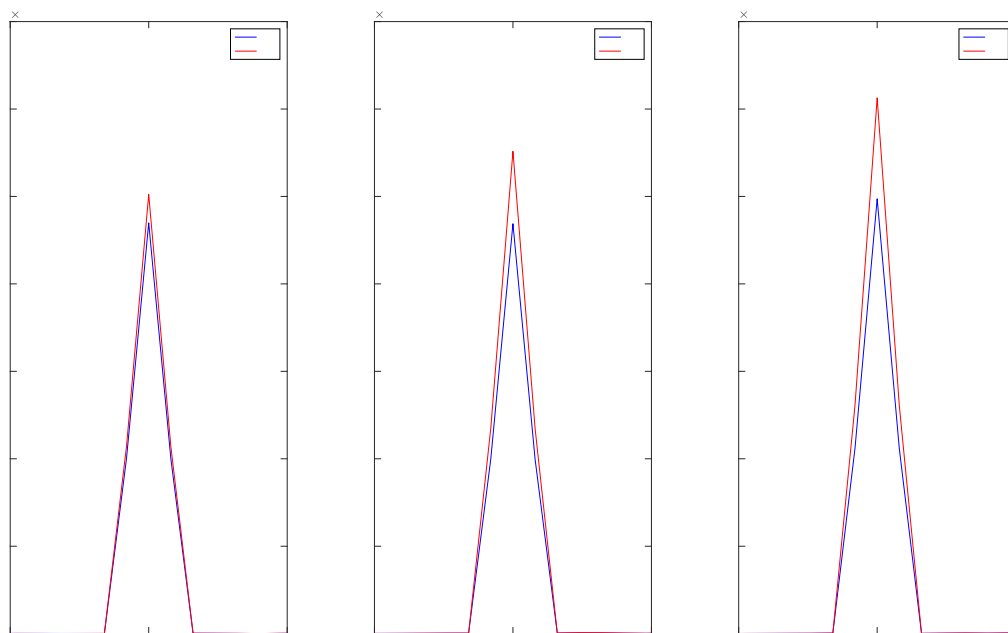
A final observation about the current sensors, the observed data is indicating that a degredation may be occuring in the windings of M2. The motor has shown an imbalance between phases greater than M1 since returning to service after the rebuild. Over time the imbalance increased. The balance increased immediately after the last inrush current applied at the restart of the motor after preparation for introduction of the iron filings. This may be the best possibility of a measure of a degradade property of the motor that is growing over time, even though this was not the intended target. This effect could be due to abuse suffered during the first dramatic test that was continued to degrade with use. The root cause will need to be determined to understand the validity of this measure of the health of the motor and the test continued to understand if a trend exists for which a successful example of RUL can be formed from on-line monitoring of induction motors. For completeness, the lack of variation between M1 and M2 from baseline to completion is shown in Figures 33 to 36, with the exception of the amplitude of the fundamental growing as the test continued.
