**GRAIN BOUNDARY MICROSTRUCTURE EFFECTS ON
STRESS CORROSION CRACK INITIATION MECHANISMS
IN ALLOY 600 AND ALLOY 690**

**Technical Milestone Report: M2LW-19OR0402031
September 2019**

Z. Zhai, M. B. Toloczko, M. J. Olszta, and S. M. Bruemmer
Pacific Northwest National Laboratory

Research Project:
**Stress Corrosion Crack Initiation of
Nickel-Base Alloys in LWR Environments**
Project Manager: S. M. Bruemmer
Pacific Northwest National Laboratory

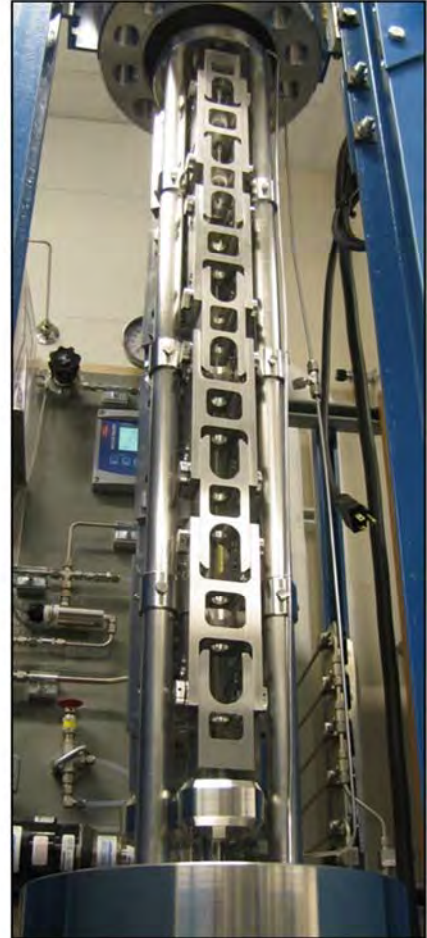
(a) 6-Specimen
SCC Initiation System

(b) 36-Specimen
SCC Initiation System

Figure 3. Crack initiation test system load train at PNNL in the (a) small SCC initiation test system with capacity of testing up to 6 fully instrumented specimens and the (b) large SCC initiation test system with capacity of testing up to 24 instrumented specimens and up to 36 specimens in total.

Figure 3 shows the load train and DCPD instrumentation for the typical SCC initiation specimen set up at PNNL. Currently two smaller SCC initiation systems and one large SCC initiation system are being used under the scope of LWRS. The two small SCC initiation systems have been converted to test up to 6 fully instrumented specimens during the past year, and the large

SCC initiation system allows 36 specimens be tested simultaneously with up to 24 specimens instrumented. The load frame in both types of systems is designed to sustain the load even when individual specimens fail during the test enabling the test to continue for the other specimens loaded in the same string. To make this possible, the controlling software is programed to partially unload the system when a sharp strain increase in an individual specimen is detected by DCPD. The load decrease (typically to ~80% of the starting value) enables the SCC-initiated tensile specimen to fail safely without significantly impacting the entire system. After the failure of the specimen is confirmed (usually by losing DCPD signal), the load is brought back to yield stress again while monitoring stress versus strain curve using DCPD for every specimen. It is important to note that none of the LWRS Alloy 600 or Alloy 690 specimens have been allowed to fail during an SCC initiation test and all specimens have been removed shortly after DCPD-indicated initiation to assess cracking.

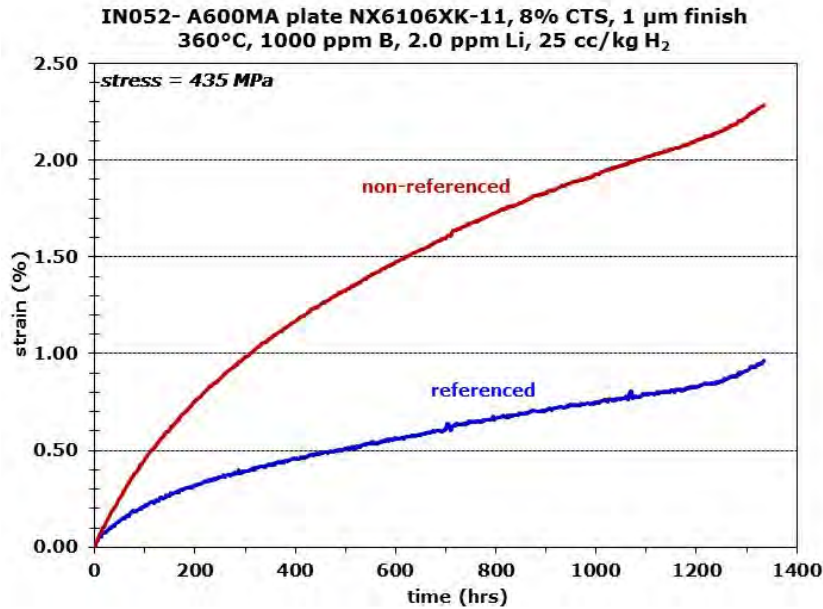
Figure 6. Non-referenced and referenced DCPD strain response for IN052, an 8%CW specimen from Alloy 600MA plate heat NX6106XK-11.

a test was interrupted for surface examinations of precursor damage, or if a specimen had exhibited crack initiation, the remaining specimens were taken back to their original load upon restart of the test, again while monitoring stress versus strain during loading. Figure 6 shows the evolution of both non-referenced and referenced strains throughout exposure of a plate specimen. As mentioned in the previous section, by subtracting the reference voltage from the gauge voltage, the contribution of resistivity drift is eliminated in the referenced strain response. While creep and cracking are both likely to be simultaneously contributing to the measured response, the SCC initiation time is determined as any obvious increase in strain rate. Tests were stopped after clear confirmation of DCPD-based initiation to allow detailed characterizations of the specimen just after the onset of initiation as well as any accompanying specimens that had not yet initiated.

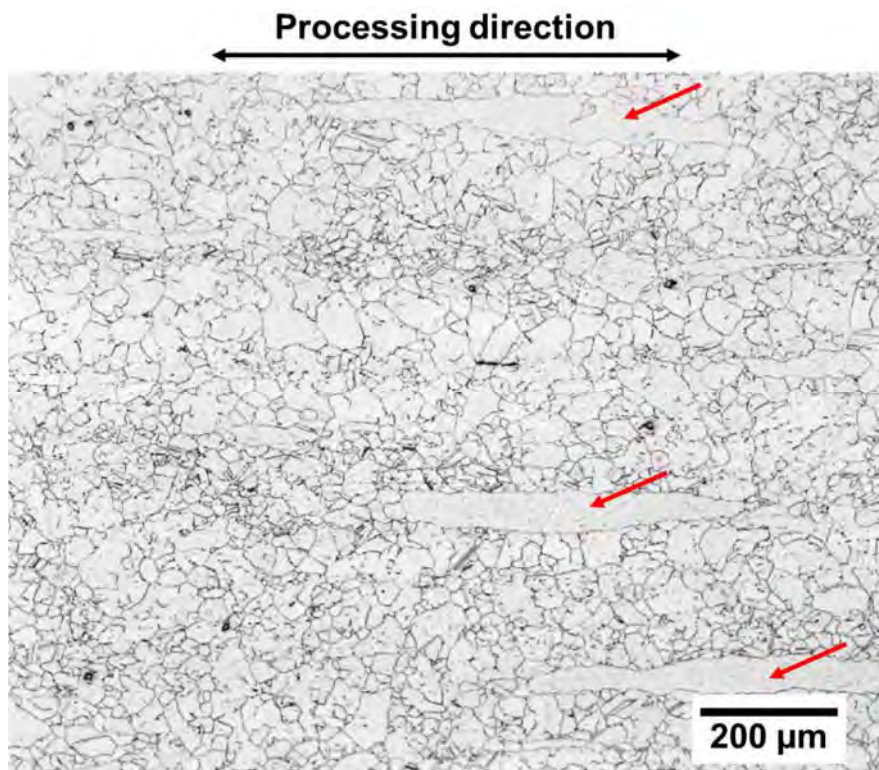
Figure 16. Optical image of the etched Alloy 600MA heat NX6106XK-11 material showing the inhomogeneous microstructure with large elongated grains highlighted by arrows.

The plate heat NX6106XK-11 was received in the form of a 5.08 mm (2 in) thick plate and in the MA condition reported as 927°C for 3.5 hours followed by a water quench. As reported earlier [20], this material features an average grain size of 65 μm with transgranular (TG) carbides on ghost grain boundaries and a non-uniform distribution of IG carbides (Figure 14). At lower magnifications, carbide banding were also observed in the material as shown in Figure 15. In addition, optical examinations on the etched cross-sections of this material revealed bands of larger and smaller grains along the processing direction (Figure 16). Some of the large “balloon” grains were highly elongated exceeding 1 mm in length.

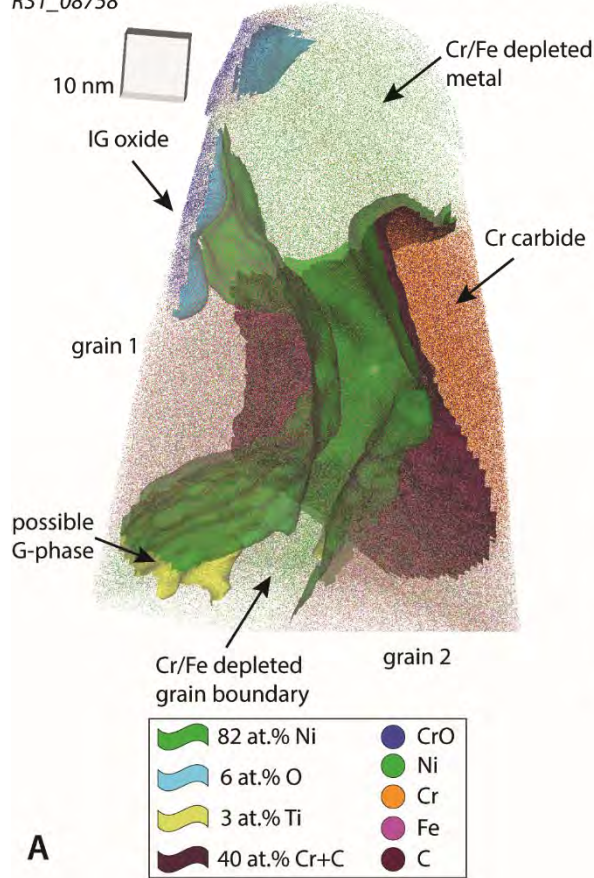
Alloy 600 - NX6106XK-11 TT
 1000 h 360 C
 R31_08758

Figure 43. APT characterization of an IGA in the non-CW Alloy 600SA heat NX6106XK-11 unstressed coupon after exposure for 1000 hours to 360°C simulated PWR primary water. (A) 3D elemental atom map and isoconcentration surface depicting regions of IG oxide, IG Cr carbide, and Cr depleted metal. (B) APT concentration profile across the oxide/metal interface showing the presence of a Cr-Ni oxide. Note the extreme level of depletion of Cr and Fe from the adjacent metal. (C) Concentration profile across the interface from the noted grain 1 and a possible IG G-phase region (yellow isosurface in panel A). This identification is speculative and based only on the measured enrichment of Ti and Nb.

A second example of terminal IGA from APT analysis of the same GB is presented in Figure 43. Isoconcentration surfaces are drawn with 6 at.% O (blue) to outline the location of the terminal IG oxide, 40 at.% Cr+C (maroon) for an IG Cr carbide precipitate, 82 at.% Ni (green) for a Ni-rich / Cr-poor metallic region, and 3 at.% Ti (yellow) for a small region of Ti enrichment along the Cr-poor grain boundary. The general GB plane, determined by SEM imaging during specimen fabrication, extends from the upper right to the lower left. In this case, the IGA again terminated near an IG Cr carbide, but the oxide is not in intimate contact with the carbide itself. The oxide is separated from the carbide by the prominent region of Cr- and Fe-depleted metal. The interface between the IG oxide and the altered metal is presented in panel B, which reports nearly complete depletion of both Fe and Cr. The oxide itself is Cr rich, but again contains a significant amount of Ni (~20 at.% Cr and Ni). Given the approximate O concentration of ~42 at.%, this composition is most consistent with an MO-like oxide phase. Two distinct Ni-rich features are apparent: a very thick region near the tip apex above the IG Cr carbide, and a relatively narrow region adjacent to the carbide extending towards the bottom of the dataset. While the narrow region is typical GB depletion of Cr and Fe from IG oxidation, the upper region could be interpreted as a migrated GB and/or partially consumed Cr carbide that has converted to a Ni-rich metal. In either case, the oxide clearly follows a path separated from the carbide by this Ni-rich metal and is not in direct contact with the carbide itself.

The final feature of this dataset is the Ti-rich region located within the Cr- and Fe-depleted metal near the bottom of the reconstruction. A concentration profile from metal grain 1 into the Ti-rich feature is shown in panel C of Figure 43. It is first noted that grain 1 exhibits a lower Cr concentration (~10 at.% Cr) than the nominal alloy composition due to the material's TT conditioning and Cr carbide precipitation. This dataset also contains a unique Ti-rich region that has not yet been observed in any other Alloy 600 heats at PNNL. No enrichment was found for C or N in this region, suggesting the feature is unlikely associated with the Ti carbonitrides found in this heat. Instead, the region is primarily Ni-rich and Cr/Fe-poor with ~5 at.% Ti and ~0.4 at.% Nb. We speculate this may be a small region of G-phase, but the interpretation is confounded by the coinciding presence of altered alloy composition from both carbide precipitation and IG oxidation. Our TEM analyses of heat NX6106XK-11 TT revealed Ti-rich regions along the GB plane, which were initially thought to be the common Ti carbonitrides observed previously. The density of these IG particles is too low to reliably target by APT characterization. Further analysis of this material without exposure to high-temperature water by TEM would be needed to determine if G-phase is forming during the TT anneal, or if the observed feature in this APT data could result from leaching of C and N from a carbonitride during corrosion.

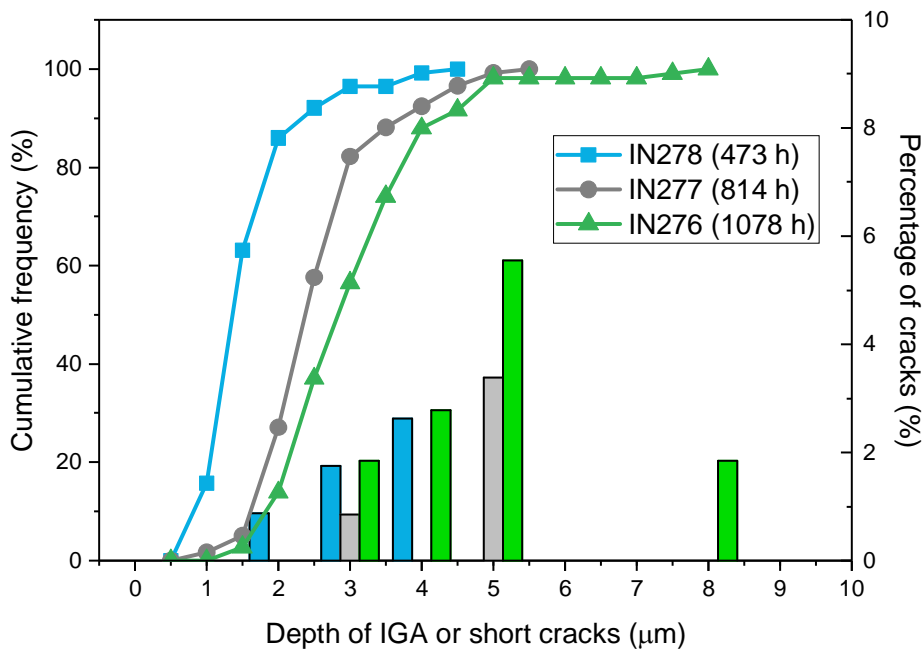
Figure 46. Cumulative frequency of precursor damage depth for the 15%CF Alloy 600TT heat NX6106XK-11 SCC initiation specimens taken out at each test interruption and the conclusion of the tests in 360°C simulated PWR primary water.

Summarized first is the cumulative frequency of the depth evolution of precursor damage, which includes IGA and short crack less than 10 μm deep, in the SCC initiation specimens for all three material conditions as shown in Figures 44-46. It should be noted that data at each test interruption is acquired from a different specimen, but it is considered the precursor damage development is relatively consistent in all specimens with the same material condition. A gradual increasing trend was observed for the depth of precursor damage with the increase in exposure time. In particular, it is revealed that despite the increase in exposure time, the percentage of GBs that showed a certain degree of cracking remained relatively stable at $\sim 10\%$ for the SA and TT+15%CF conditions, but increased from $<5\%$ to $>20\%$ in the MA+15%CF condition. To better visualize the contribution of these short cracks to the overall distribution, the depth of short cracks is also plotted for each specimen in the bar diagram in terms of percentage of cracks over all GBs observed. It turns out that with the progression of test time, the formation of new cracks in the SA and TT+15%CF condition appears limited because the specimens underwent longer exposure did not show a higher fraction of very short cracks, but instead, they show a higher distribution gravitating towards deeper cracks. This suggests that in all material conditions, nucleation of new cracks decreases as exposure time increases, although IGA continues to grow. One possible explanation for this phenomenon is that the transition from IGA to short cracks is associated with bulk creep strain rate – with the exhaustion of primary creep at early stage of the tests, it becomes difficult for new cracks to form compared to growth of existing cracks.

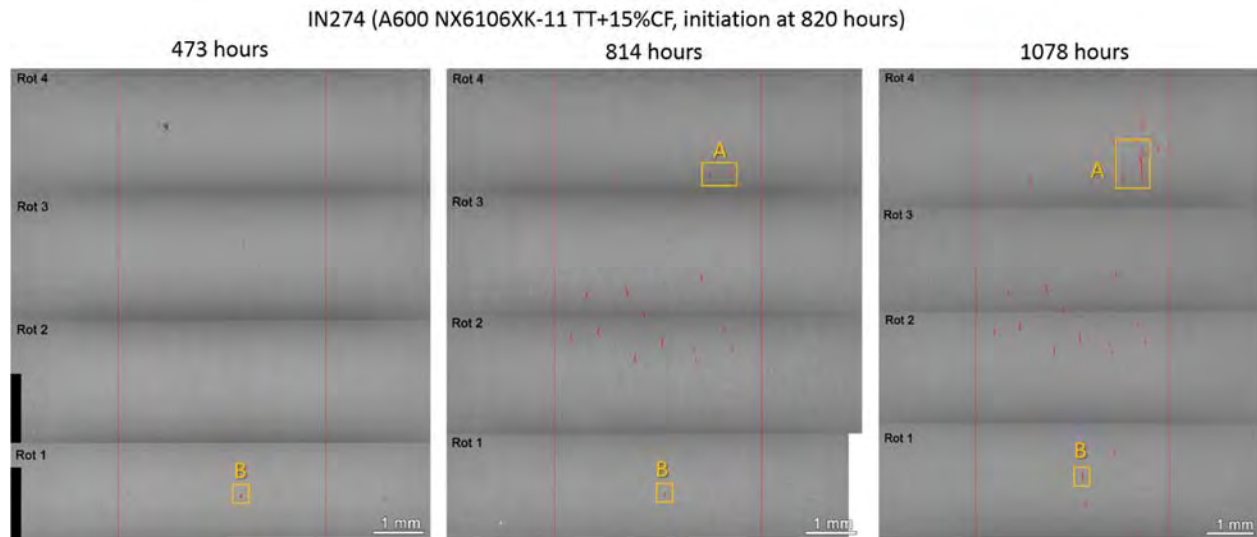
Figure 70. Mid- and post-test SEM-BSE montage image of the surface of the 15%CF Alloy 600TT heat NX6106XK-11 specimen IN274 in which SCC initiation was detected by DPCD at 820 hours of exposure at yield stress. Obvious cracks are highlighted in red.

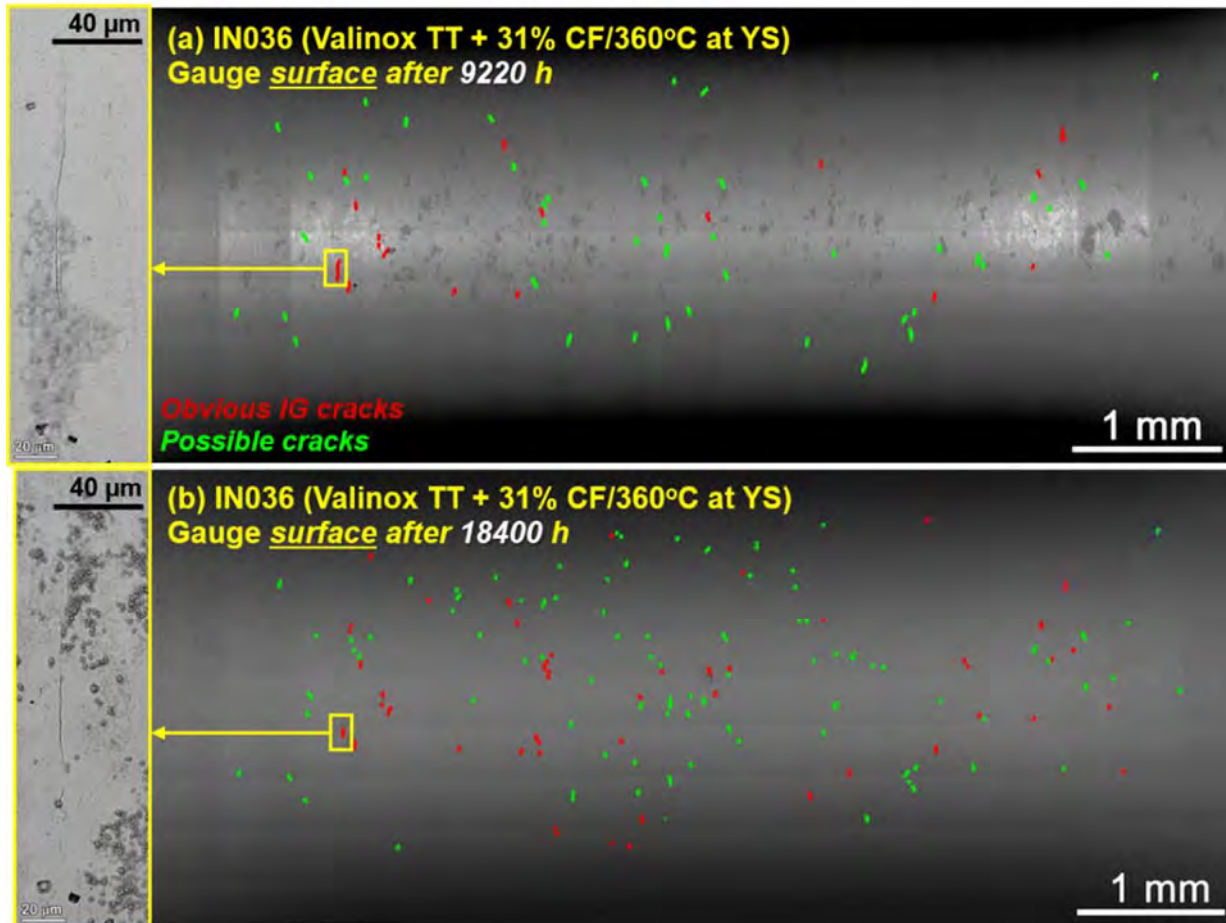
Figure 83. SEM-BSE montage images of the gauge surface in one rotation of the 1 μm finish, TT+31%CF Alloy 690 Valinox CRDM specimen IN036 after (a) Phase I and (b) Phase II exposure.

Evolution of gauge surface morphology of highly polished specimens IN036 (TT+31%CF Valinox CRDM), IN039 (TT+31%CF Doosan CRDM) and IN042 (TT+31%CF TK-VDM Plate) after Phase I and Phase II exposure are presented in Figures 83-85, respectively. As reported previously, IG damage was identified in all highly polished TT+31%CF specimens after Phase I, which include obvious cracks with identifiable openings on the surface (highlighted in red) and possible cracks with continuous darker contrast along GBs (highlighted in green) [16]. After the additional ~9,180 hours of exposure during Phase II, most cracks in these specimens exhibited little growth on the surface. No apparent extension in length nor widening of crack opening were observed for existing obvious cracks. Instead, new short cracks had either grown from previously identified possible cracks or were formed along different GBs, resulting in a slight increase in overall crack density.

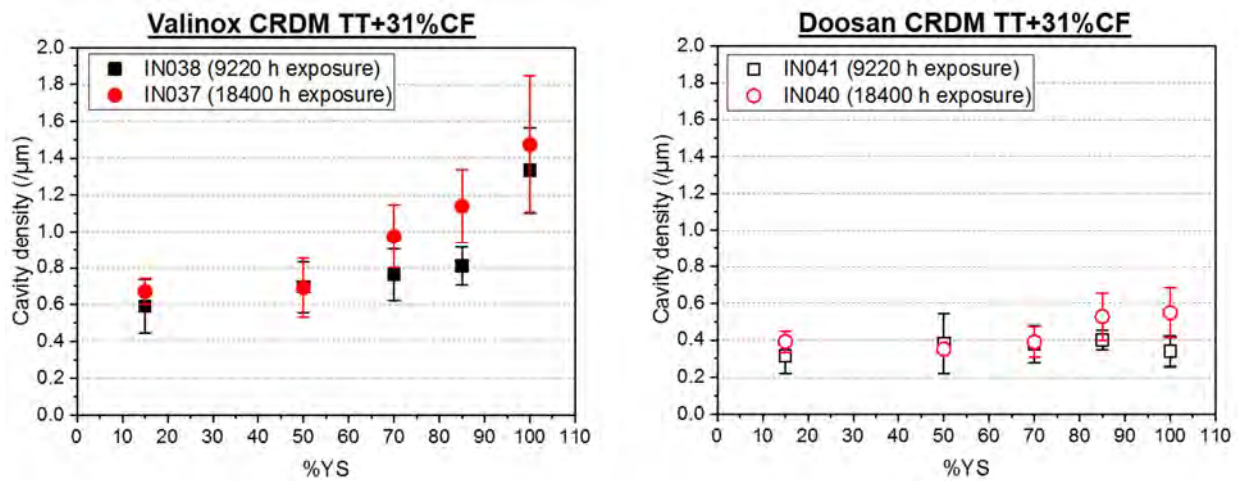
Figure 99. Quantification on cavity density evolution after Phase I and Phase II exposures as a function of applied stress in (a) TT+31%CF Valinox CRDM and (b) TT+31%CF Doosan CRDM SCC initiation specimens.

As mentioned in the Microstructure Characterizations section, quantification has been performed on the TT+31%CF Valinox and Doosan CRDM specimens to evaluate GB cavity evolution with increase in exposure time and applied stress. These two materials exhibit a similar grain size but very different GB carbide morphologies, enabling a direct comparison on the effect of starting GB microstructure. Results are presented in terms of cavity density and cavity coverage per unit GB length as shown in Figures 99 and 100, respectively. The data for these two materials are shown using the same scale to facilitate comparison. The TT+31%CF Doosan CRDM material exhibits an average of one carbide per every 2-2.5 μm along GBs throughout the specimen. The percentage of GB length containing cavities remained constant at ~5% regardless of test time and applied stress. These results suggest that formation of new cavities has not occurred nor has significant growth of existing cavities taken place in the specimens. In contrast, a large increase in cavity density and cavity coverage at GB was found for the TT+31%CF Valinox CRDM material after Phase II exposure in the gauge section loaded at 100% YS. Although there is scatter in the measurements for these two parameters due to boundary-to-boundary variability in

cavity distribution, the average cavity spacing has grown in average from one cavity per every 0.75 μm after Phase I to one per every 0.67 μm after Phase II, and to one per every 0.5 μm in extreme cases. Meanwhile, the average percentage of cavity coverage at GBs, i.e. decohered fraction of GB has almost doubled in the gauge from $\sim 15\%$ to $\sim 25\%$, and for some GBs it reached as high as $\sim 37\%$. It should be noted that cracked portion of the GBs observed in the gauge section were excluded from quantification, therefore the actual value of these two parameters at 100% YS are even higher. The effect of applied stress also started to pick up as testing time proceeds. After Phase I exposure, the GB cavity density and coverage were relatively low until reaching 100% YS, but the increasing trend has become clear starting from $\sim 70\%$ YS after Phase II exposure. Nevertheless, the absolute values are still much lower in comparison to those at 100% YS.

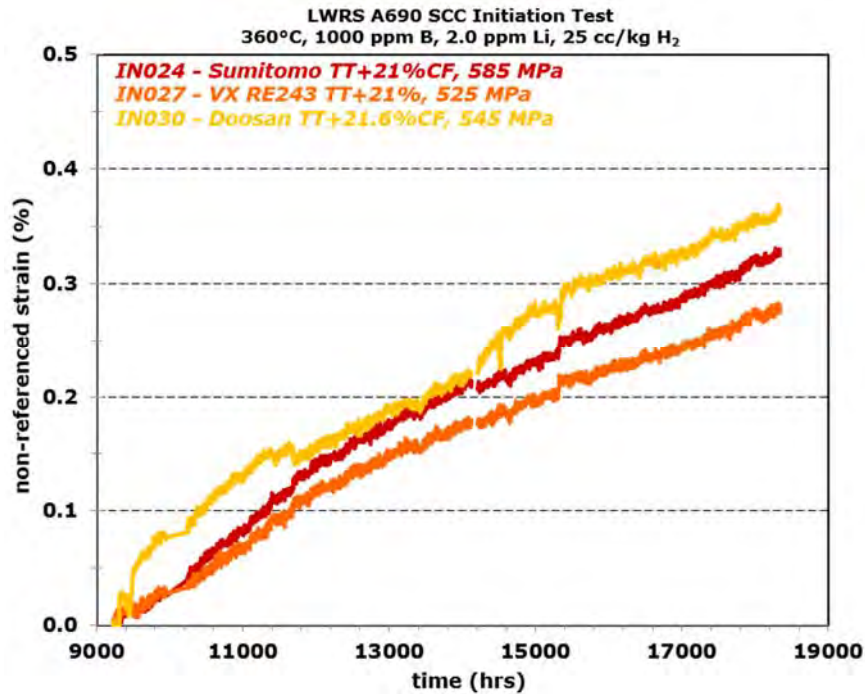
Figure 101. DCPD non-referenced strain response for the instrumented specimens from the three TT+21%CF Alloy 690 CRDM heats during the entire Phase II testing period.

The overall DCPD non-referenced strain response of the instrumented TT+21%CF specimen from the three Alloy 690 CRDM heats during Phase II and Phase III exposure are presented in Figure 101 and Figure 102, respectively. No DCPD indication of crack initiation has been seen in any of these specimens. Plotted using the same scale for the DCPD non-referenced strain in these two figures, it is obvious that these three specimens consistently exhibit a decreasing strain evolution over the entire test period. While resistivity drift is not corrected, this decreasing trend is an indicator of creep that is gradually slowing down. It is also interesting to note that the magnitude of strain evolution in the TT+21%CF specimens is much smaller than that observed in their TT+31%CF counterparts (Figure 81), suggesting % cold work/and the applied stress control the strain evolution for specimens loaded at their yield stress.
