Light Water Reactor Sustainability Program

Long-Term Crack Initiation Behavior of Alloy 690 and Its Weld Metals in PWR Primary Water

Pacific Northwest National Laboratory

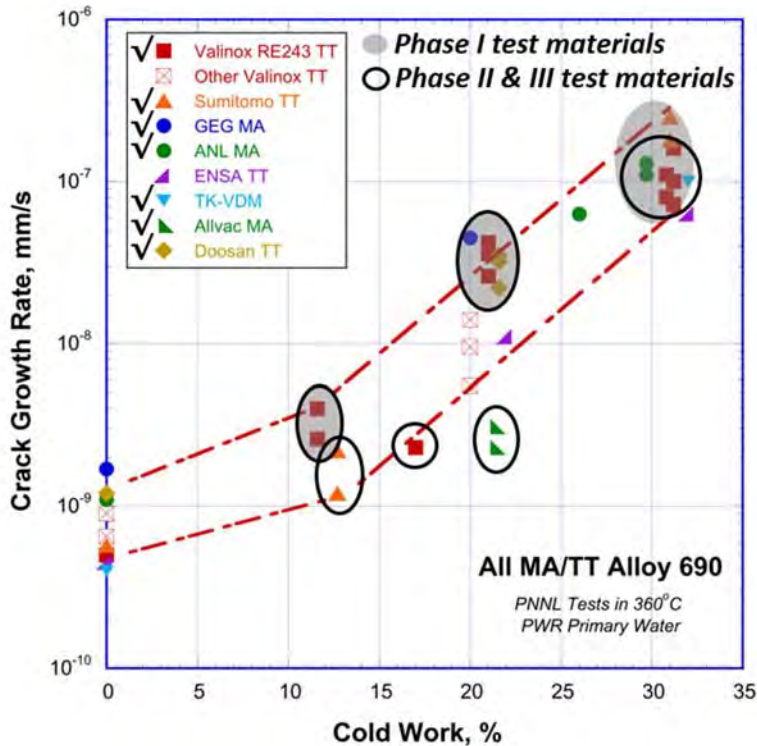
Figure 9. SCC CGR response of TT/MA Alloy 690 materials obtained at PNNL through a Nuclear Regulatory Commission (NRC) project [17, 18]. The heats and cold work levels selected for SCC initiation evaluation at each stage were checked in the label box and circled in the plots, respectively.

Because Alloy 690 shows a strong increase in SCC CGR with cold work, it was determined to assess the susceptibility to SCC initiation in CW Alloy 690 materials. To better understand SCC initiation response in CW Alloy 690 materials, long-term SCC initiation testing has been established and continued since 2014. Figure 9 shows the SCC CGR obtained by our NRC project [17, 18] for the materials that have been selected for SCC initiation evaluation. The research first started with three Alloy 690TT CRDM heats and three TT/MA plate/bar heats that exhibited high SCC crack growth rates at CW levels from 20–30%. These materials are being tested for SCC initiation response in 360°C simulated PWR primary water in 12–31% CW conditions. Starting from Phase II, the test matrix was expanded to include more variations in GB carbide distribution (TT vs. SA), applied stress (100% YS versus 90% YS), and heat IGSCC susceptibility in the highly CW condition (moderate-high CGR vs. low CGR). To-date the study consists of four phases each lasted for approximately one year with selected specimens continuing through all four exposures. Phase I and II exposures were conducted each for approximately one year on 36 specimens in the large SCC initiation test system. 13 specimens were removed after Phase I exposure with another 13 new replacement specimens adding in. 7 specimens were removed after Phase II exposure with another 10 new specimens added. Since crack initiation was detected by DCPD in a highly CW Alloy 690TT Valinox CRDM specimen near the end of the Phase II exposure, decision was made to move three specimens that have a higher susceptibility to SCC initiation than the others from the large test system to a small test system. This gave more flexibility in stopping the test to remove the specimens once crack initiation is detected, while exposure can continue in the large test system without disturbance. It also allows referenced DCPD response to be monitored on these specimens, thus providing more accurate determination of crack initiation. This turned out to be a wise decision as one of the three specimens in the small system did show sign of initiation after ~3,800 hours of additional exposure, and we were able to shut down the test, remove the specimen, and restart the test much more quickly than handling the large 36-specimen system. Besides the initiated specimen, no more specimens were removed after Phase III exposure ended, but it was again determined to move six of the original specimens to a small system for better DCPD monitoring and more flexibility in test control. Therefore, six more new replacement specimens were prepared and added to the large system, making a total number of specimens in test to 42. As of March 2020, Phase IV exposure has been ongoing for ~2,700 hours in the large 36-specimen test system and ~3,500 hours in the small 6-specimen test system with the original specimens now reaching a total exposure time of >31,300 hours. In Figure 10, a progression bar chart is provided illustrating the heat and material conditions evaluated in each phase and their up-to-date exposure times. A more detailed status summary on all the tested and in-test specimens is provided in Table 6.

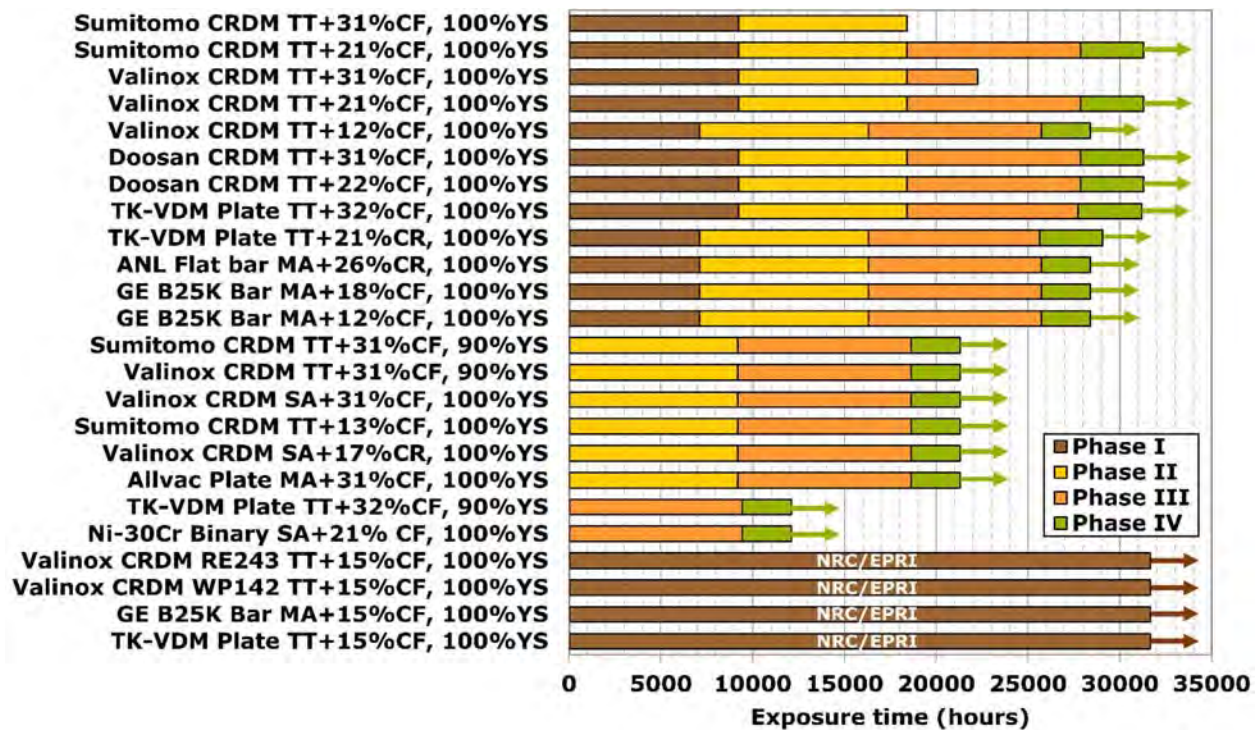
Figure 10. Exposure time of the CW Alloy 690 materials evaluated at Phases I–IV of the SCC initiation testing. The Phase IV is ongoing and the plotted exposure time is up-to-date as of March 2020.

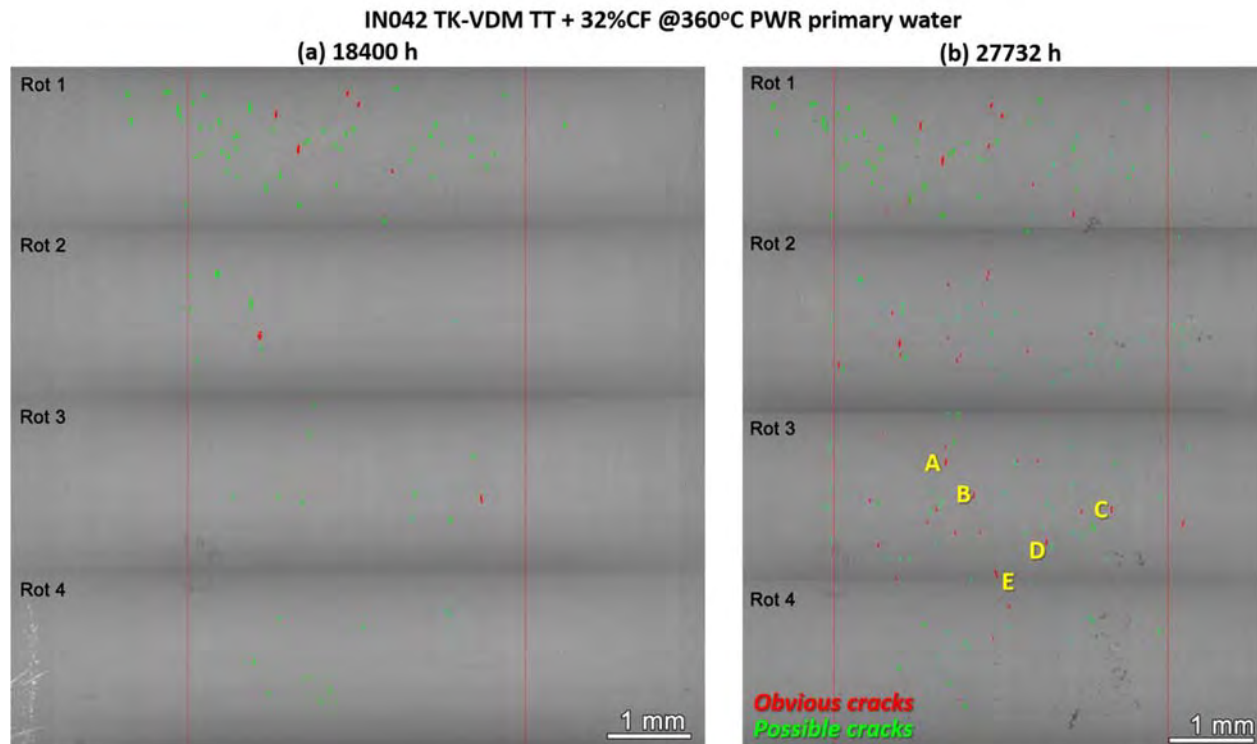
Figure 11. SEM-BSE montage images of the entire gauge surface and part of the fillet surface after Phase II (left) and Phase III (right) exposure in the 1 μ m finish, TT+31.9%CF Alloy 690 TK-VDM plate specimen IN042. Obvious cracks are highlighted in red and possible cracks in green.

As indicated in Table 3, the Alloy 690TT TK-VDM heat features small GB carbides that have similar size to those in the Alloy 690TT Sumitomo and Valinox CRDM heats, but with slightly larger spacings in between. As shown in Figure 11a, only a few obvious short cracks were discovered on the gauge surface of the TT+31%CF TK-VDM specimen IN042 after Phase II exposure (highlighted in red) plus some additional continuous IG features of darker contrast indicative of possible cracks (highlighted in green). After an additional ~1.1 year of exposure, a clear increase in the number of obvious cracks was discovered in the gauge surface of this specimen. These cracks were formed either from features previously identified as possible cracks or GBs that previously appear to be intact with examples shown in Figure 12. To get an idea of the sub-surface morphology of these cracks, FIB trenching was carefully employed to intersect selected cracks towards their tip ending location on the surface. Results revealed a series of densely spaced cavities leading at the crack front in the cross-sections, similar to what was observed in the TT+31%CF Sumitomo and Valinox CRDM specimens after Phase I and Phase II exposure. This suggests that while the formation and aggregation of GB cavities may be slower in the TT+31%CF TK-VDM plate material than in the Sumitomo and Valinox CRDM materials due to larger spacings between GB carbides, it has continued to grow with extended exposure and may have acted as precursor to more crack formation. Since most of the cracks are still quite small and no crack initiation has yet been indicated by DCPD, decision was made to put this specimen back to test for longer exposure.

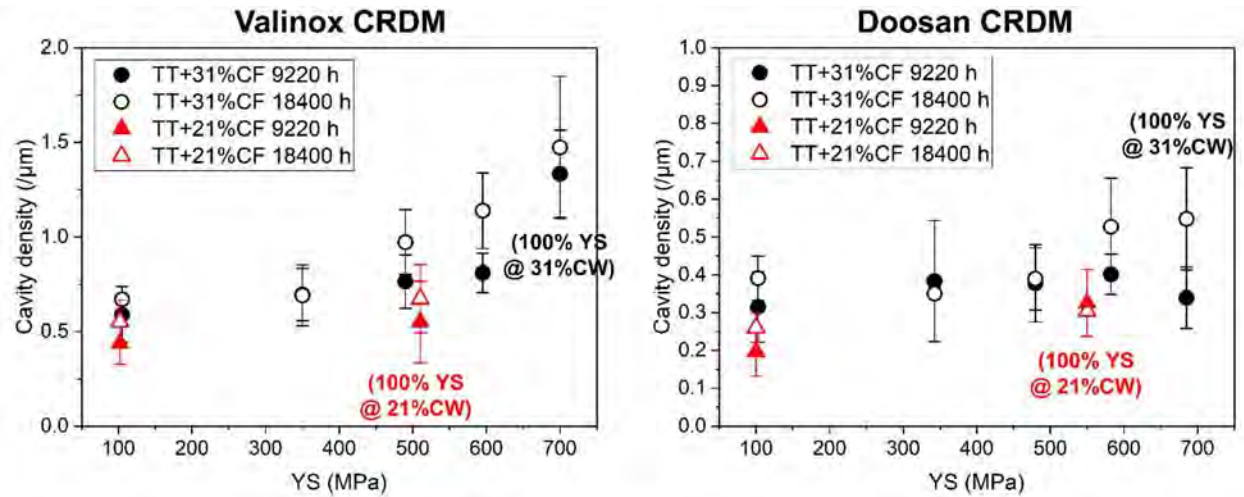
Figure 25. Quantification on cavity density evolution after Phase I and Phase II exposures as a function of applied stress in (a) 21% and 31%CF Alloy 690TT Valinox CRDM and (b) 21% and 31%CF Alloy 690TT Doosan CRDM SCC initiation specimens.

To facilitate the prediction of long-term degradation behavior of service materials, quantification has expanded this fiscal year to investigate materials with lower cold work levels. The same Alloy 690TT Valinox and Doosan materials were investigated, this time in specimens at moderate cold work levels of 21% in the gauge center (at 100% YS) and the reference shoulder region (at $\sim 15\%$ YS). The new results are plotted in red symbols together with the corresponding TT+31%CF data for cavity density in Figure 25 and for GB cavity coverage in Figure 26. Consistent with the qualitative cross-section observations, the TT+21%CF specimens from both the Valinox and Doosan CRDM heats exhibited a lower cavity density and GB coverage than their 31%CF counterparts after the first 1.1 year of exposure. With the exposure time increased to ~ 2.1 years, the cavity density and GB coverage also increased slightly in both the 15% and 100% YS region in the TT+21%CF Valinox CRDM specimen with actual values reaching the pre-test distribution in its 31%CF counterpart. However, no significant increase in cavity distribution was observed with increase in applied stress from low load to yield stress. In the TT+21%CF Doosan CRDM specimen, the cavity density and GB coverage increase slightly in the low load region but decreased in the highly stressed gauge region. While this is probably due to data scatters, the result indicates in general, little change had occurred in GB cavity distribution over time in this material featuring larger GB carbides with wider spacings.
