Light Water Reactor Sustainability Program

Progress on Dissolved Oxygen Effects Evaluation on the Stress Corrosion Cracking Initiation Susceptibility of Stainless Steel in PWR Primary Water

Ziqing Zhai
Mychailo Toloczko
Pacific Northwest National Laboratory

September 2024
U.S. Department of Energy
Office of Nuclear Energy

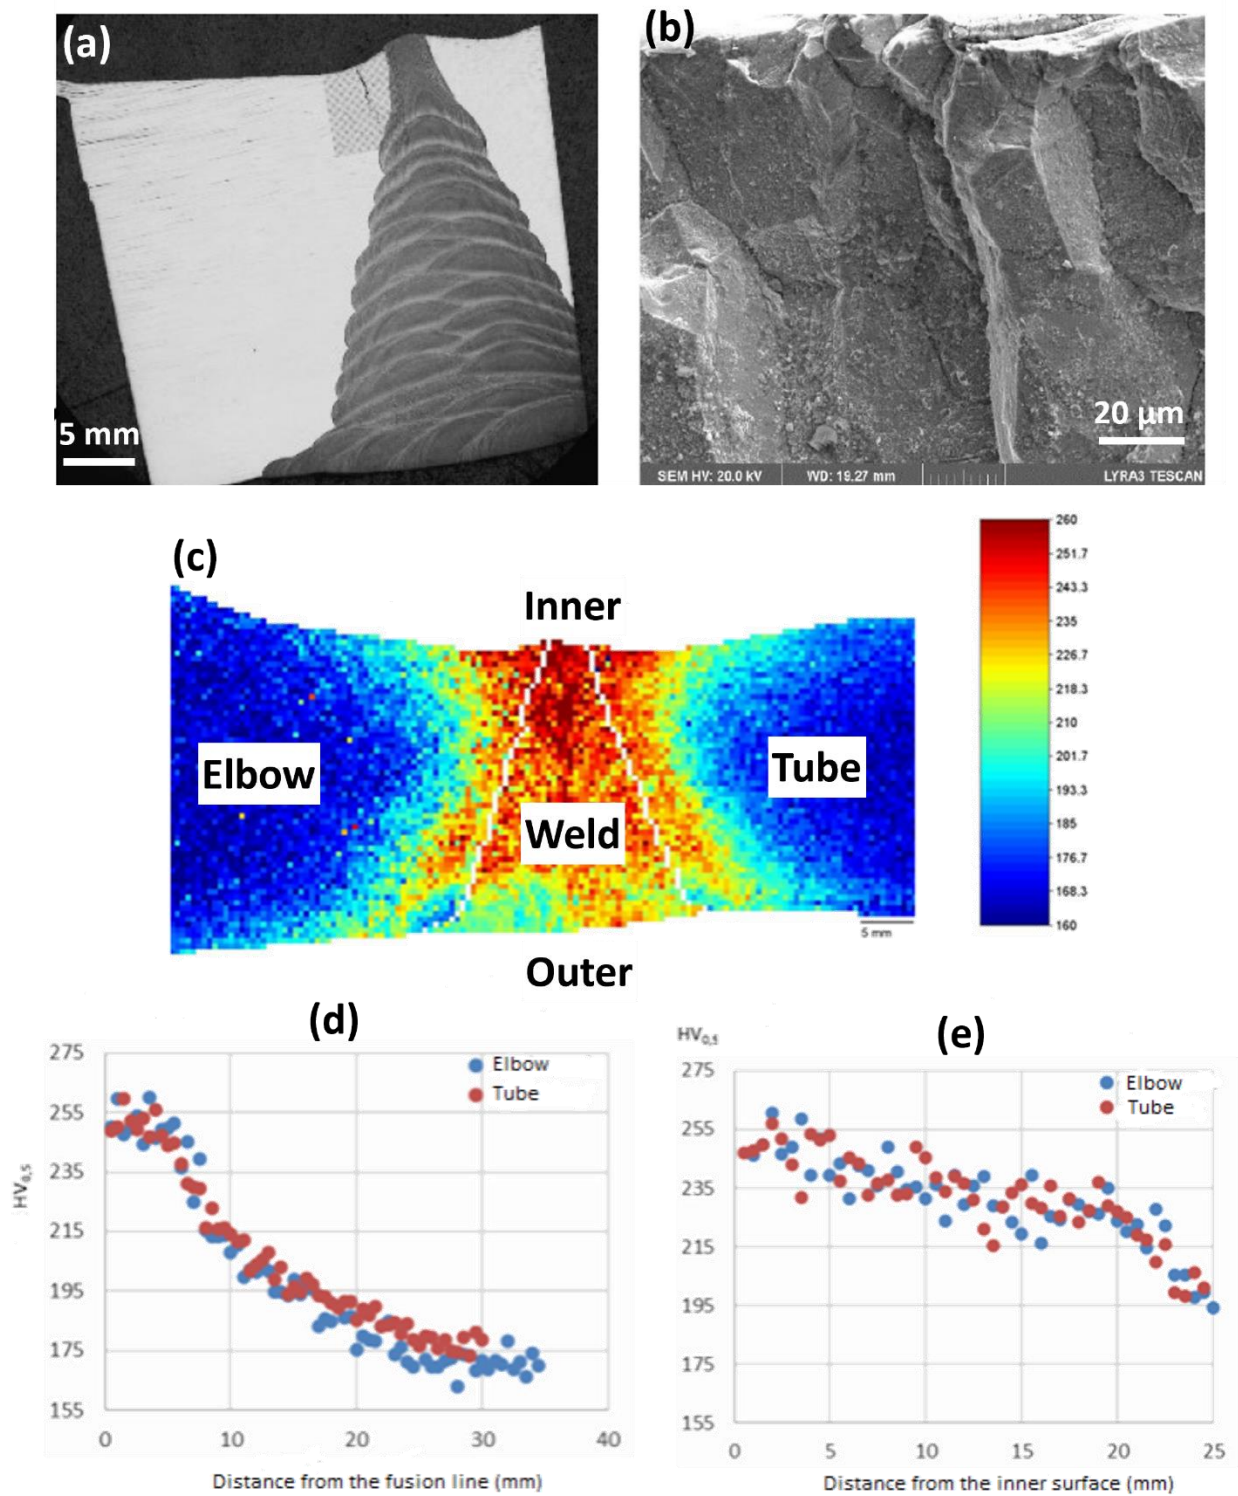
Figure 3. (a, b) Destructive examination and (c–e) hardness measurements of a cross-section containing the SCC crack found in location ① in Figure 2 [7].

These cracks exhibit a circumferential orientation with a large aspect ratio (surface length \gg depth) in the weld heat affected zone (HAZ). As shown in Figures 03 and 04, these elbow welds both have a very large root pass, but the subsequent passes were annealed during welding, which is believed to introduce compressive residual stress in the adjacent base metal [2]. This welding procedure may help explain the wider profile of elevated hardness values measured from the inner face (Figure 3) [7]. The fact that the crack did not grow deeper beyond the root pass also seems consistent with the quick drop in hardness measured from the inner surface near the subsequent passes. It is worth noting that the highest hardness values measured in these two welds did not exceed 270 HV, which is below the 300 HV previously identified as the threshold value based on operational experience for SCC initiation to occur in PWR primary water [8].

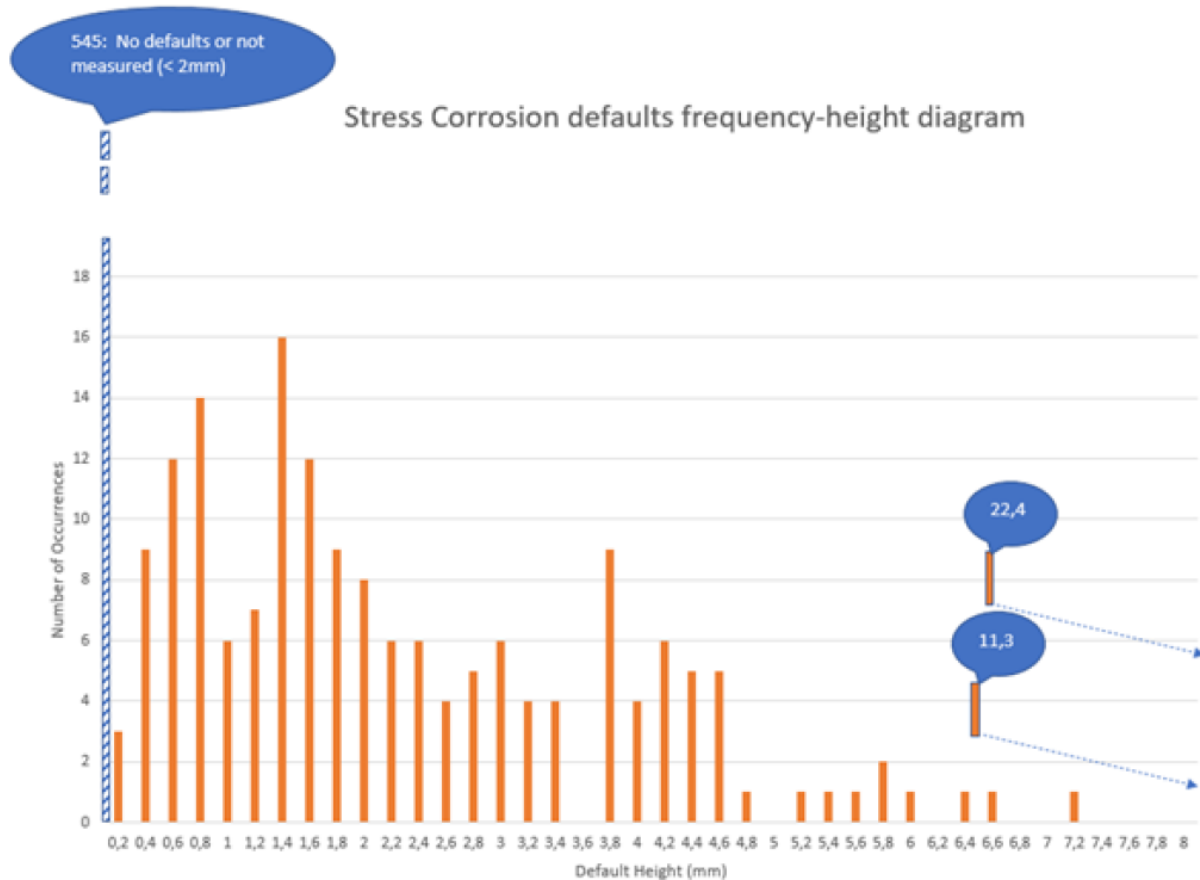
Figure 7. Distribution of IGSCC cracks depth (in mm) on emergency core cooling systems and RHR system welds examined between the end of 2021 and the beginning of 2023 in French PWRs [13].

As shown in Figure 7, most of these detected IGSCC remained shallow, with only two cracks exceeding a depth of 10 mm, and another nine cases exhibiting IGSCC cracks between 5 to 10 mm deep. Both welds made of 304L and 316L exhibited cracks. According to the manufacturing reports, various types of welding methods were used on the welds with IGSCC cracks including automated or tungsten inert gas welding, shielded metal arc welding, or flux welding. On some welds, a combination of these methods was used [13]. No specific welding method was found to be the most susceptible to SCC, but there are indications that automated process tends to create deeper cracks [15]. The fact that the cracks did not grow deeper is likely associated with decreasing weld residual stress from inner surface to the outer surface. However, questions remain on the cause of the initiation of these SCC cracks. According to the Autorité de Sûreté Nucléaire (ASN), elevated stresses caused by cyclic loading due to thermal stratification are suspected to be the primary contributor [2], followed by weld residual stress and potentially elevated oxygen due to dissolved oxygen in make-up water [16].

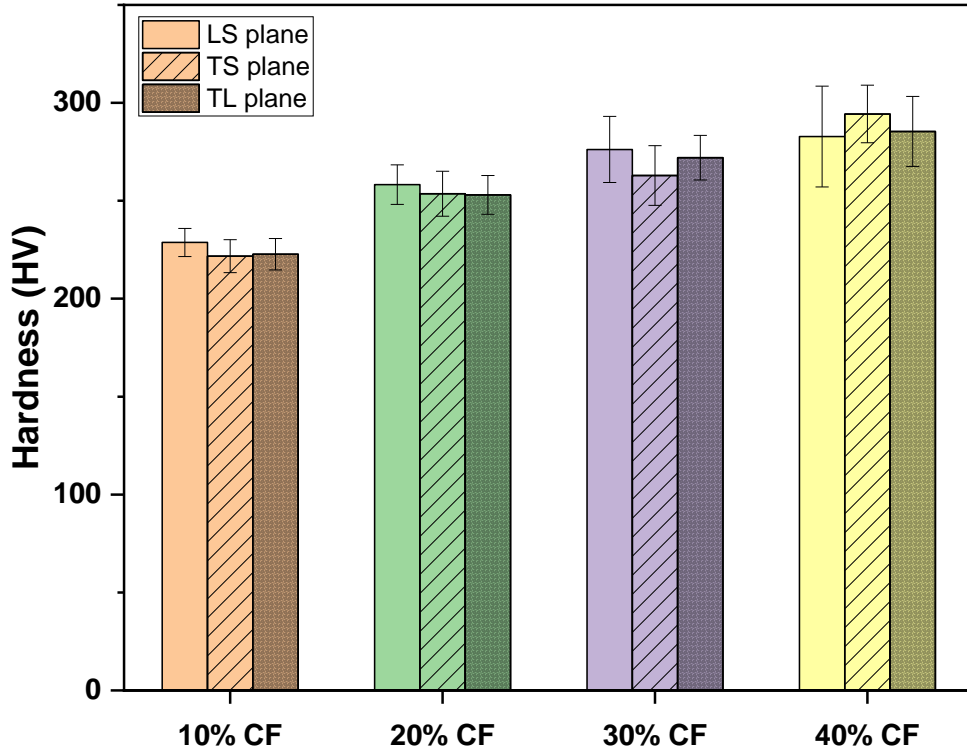
Figure 25. Hardness values measured on the LS, TS, and TL planes of the 304L blocks cold forged to 10%, 20%, 30%, and 40% reduction in thickness.

The measured average hardness data is summarized in Table 5 and plotted in Figure 25 for better visualization. The average hardness values measured from each plane steadily increased with increasing cold work, and the difference in hardness values among the planes are within statistical error at each cold forge level. As shown in Table 5, the overall average hardness measured for the 10%CF 304L material is ~224 HV, and increased by 30 HV to 255 HV for the 20%CF material. Then the increase in hardness slowed down and increased by 15HV for each 10% additional increment in cold forging level, resulting in an average hardness value of ~288 HV for the 40%CF 304L material. This trend is best interpreted by a power law fit as shown in Figure 26, which suggests that 50%CF level is required to reach an overall average hardness of ~300 HV, consistent with what was reported in literature [8].

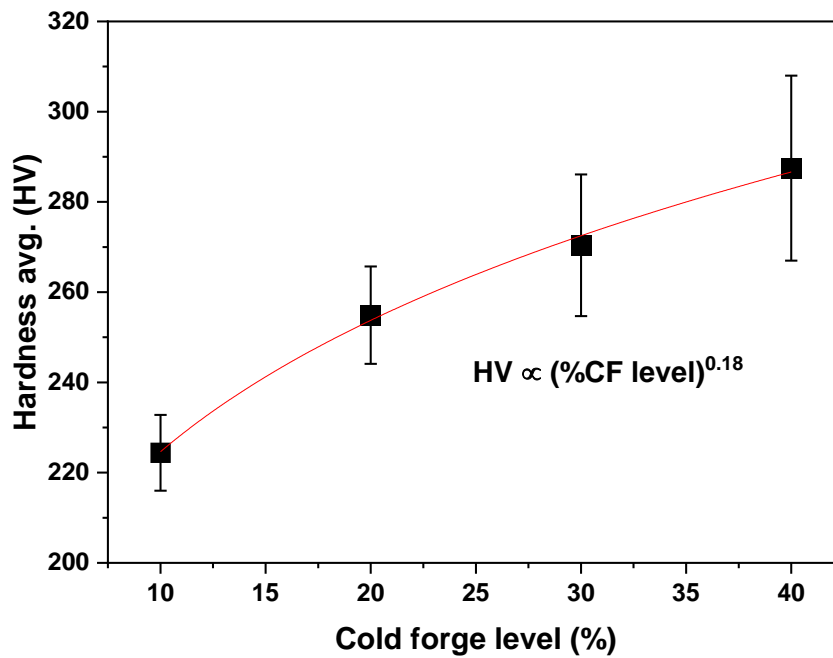
Figure 26. Overall average hardness values as a function of cold forge level.

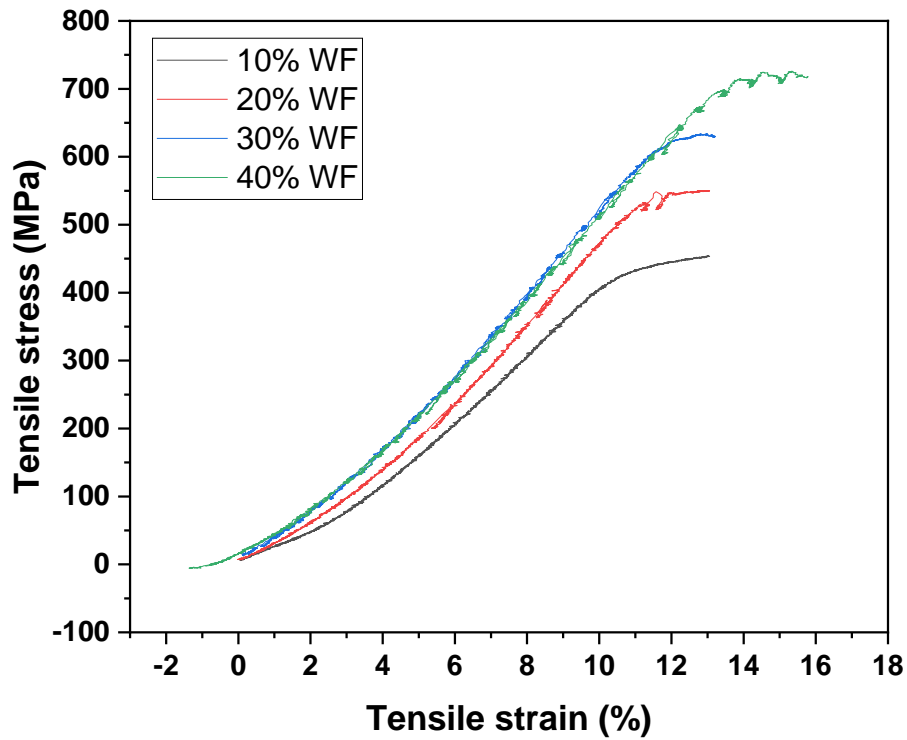
Figure 29. Stress vs. strain curve for the 10–40%CF 304L materials obtained in 300°C air.

Tensile properties were measured on materials cold forged to all four levels. The orientation and dimensions of the tensile specimens used for this testing have been shown in Figures 12 and 28, respectively. The testing temperature was set at 300°C, the same temperature at which the SCC initiation testing will be performed. The stress vs. strain curve for all four cold forged condition is shown in Figure 29. Since the primary objective was to obtain the YS of these materials, the tests did not continue till specimen failure, but were stopped after a few percentages of plastic strain were reached after yielding. The obtained YS values are plotted against the corresponding hardness data of the same material and summarized in Figure 30. They were correlated with both the hardness values measured from the TS plane, i.e., the plane normal to the loading direction of the tensile specimens, and the overall averaged hardness values measured from all three planes. A very similar linear dependence was found between the hardness values and material's YS in the form of $hardness = A \times YS$, where A varied between 0.28 and 0.30.

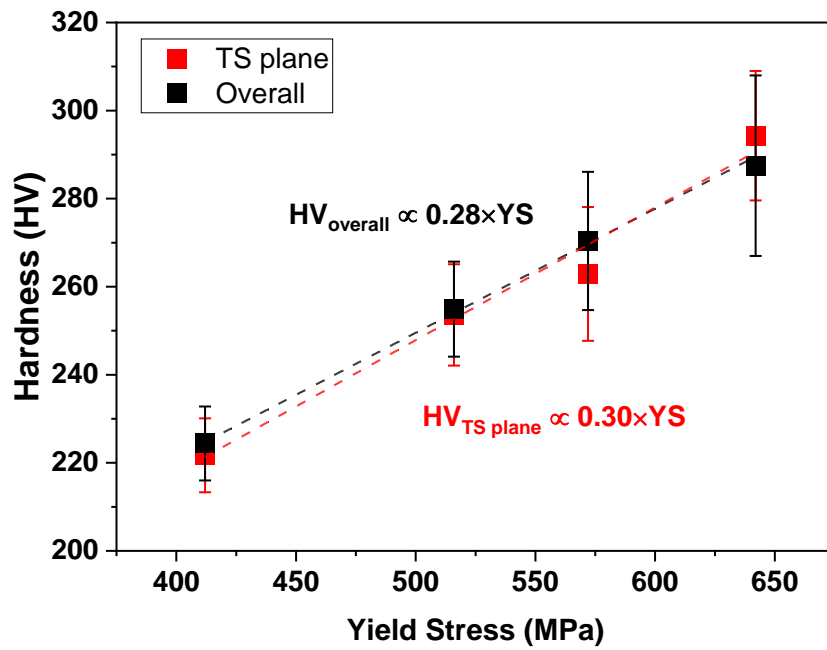
Figure 30. Hardness measured on the TS plane and the overall average hardness measured from all three planes in the 10–40%CF 304L materials as a function of their yield stress.

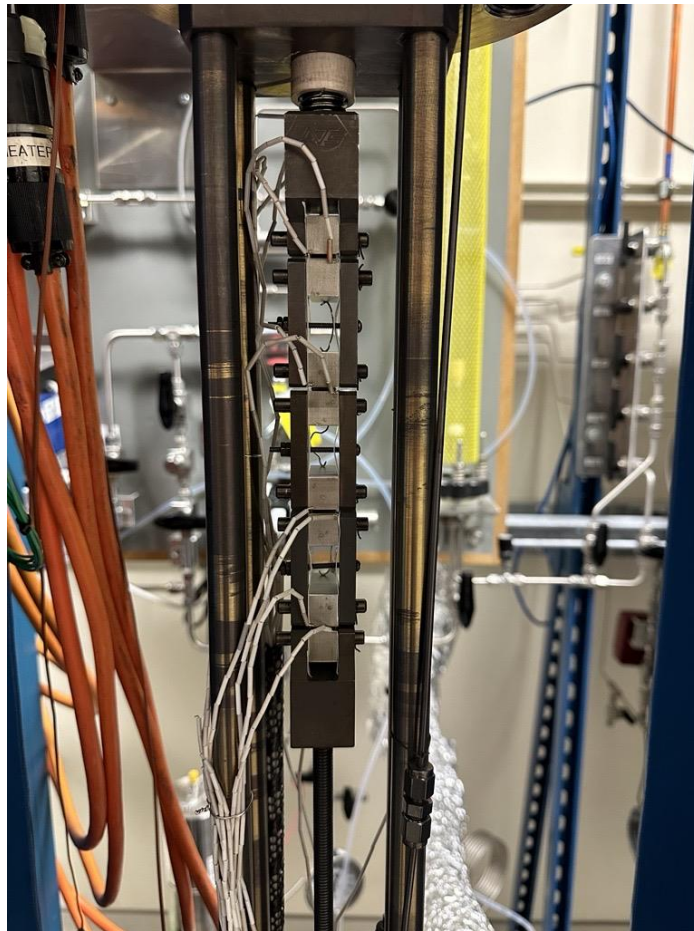
Figure 33. The loading train with four BNCT specimens installed and spot welded with insulated Pt wires for in-situ DCPD monitoring of crack initiation and growth.

The two mid-sized LWRS SCC test systems (denoted as LWRS2 and LWRS3 hereafter) are being used for the first phase testing. The SCC test systems are equipped with active load control via a high-precision servo-electric load control system and in-situ monitoring using direct current potential drop (DCPD) technique. Detailed information on the development of the SCC test system and DCPD technique can be found in previous publications [25]. As shown in Figure 33, four BNCT specimens (one from each cold forging condition) are loaded in series in each test systems. The test environment simulates PWR primary water with 1000 ppm of boron and 2 ppm of lithium at 300°C, the highest operating temperature reported for the SS auxiliary piping.

During the test, the DO content was maintained at the preset value via running an oxygen feeding tube to the water column of each test system. Mixed oxygen-nitrogen gas bottles with specific volume ratios were purchased and fitted with a 0-60 PSI regulator that was set to 15 PSI to ensure a steady flow out from the bottle. The tubing from the regulator to the water column gas inlet was then attached to an isolating valve in line with a metering valve. Once all connections were made, the lines were flushed of any potential residual gases before the test was started. The metering valve was then set at the calculated pressure needed to achieve the desired DO content in each test system. The combination of using the metering valve with a pressure regulator on the water column allows a steady pressure to be maintained on the oxygen feed thus constant DO content during testing. In addition, the outlet conductivity of the flow loop is being continuously monitored during testing, providing an indicator on the stability of the DO level in the test system.

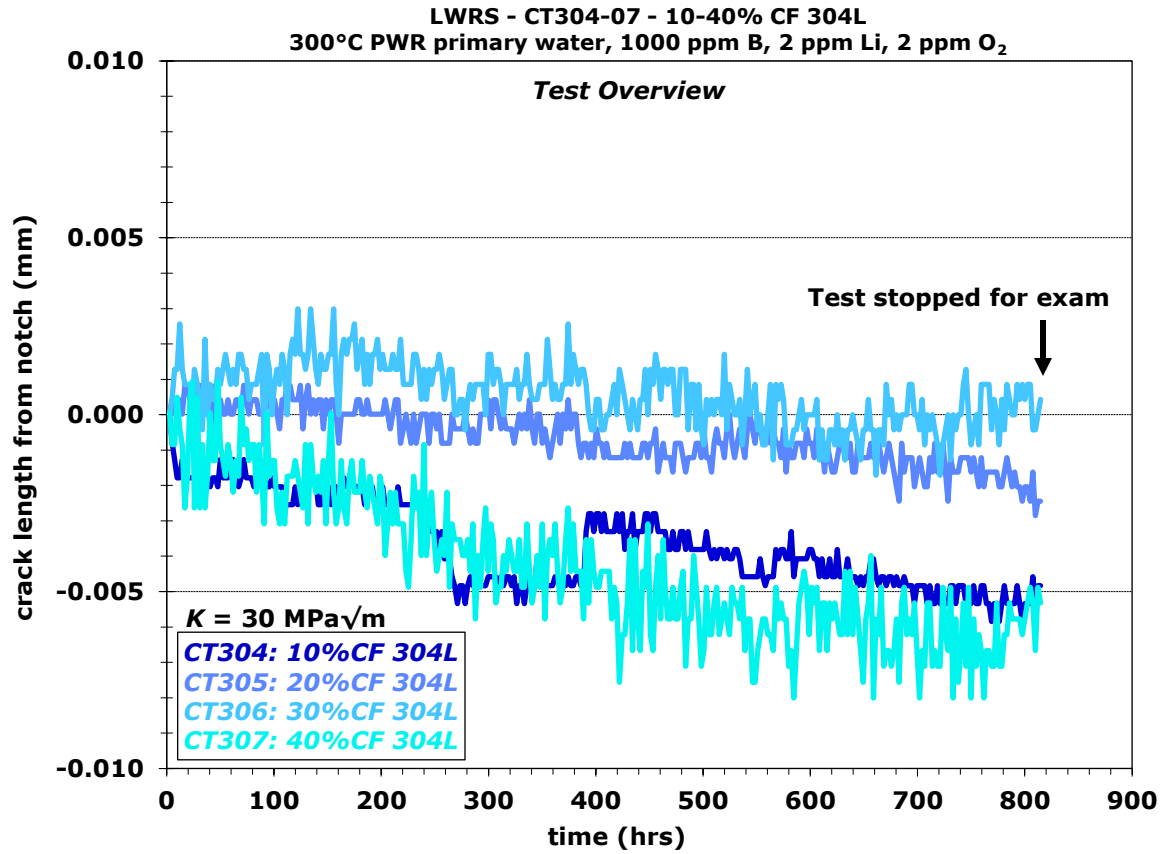
Figure 34. Test overview of the crack length evolution in 10–40% CF 304L BNCT specimens in 300°C PWR primary water containing 2 ppm DO.

This test was started at constant load with a stress intensity (K) of $\sim 30 \text{ MPa}\sqrt{\text{m}}$ for four BNCT specimens CT304-307, one each from the 10, 20, 30, and 40% CF condition. These K levels are better described as a “pseudo K ” as they are calculated assuming a tight crack is present across the specimen versus a blunt notch with a smooth surface. The K of $30 \text{ MPa}\sqrt{\text{m}}$ was chosen as it has been commonly used for SCC crack growth rate testing of cold worked stainless steels, and is considered as a reasonable start point for the SCC initiation test.

The test was started in early July 2024 and an overview of the DCPD-indicated crack length evolution from the notch of the four tested specimens is shown in Figure 34. The trend for all specimens during the first 800 hours of testing are generally flat or slightly negative, which should be phantom and is likely associated with internal strain redistribution under loading and the oxides formation on the notch surface. Since many studies in literature pointed out that constant load may not be sufficient to induce SCC initiation in 304L/316L even in highly cold worked conditions, it was decided to stop the test after reaching 800 hours of exposure to examine the notch surface of all specimens for precursor damage and initiation indications. The results are summarized in Figures 35–38 for the 10%, 20%, 30%, and 40%CF specimen, respectively. Although not obvious in these low-magnification images, formation of surface oxides was confirmed on the notch surface of all specimens. No prominent evidence of intergranular corrosion was observed in any of these specimens. It is worth noting that a high density of slip bands were identified on the notch surface of the 10% and 20%CF 304L specimens, with examples shown in the lower images in Figures 35–36. In comparison, no slip bands were observed in the 30% and 40%CF 304L specimens (Figures 37–38). These observations suggest that the constant load at $30 \text{ MPa}\sqrt{\text{m}}$ had led to substantial localized hardening in the notch region of the 10% and 20%CF 304L specimens but to a much less degree in the 30% and 40%CF 304L specimens, which is consistent with the lower YS measured for the 10% and 20%CF 304L materials (Section 3.3.5). Was et al. [26] has long been suggesting that dislocation channels, presented in the form of stacked slip planes, has a key role in irradiation assisted SCC initiation in austenitic stainless steels. When encountering a grain boundary (GB), the dislocation channels (DC) can either transfer to a neighboring grain (i.e., continuous DC) or terminate at the grain boundary (i.e., discontinuous DC), resulting in very different strain/stress states at the DC-GB site. The discontinuous DC-GB site exhibit a much higher stress and has been shown to lead to a much higher probability of cracking than that for continuous DC-GB sites. In addition, it has been reported that a high propensity for crack initiation was seen when discontinuous dislocation channels intersect MnS inclusions in 304L [27]. Since MnS inclusion has been confirmed in the 304L being tested in this study, it would also be of interest to evaluate the interactions between DO level, precipitates, and loading condition to obtain a better understanding of SCC initiation mechanism in these CF 304L materials when applicable.

As the immediate next step, it was decided to increase the constant load from 30 to $40 \text{ MPa}\sqrt{\text{m}}$ on all specimens during the subsequent testing and monitor the DCPD response for at least 1,000 more hours. Another test interruption is planned after that and future testing conditions will be determined based on the next-round SEM examination results. Currently, the four BNCT specimens CT304-307 have been reinstalled in LWRS2 in preparation for the test restart.

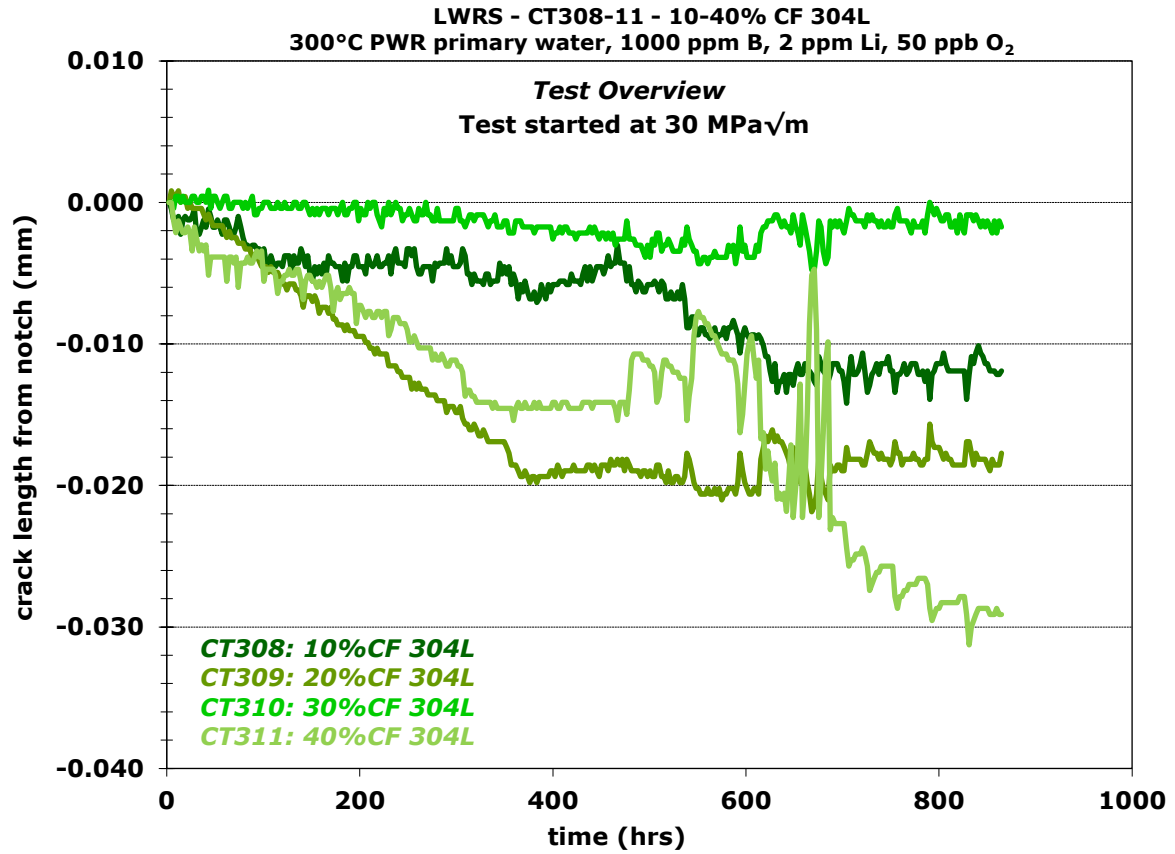
Figure 39. Test overview of the crack length evolution in 10–40% CF 304L BNCT specimens in 300°C PWR primary water containing 2 ppm O₂.

This test was started in August 2024 at the same loading condition as the test with 2 ppm DO on another set of four CF 304L specimens CT308–311, one each from the 10%, 20%, 30%, and 40% CF condition. The DO content of this test is maintained at 50 ppb. A constant load at a “pseudo K ” of ~ 30 $\text{MPa}\sqrt{\text{m}}$ is applied on all the specimens. The test overview of the DCPD-indicated crack length evolution from the notch of the four tested specimens is provided in Figure 39. The test currently reached a similar total exposure time (~ 860 hours) as the test in LWRS2, showing a generally flat or slightly negative slope in crack length evolution for all specimens. This suggests that no obvious crack initiation has yet occurred in any of the specimens. Since the notch surface morphology of the specimens likely are very similar to those observed in CT304–307, no test interruption is planned at the moment to stop the test for notch surface examinations. It has been decided to increase the constant load from 30 to 40 $\text{MPa}\sqrt{\text{m}}$ together with the test in LWRS2 and monitor the crack length evolution for at least another 1,000 hours. After that, the specimens will be taken out for detailed notch surface examination to devise the testing plan for subsequent exposure.
