Oxygen Effects on Stress Corrosion Cracking Initiation Susceptibility of Stainless Steel in PWR Primary Water

Ziqing Zhai
Mychailo Toloczko
Pacific Northwest National Laboratory

September 2025
U.S. Department of Energy
Office of Nuclear Energy

**Light Water Reactor Sustainability Program
Materials Research Pathway**

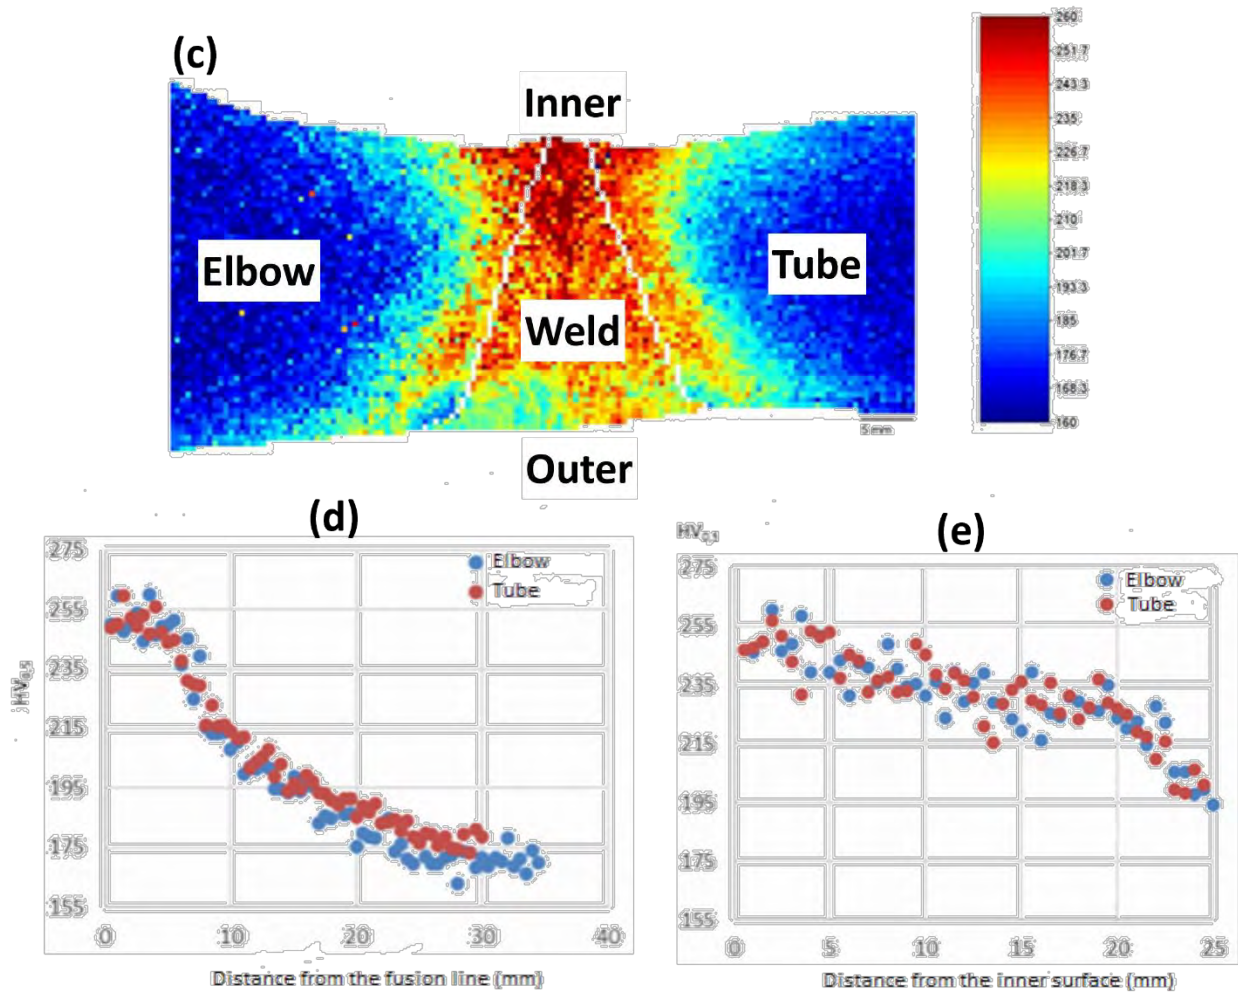
Figure 3. (a, b) Destructive examination and (c–e) hardness measurements of a cross-section containing the SCC crack found in location ① in Figure 2 [8].

These cracks exhibit a circumferential orientation with a large aspect ratio (surface length \gg depth) in the weld heat affected zone (HAZ). As shown in Figures 3 and 4, these elbow welds both have a very large root pass, but the subsequent passes were annealed during welding, which is believed to introduce compressive residual stress in the adjacent base metal [2]. This welding procedure may help explain the wider profile of elevated hardness values measured from the inner face (Figure 3) [8]. The fact that the crack did not grow deeper beyond the root pass also seems consistent with the quick drop in hardness measured from the inner surface near the subsequent passes. It is worth noting that the highest hardness values measured in these two welds did not exceed 270 HV, which is below the 300 HV previously identified as the threshold value based on operational experience for SCC initiation to occur in PWR primary water [9].

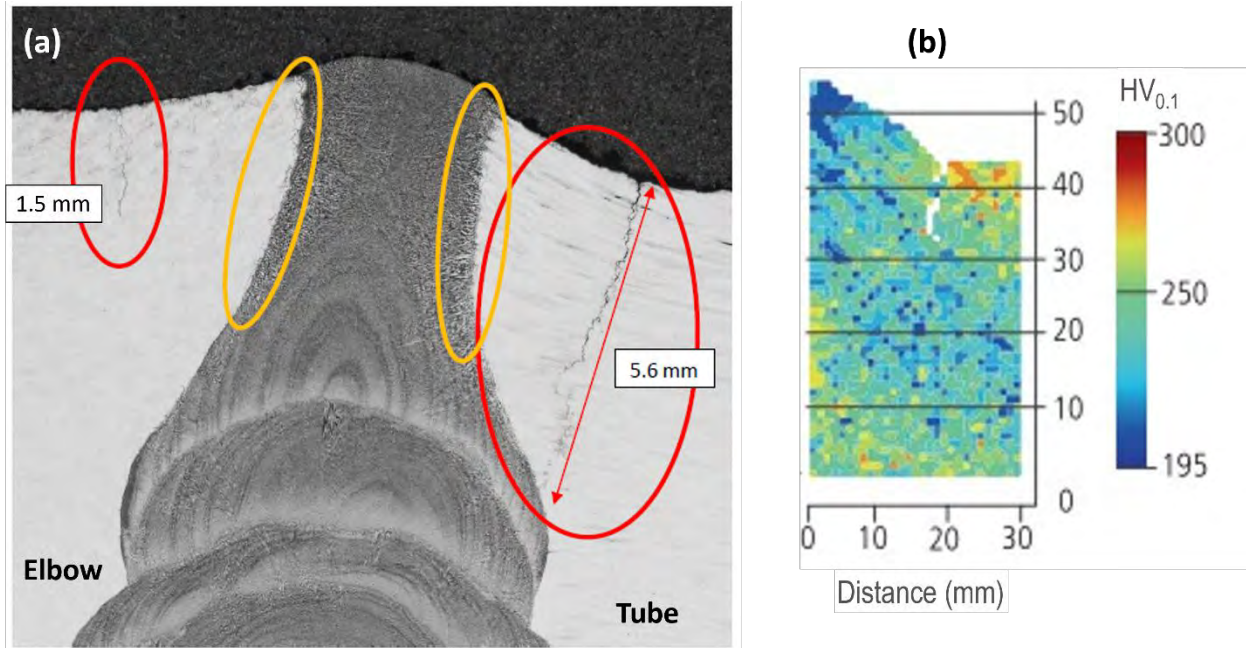
Figure 4. (a) Destructive examination of a cross-section containing the SCC cracks found in location ② in Figure 2, and (b) hardness map including part of the weld, HAZ, and base metal of the tube side. The location where the 5.6 mm-long crack is marked in (a) appears to coincide with the high-hardness area measured near the inner surface [13].

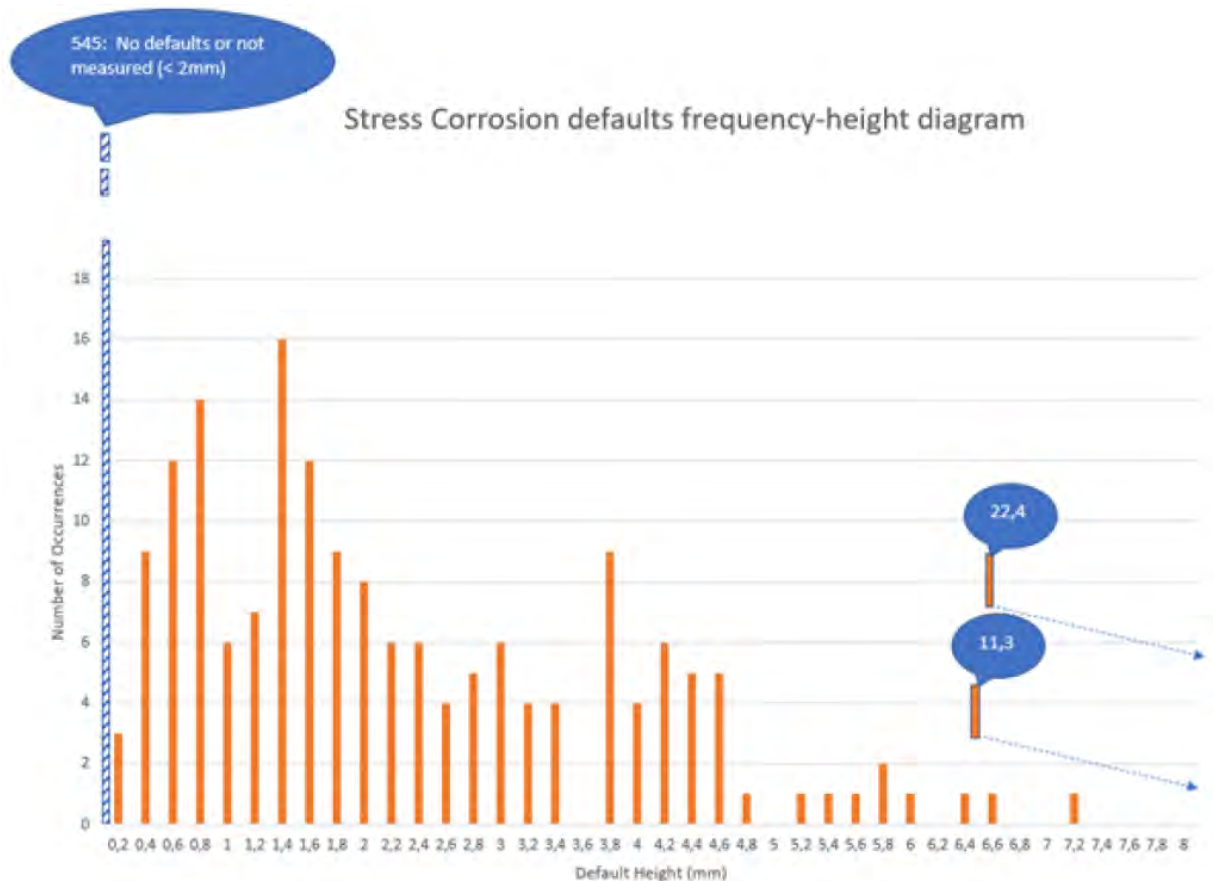
Figure 7. Distribution of IGSCC cracks depth (in mm) on emergency core cooling systems and RHR system welds examined between the end of 2021 and the beginning of 2023 in French PWRs [14].

As shown in Figure 7, most of these detected IGSCC remained shallow, with only two cracks exceeding a depth of 10 mm, and another nine cases exhibiting IGSCC cracks between 5 to 10 mm deep. Both welds made of 304L and 316L exhibited cracks. According to the manufacturing reports, various types of welding methods were used on the welds with IGSCC cracks including automated or tungsten inert gas welding, shielded metal arc welding, or flux welding. On some welds, a combination of these methods was used [14]. No specific welding method was found to be the most susceptible to SCC, but there are indications that automated process tends to create deeper cracks [16]. The fact that the cracks did not grow deeper is likely associated with decreasing weld residual stress from inner surface to the outer surface. However, questions remain on the cause of the initiation of these SCC cracks. According to the Autorité de Sûreté Nucléaire (ASN), elevated stresses caused by cyclic loading due to thermal stratification are suspected to be the primary contributor [2], followed by weld residual stress and potentially elevated oxygen due to dissolved oxygen in make-up water [17].

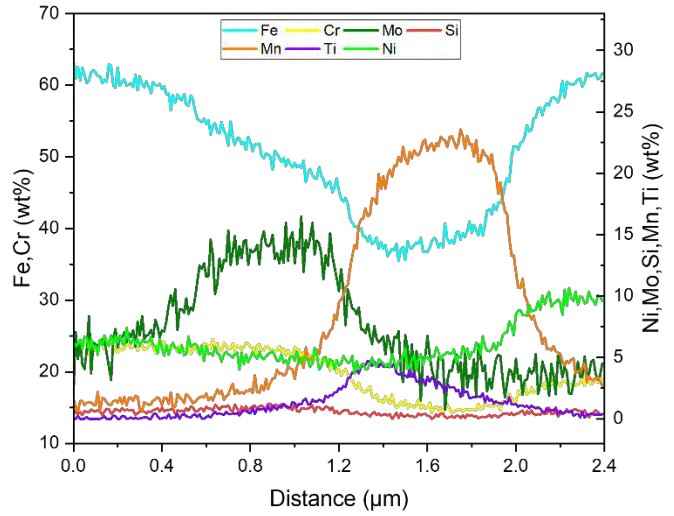
Figure 27. SEM-BSE image and EDS line scan of two precipitates residing on the delta ferrite-matrix interface in the 10%CF 316L material.

Then the EDS analyses were performed with a focus on evaluating the precipitates observed in the delta ferrites or along the interface between the delta ferrites and the matrix. An example is provided in Figure 26 on the 20%CF 316L material, where the precipitates that feature a brighter contrast than the delta ferrites and the matrix in the SEM-BSE image are predominantly enriched by Mo with minor enrichment of Si. In addition, a darker precipitate observed in the upper center region of the image, next to Mo-rich precipitates near the delta ferrite-matrix interface, is essentially enriched in Mn, indicating the presence of manganese sulfide (MnS). In fact, a mild presence of MnS inclusions was observed in the 316L materials cold forged to different levels, as evidenced by EDS line scans shown in Figures 27 and 28 for the 10% and 30% CF 316L, respectively. They frequently coexist with other precipitates such as

Mo-rich precipitates and TiAlO particles (Figures 26, 27, and 28b). The association of MnS with delta ferrite interfaces suggests preferential segregation during solidification, influenced by localized chemical composition and phase transformation dynamics. These inclusions are known to be initiation sites for pitting corrosion, and may impact localized mechanical properties. It would be interesting to evaluate their role in SCC initiation in the subsequent tests.

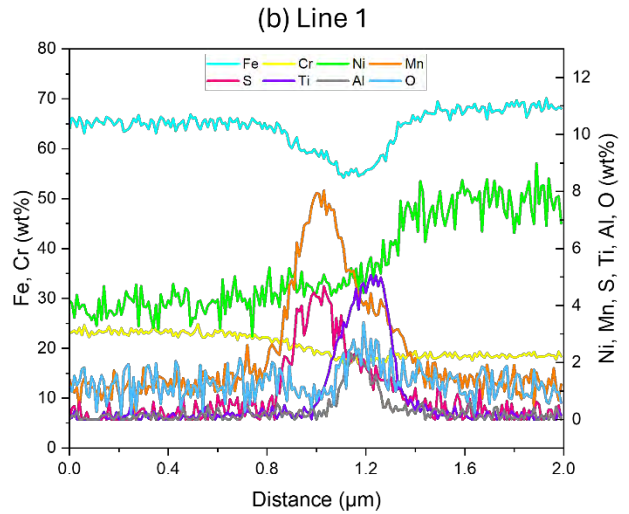
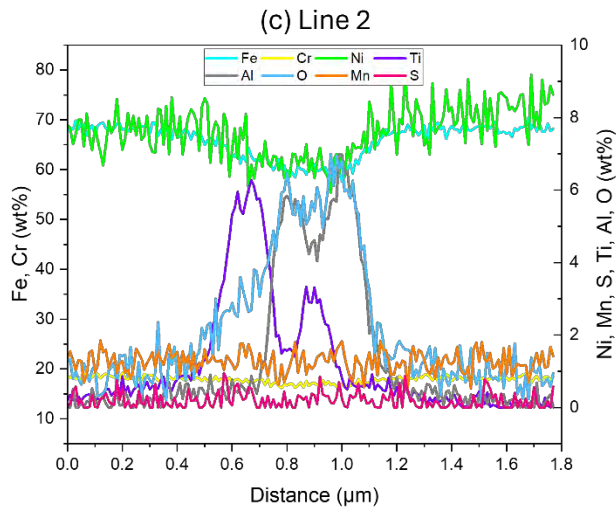
Figure 28. SEM-BSE image and EDS line scans of three precipitates located in or near a delta ferrite in the 30%CF 316L material.

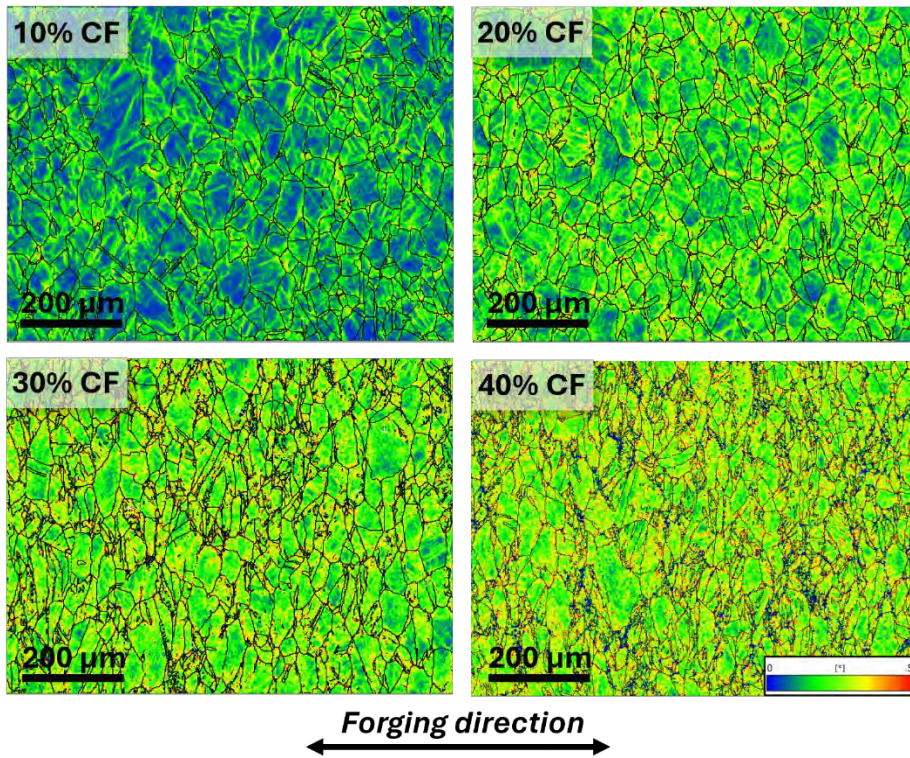
Figure 32. Comparison of EBSD KAM maps taken at 150X on the TS plane of the 10, 20, 30, and 40%CF 316L materials.

EBSD was performed on the 316L materials following a similar procedure used for 304L as described in Section 3.3.1.2. All EBSD were performed in the center of the TS plane sample as shown in Figure 13b. Microstructural comparisons between different levels of cold work were first carried out at constant settings using a 150X magnification with a 2 μm step size, and the results are presented in Figures 29–34. The inverse pole figure maps (Figure 29) and pole figures (Figure 30) illustrate the texture development as deformation progressed. In the 10%CF material, the grains exhibit relatively random orientations indicative of a less pronounced texture. With the increase in cold forge level, especially in the 30% and 40%CF materials, the grains show stronger alignment along specific crystallographic directions, reflecting the growing influence of deformation-induced texture formation and the activation of slip systems. Phase identification primarily consisted of differentiating between BCC (second phase) and FCC (matrix) iron and the results are presented in Figure 31. The stringers marked in red in these maps are identified as of BCC structure. Combined with the results of EDS analysis on these features, it is further confirmed that they are delta ferrites instead of strain-induced martensite, since strain-induced martensite is not compositionally different from austenite. The KAM maps shown in Figure 32 provide a detailed visualization of local strain variations within the microstructures of cold forged 316L. At 10%CF level, elevated strains are generally localized to regions in the vicinity of high-angle grain boundaries (HAGB). The increase in cold forge level clearly led to increasingly pronounced and widespread strains through the grains and localized areas of high misorientation, suggesting dislocation pile-ups and strain accumulation. In Figure 33, GB types are highlighted for HAGBs and twin boundaries, where an obvious increase in HAGBs was observed with the increase in cold forge level. These changes are indicative of progressive grain refinement via the deformation processes, which will likely result in changes of mechanical properties such as strength and hardness. In addition, grain boundary distribution analysis was performed with respect to the FCC and BCC phases and the results are summarized in Figure 34. Cold forging appears to have minimal influence on the grain boundary character distribution within the ferrite phase. Regardless of the cold forge levels, ferrite grains predominantly exhibit low-angle grain boundaries (LAGBs). This stability suggests that ferrite grains are less susceptible to extensive strain accumulation or grain refinement during cold forging. In comparison, the austenitic phase of the matrix behaves differently under cold work conditions. When analyzed as random pairs, the FCC phase exhibits a typical Mackenzie distribution, which is generally observed for materials with random misorientations. This distribution is closely related to the statistical prevalence of HAGBs within the FCC matrix prior to deformation, reflecting the structure's grain boundary equilibrium state. Cold forging did induce changes in boundary characteristics as deformation progresses, but this random pairing behavior in terms of misorientation distribution was generally preserved in the 10% and 20% CF materials, while progressively larger offset towards higher angles was observed when the cold forge level was increased to 30% and then 40% reduction in thickness. Another key observation is the distinct increase in the fraction of LAGBs between neighboring grains with increasing cold work. This trend signifies strain-induced adjustments to the misorientation of grain boundaries, with higher cold forge level inducing stronger local substructure formation.

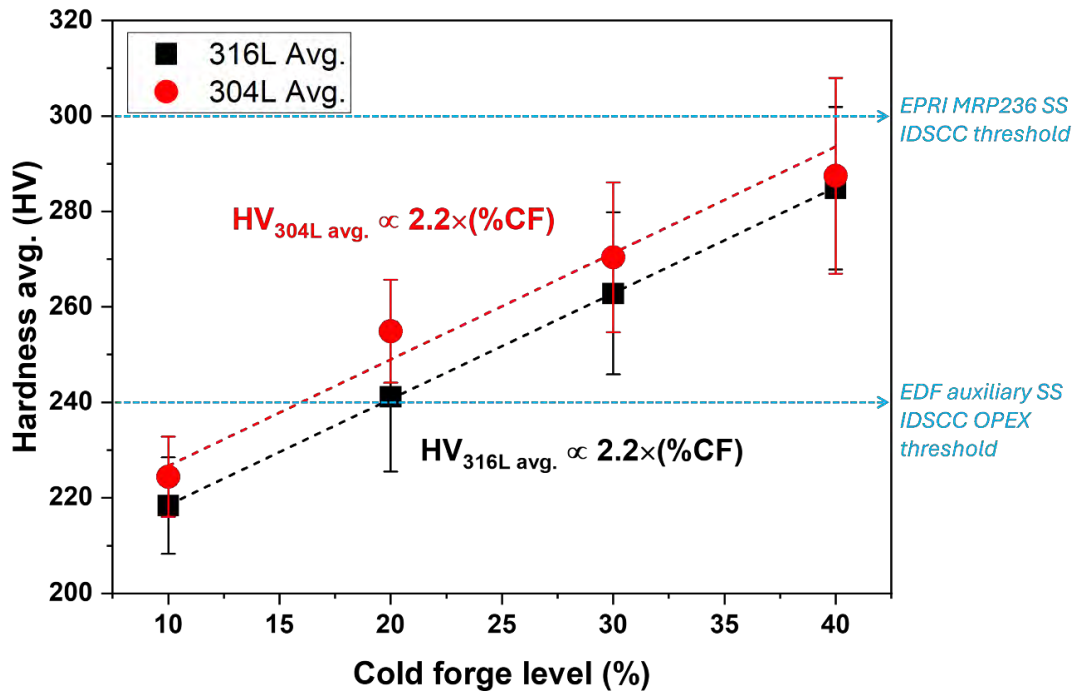
Figure 44. Overall average hardness values of 304L and 316L as a function of cold forge level with linear fit for both materials.

The hardness data clearly suggest there is some difference in the work hardening behavior between 304L and 316L. The overall average hardness values in cold forged 316L in the range of 10% to 40% reduction in thickness clearly follows a linear relationship with cold work, while the magnitude of increase in the overall average hardness values in the cold forged 304L tend to slow down with the increase in cold work, of which the trend appears to be best interpreted by a power law fit, as shown in Figure 43. Nevertheless, an attempt was also made to fit the overall average hardness values from both 304L and 316L to a linear relationship with the cold work level, and the result is presented in Figure 44. Interestingly, the linear coefficient turned out to be the same for both materials. The hardness threshold reported for SCC to occur in stainless steels in PWRs based on operation experience was also marked in these figures. It suggests that the 304L and 316L materials cold forged to 20% reduction and above have produced average hardness values equivalent or higher than the hardness threshold reported for SCC to occur in the SS auxiliary piping in French NPPs, but cold work higher than 40% reduction is needed to achieve the threshold hardness of 300 HV identified in MRP-236 for SCC in stainless steels in nominal PWR primary water, consistent with what was reported in literature [9]. Nevertheless, it should be noted that the measurements for determining the hardness threshold from operation experience may have been obtained using a different force during hardness testing. For example, the hardness measurement performed on the plant weld materials from the French NPPs were usually performed with an applied force of either 100 g or 500 g. In order to evaluate the impact of using different forces on the resulted HV values, additional hardness testing was performed on the 40%CF 304L sample on the TS plane at four different test loads: 100 gf, 300 gf, 500 gf, and 1 kgf. A total of 169 indents were produced in a $\sim 3 \times 3 \text{ mm}^2$ were produced at each test load, of which the distance between the centers of neighboring indents is at least 3X the diagonal length of the indent (Figure 45). The general statistics of the results are summarized in Figure 46 where a decrease in the average and median hardness values is seen when the test load was increased from 0.1 to 0.5 gf, while further increase to 1 kgf resulted in hardness values similar to those produced at 0.3 gf. As shown in Figure 47, the average hardness value consistently decreased by 10 HV when the load was increased by every 200 gf between 100 and 500 gf, indicating a linear relationship for this load range. As a result, it can be concluded that the cold forging conducted on 304L and 316L in this suggest has successfully produced high hardness values matching those measured on French SS auxiliary piping where SCC incidents were reported.

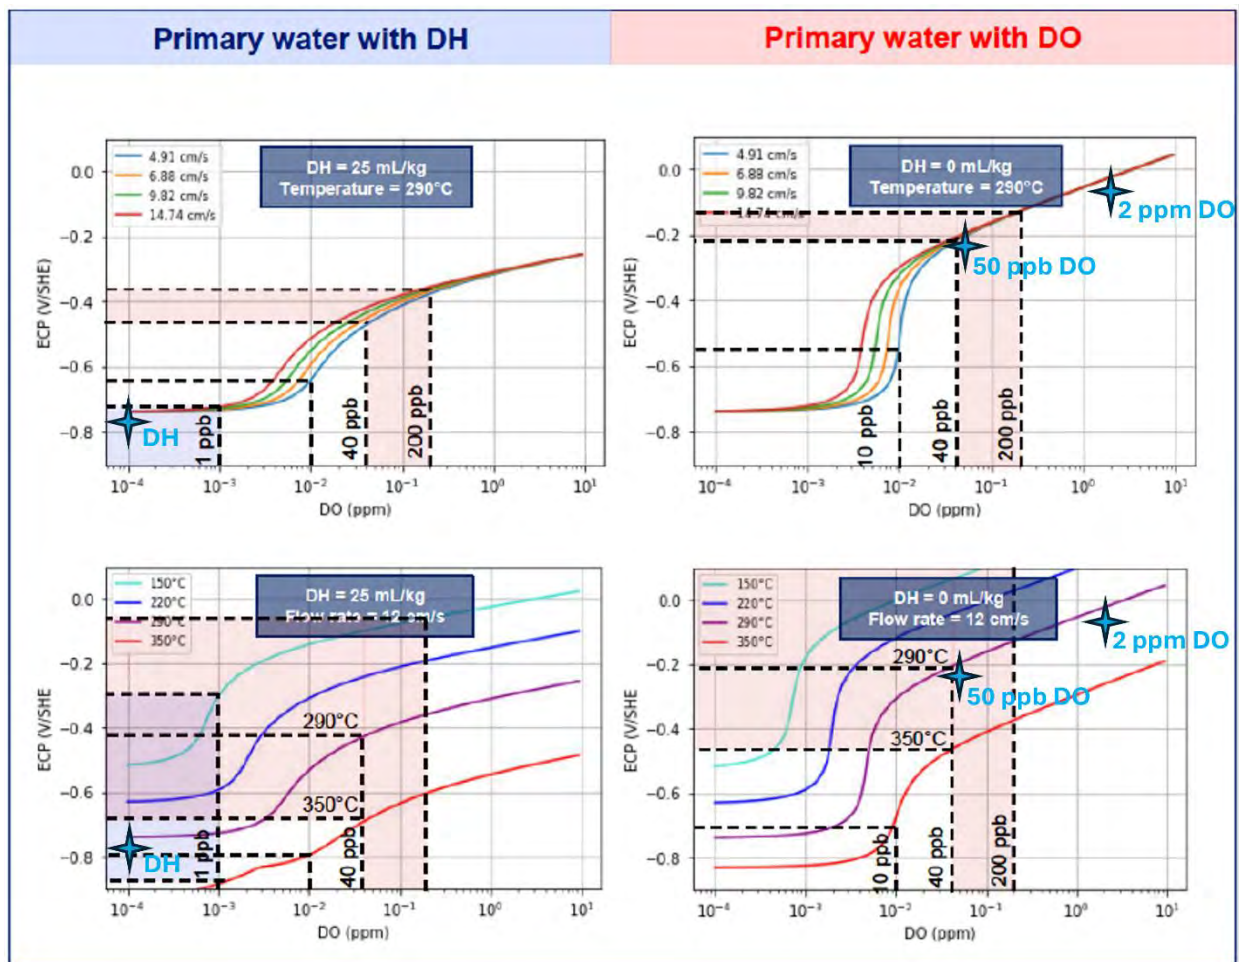
Figure 55. EdF's electrochemical potential (ECP) modeling of the ECP of SS in PWR primary water as a function of dissolved gas content, temperature, and flow rate (*private communication from EDF R&D, used with permission*). Estimated ECP values from this model for the SS 304L specimens tested in the three water chemistries at PNNL are also highlighted.

An estimate of the electrochemical potential (ECP) of the 304L specimens in the tested water chemistries was made according to EdF's ECP model (Figure 55). A few important indications can be drawn from this figure. (1) Trace amount of DO between 1 ppb and 40 ppb leads to the most profound change in the ECP of SS. (2) The ECP of SS becomes independent of flow rate when the DO content in primary water exceeds 40 ppb. (3) At a fixed flow rate such as 12 cm/s (similar to the flow rate in our tests), the ECP of SS decreases with increasing temperature in both DO and DH water chemistries. Using this model, the ECP estimated for the 304L specimens tested in this SCC study with 2 ppm DO and 50 ppb DO are ~ -0.08 mV and slightly below -0.2 mV, respectively. However, low levels of DO, such as 50 ppb, are known to be difficult to maintain consistently in the water loop because oxygen would be partially consumed during water recirculation, even when it is fed at a constant pressure and injected at a high flow rate. As a result, the DO in the test system is likely below 50 ppb, which would lead to a lower ECP, likely somewhere between -0.6 and -0.2 mV, for the 304L specimens tested in the 50 ppb DO-containing water. Meanwhile, the ECP of the specimens tested in the DH water chemistry containing 30 cc/kg H_2 is estimated to be between -0.7 and -0.8 mV according to EdF's model. Such water chemistry represents the typical reducing water condition implemented in the SS auxiliary piping systems in Japan and U.S. PWRs, and serves as a reference to the tests in DO-containing water chemistries.

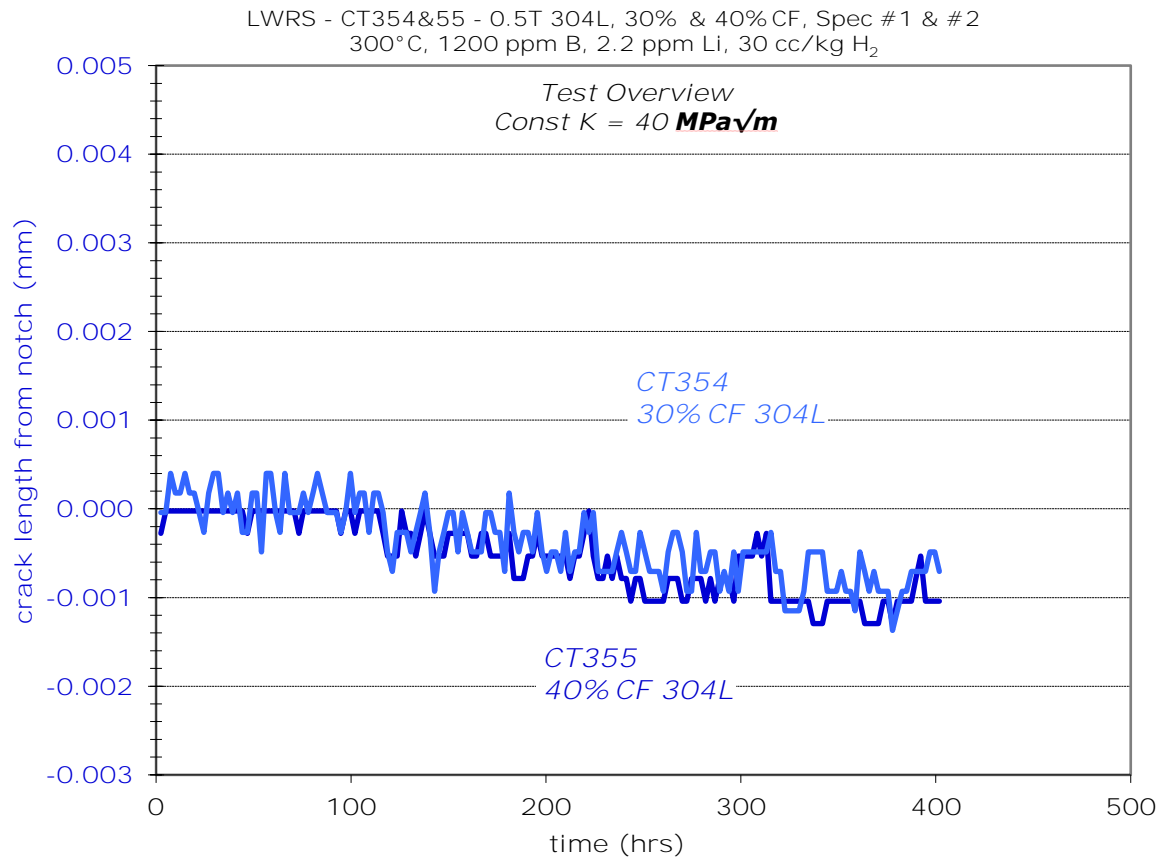
Figure 72. Test overview of the DCPD indicated crack length evolution of CT 354 (30%CF 304L) & 355 (40%CF 304L) BNCT specimens in 300°C PWR primary water containing 30 cc/kg H₂. The testing is ongoing as of the writing of this report.

As discussed in Section 4.1.2, the third SCC initiation test was started this summer in a small autoclave on two CF 304L specimens, one in 30% CF condition and the other in 40% CF condition, in 300°C PWR primary water containing 30 cc/kg H₂. Figure 72 provides an overview of the DCPD indicated crack length evolution of these two specimens. To date, the test has been running for 400 hours at a constant load of 40 MPa√m, with no indication of crack initiation. The plan is to continue the test in its current condition for a total of at least 2,000 hours and perform SEM examination on the notch surface of both specimens. The specimen behavior will be reviewed to determine the next step for this test, with plans centered on introducing fatigue cycling through either mechanical or chemical means.
