# Light Water Reactor Sustainability Program

The role of grain boundary oxides in the susceptibility to irradiation assisted stress corrosion cracking for high dose 304 stainless steel under pressurized water reactor relevant conditions

Gary S. Was (Principal Investigator) Srinivasan Swaminathan Kai Sun

September 2022

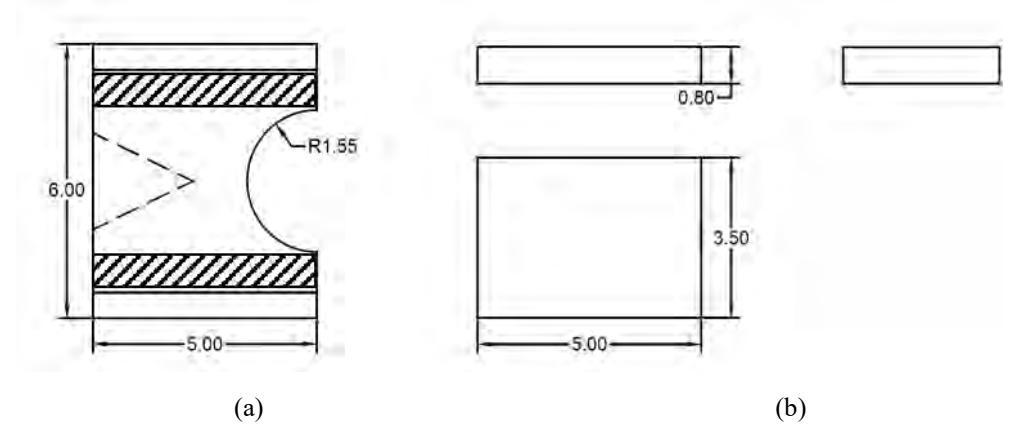
Figure 1. Schematic showing (a) tensile bar head dimensions and location of the cut (the marked area), and (b) bend test sample dimensions (unit: mm).

Two pieces of material sliced from a tensile bar head using Electron Discharge Machining (EDM) were used to prepare four-point bend specimens. The position where the slices were made and the dimensions of the four-point bend specimen are shown in Figure 1. The remaining material was used to prepare transmission electron microscopy (TEM) specimens, to study the microstructure in the as-received irradiated condition. Rectangular samples with 1 mm thickness were made after EDM cutting. A Buehler Mini-met 1000<sup>TM</sup> sample grinding and polishing tool performed sample thinning to a target thickness of 800 µm using 120, 180, and 340 grit SiC grinding paper on each side to achieve a uniform thickness (final thickness variations were less than 10 µm). One side of the sample was then polished with a nylon pad containing 3 µm polishing media in the Mini-met<sup>TM</sup> and subsequently electrochemically polished in a Struers LectroPol-5<sup>TM</sup> system in four steps. One electrochemical polishing step was applied for 15 s at a potential of 30 V at 20 °C in a commercially available Struers A2 solution (60% perchloric acid). The final dimensions of the four-point bend sample are shown in Figure 1b. The ID, dose, and thickness of all samples used for this research project are given in Table 2.

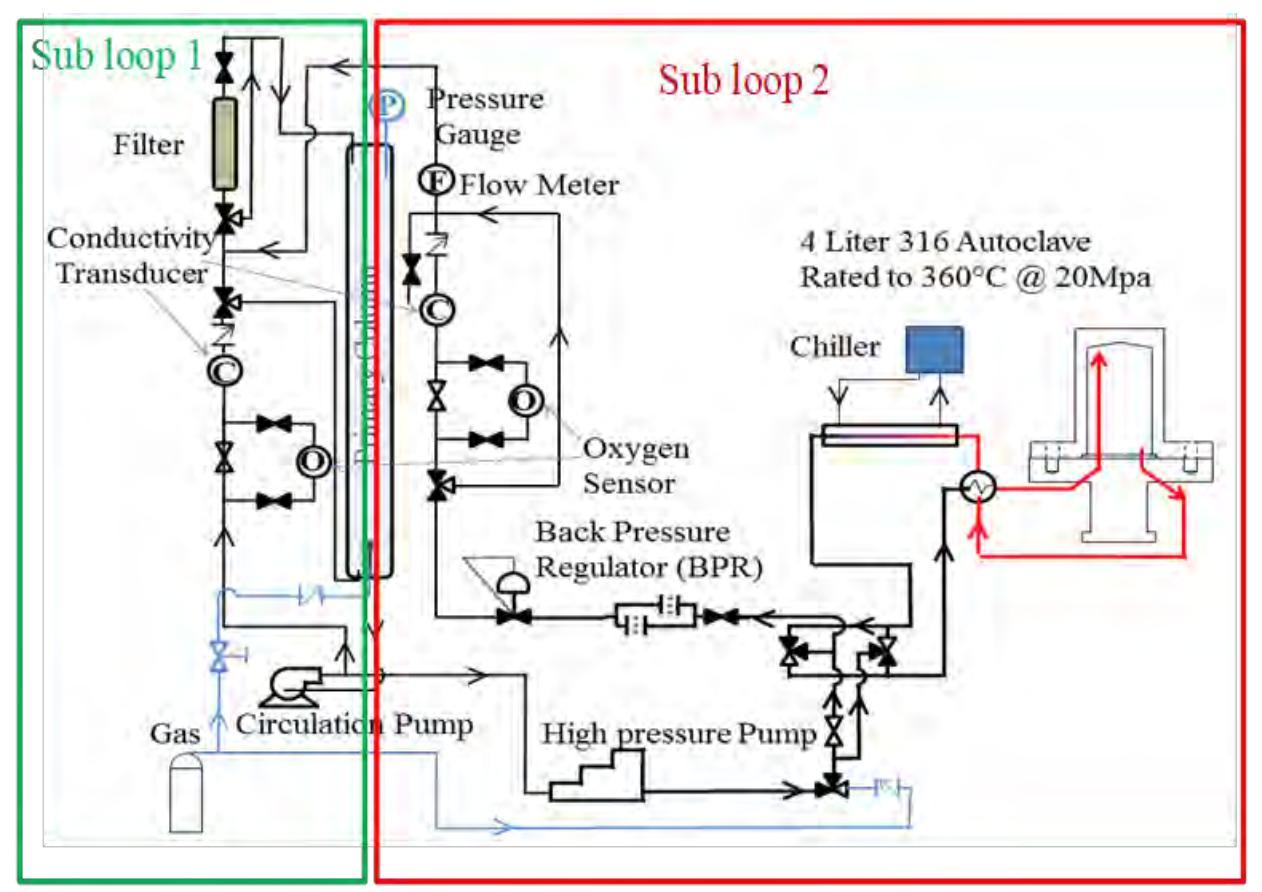
Figure 2. Schematic of the water loop used in the autoclaves at the Irradiated Materials Testing Laboratory.

The four-point bend testing systems IM2 and IM3 are located in an irradiated material testing lab (IMTL) at UM. The water loop schematic diagram is shown in Figure 2. The water loop consists of two sub loops, loop 1 for conditioning the water at room temperature and low pressure, and loop 2 for simulating light water reactor environment at high temperature and high pressure. The environmental parameters such as conductivity and dissolved gas concentration are controlled in loop 1. The water is then pressurized and heated in loop 2, reaching the desired temperature and pressure in the autoclave and recirculated to the primary water column. The conductivity and dissolved oxygen (DO) are monitored at both inlet and outlet of loop 2.

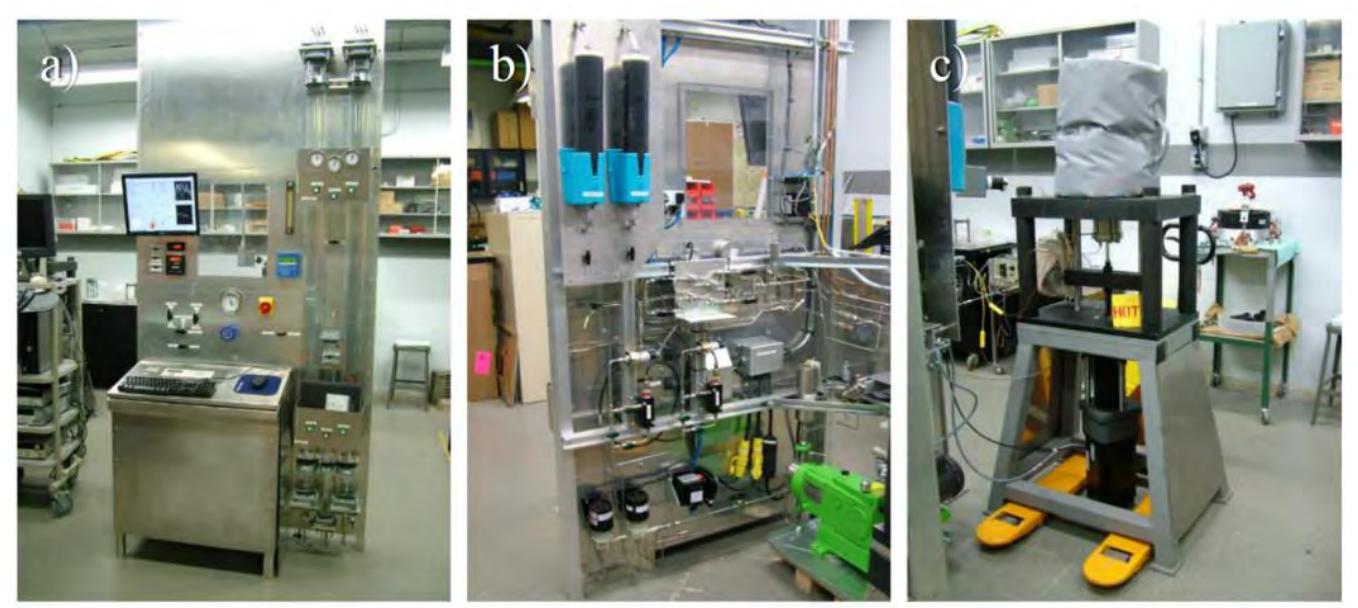
Figure 3. Photographs of the IM autoclave system and water loop. (a) Control panel front, (b) control panel back with plumbing and sensors, and (c) load frame, motor, and autoclave covered with insulating jacket.

Both the IM2 and IM3 loading systems have one pull rod located in the center of the autoclave head, which was used to meet the requirement of fine control of the deflection of the four-point bend specimen (see Figure 3). Load is applied with a 50 kN servo motor. A linear variable differential transformer (LVDT) is mounted on the pull rod to measure displacement. A load cell was connected with the pull rod, which was used to measure the load applied to the sample. The pull rod is sealed at the feed-through into the autoclave with a self-energizing graphite seal with an internal spring that expands under pressure. The pull rod inside of the autoclave is connected to an Inconel 718 sample loading fixture. Electrical insulation is provided by zirconia washers located in the loading fixtures. After loading the specimens, the autoclave body is sealed to the autoclave head, thus preventing any leakage during the experiment.

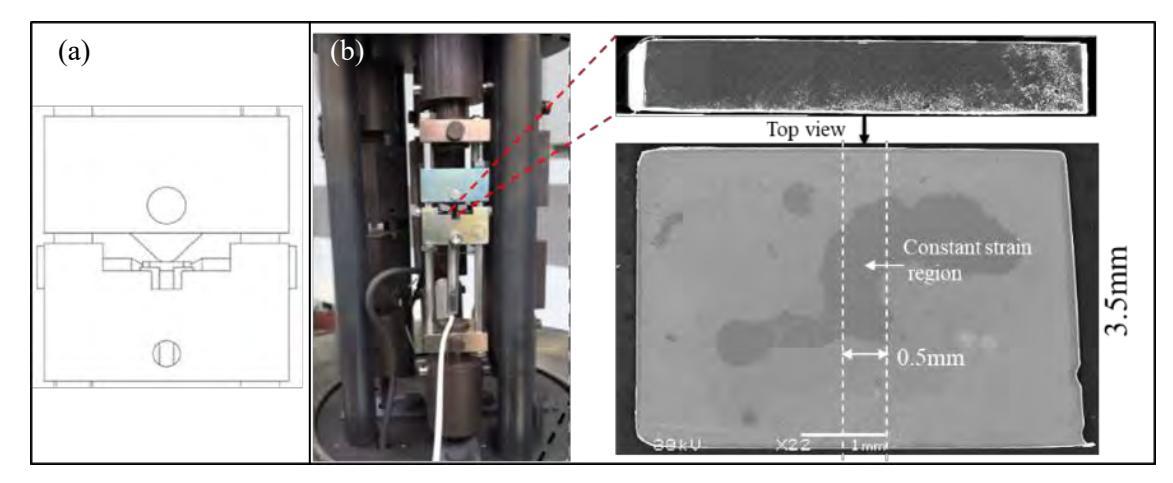
Figure 4. (a) Schematic of the four-point bend loading fixture, and (b) the real fixture including a bend sample with side and top view.

The four-point bend test method was developed by Stephenson at al. [4] and a detailed description of this method can be found in reference [5]. The four-point bend sample has a constant strain area of 0.5 mm  $\times$  3.5 mm, which makes it possible to locate the crack initiation site in a reasonable time. The four-point bend test fixture used for this study was fabricated from Inconel 718 alloy in accordance with the schematic shown in Figure 4. Heat treatment of post-fabricated fixture parts created a hardened state to prevent deformation during bend testing. Four round posts called centering pins, elevated from the bottom support surface by 0.4 mm, surrounded the sample to prevent rotational misalignment. Set screws to the left and right of the sample and centered the sample laterally and were retracted after pre-loading the sample to prevent constraint during bending.

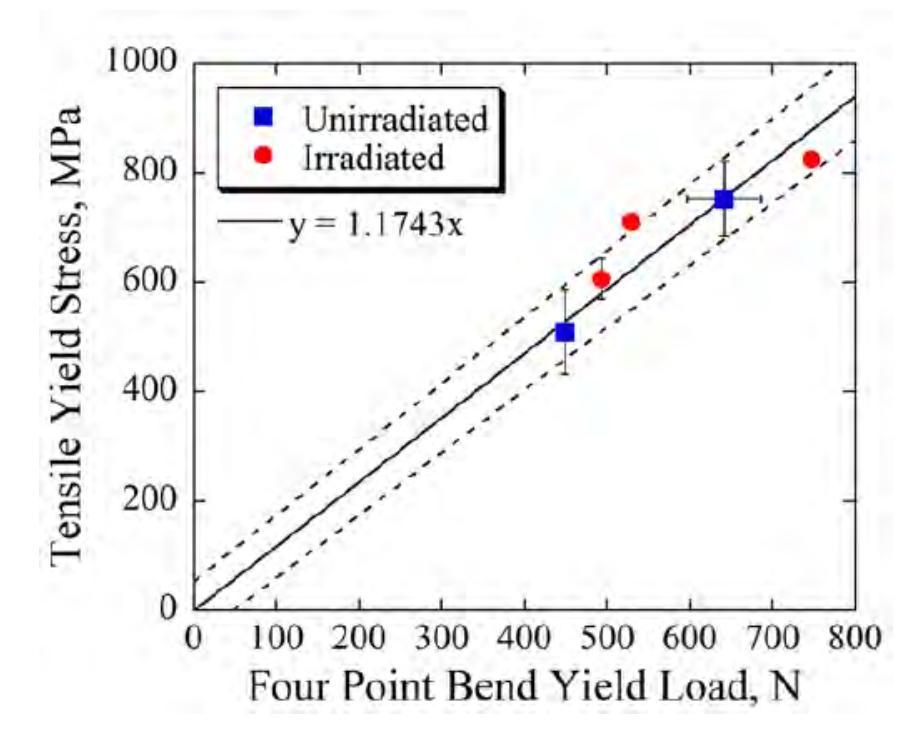
Figure 5. Comparison between the measured tensile yield stress and four-point bend yield load for several specimens, both irradiated and unirradiated. The linear fit was utilized to predict the bend yield load for conditions previously strained in tensile experiments.

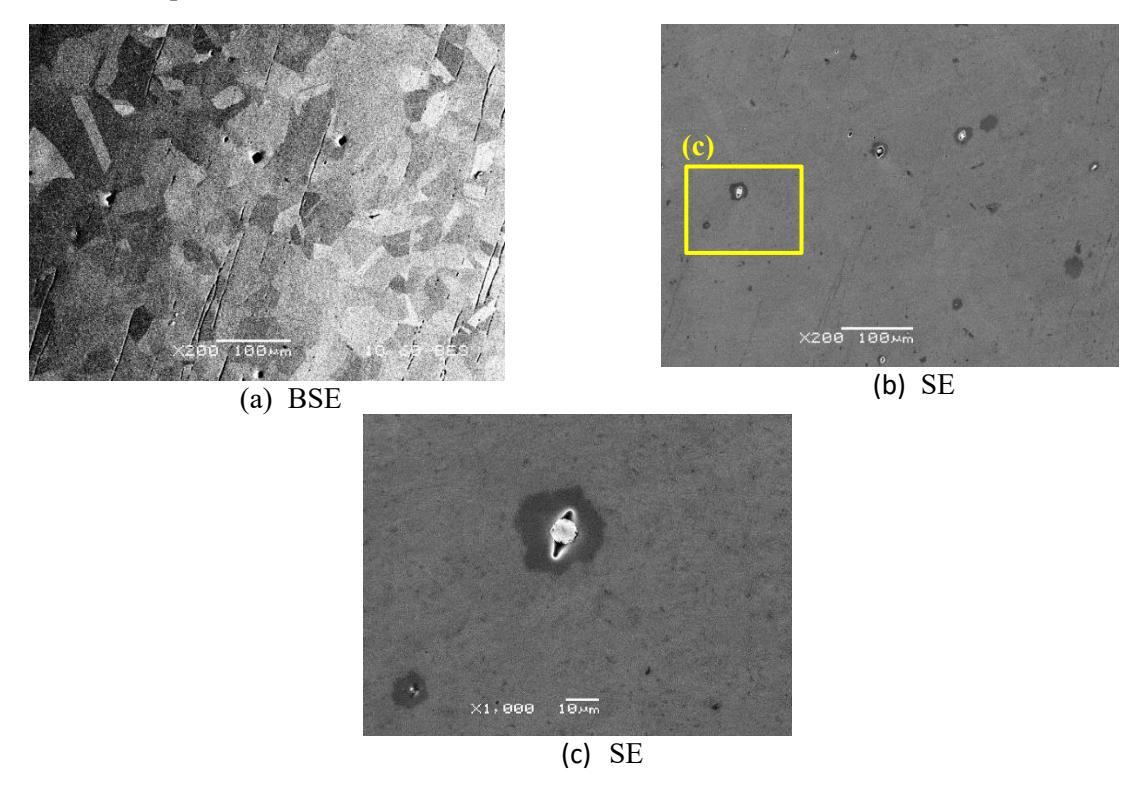
Figure 7. Surface morphology of the as-received four-point bend sample A84-4 (5.4 dpa; SA304 SS), (a) BSE image, and (b-c) SE images showing the microstructure of as-received surface condition and the appearance of inclusions.

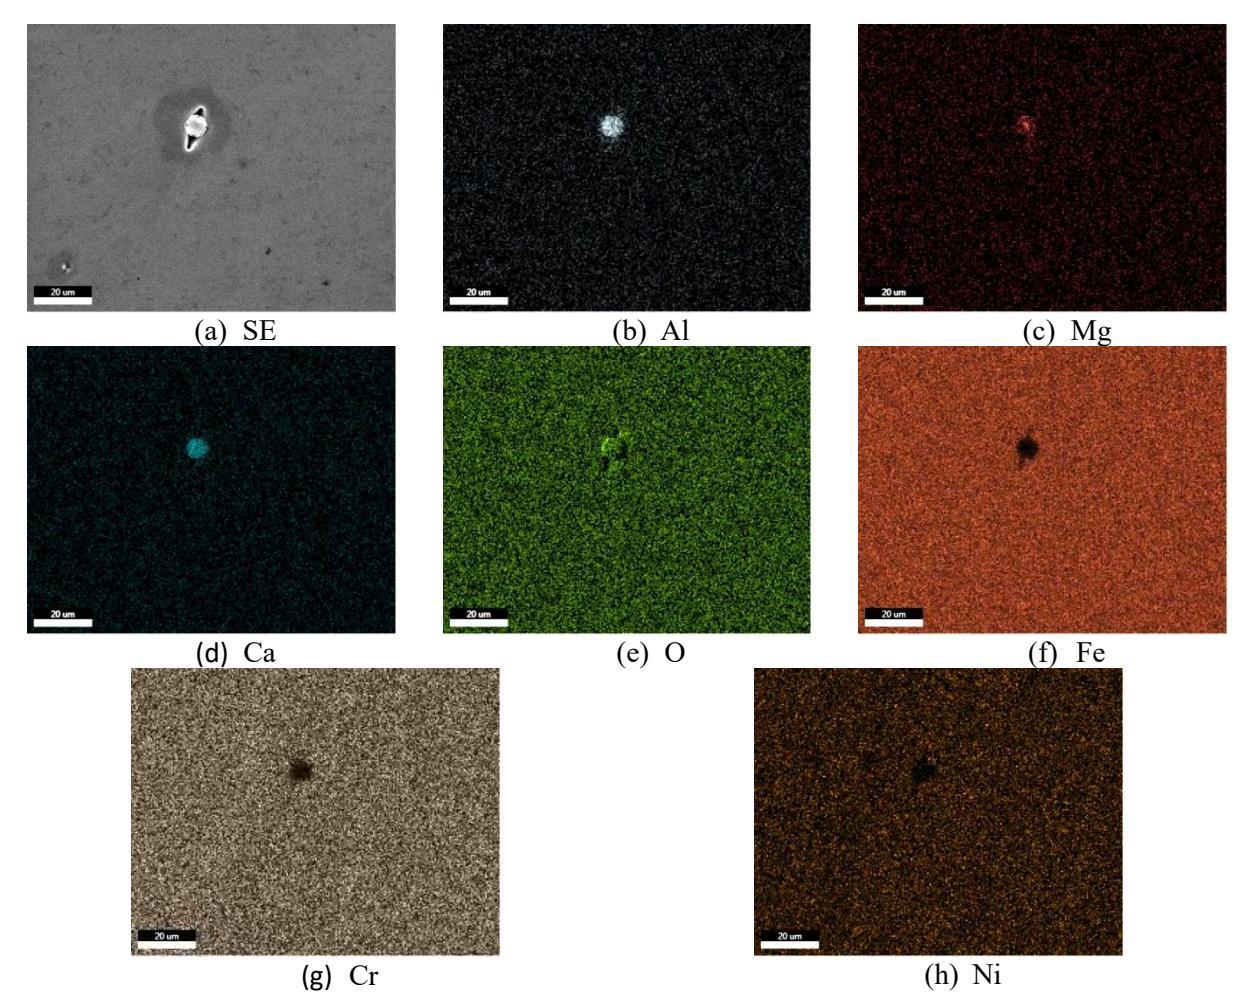
Figure 8. Surface morphology and EDS mapping of non-metallic oxide inclusion in as-received four-point bend sample A84-4 (5.4 dpa; SA304 SS), (a) SE image, and (b-h) EDS elemental mapping showing the chemistry of the inclusion.

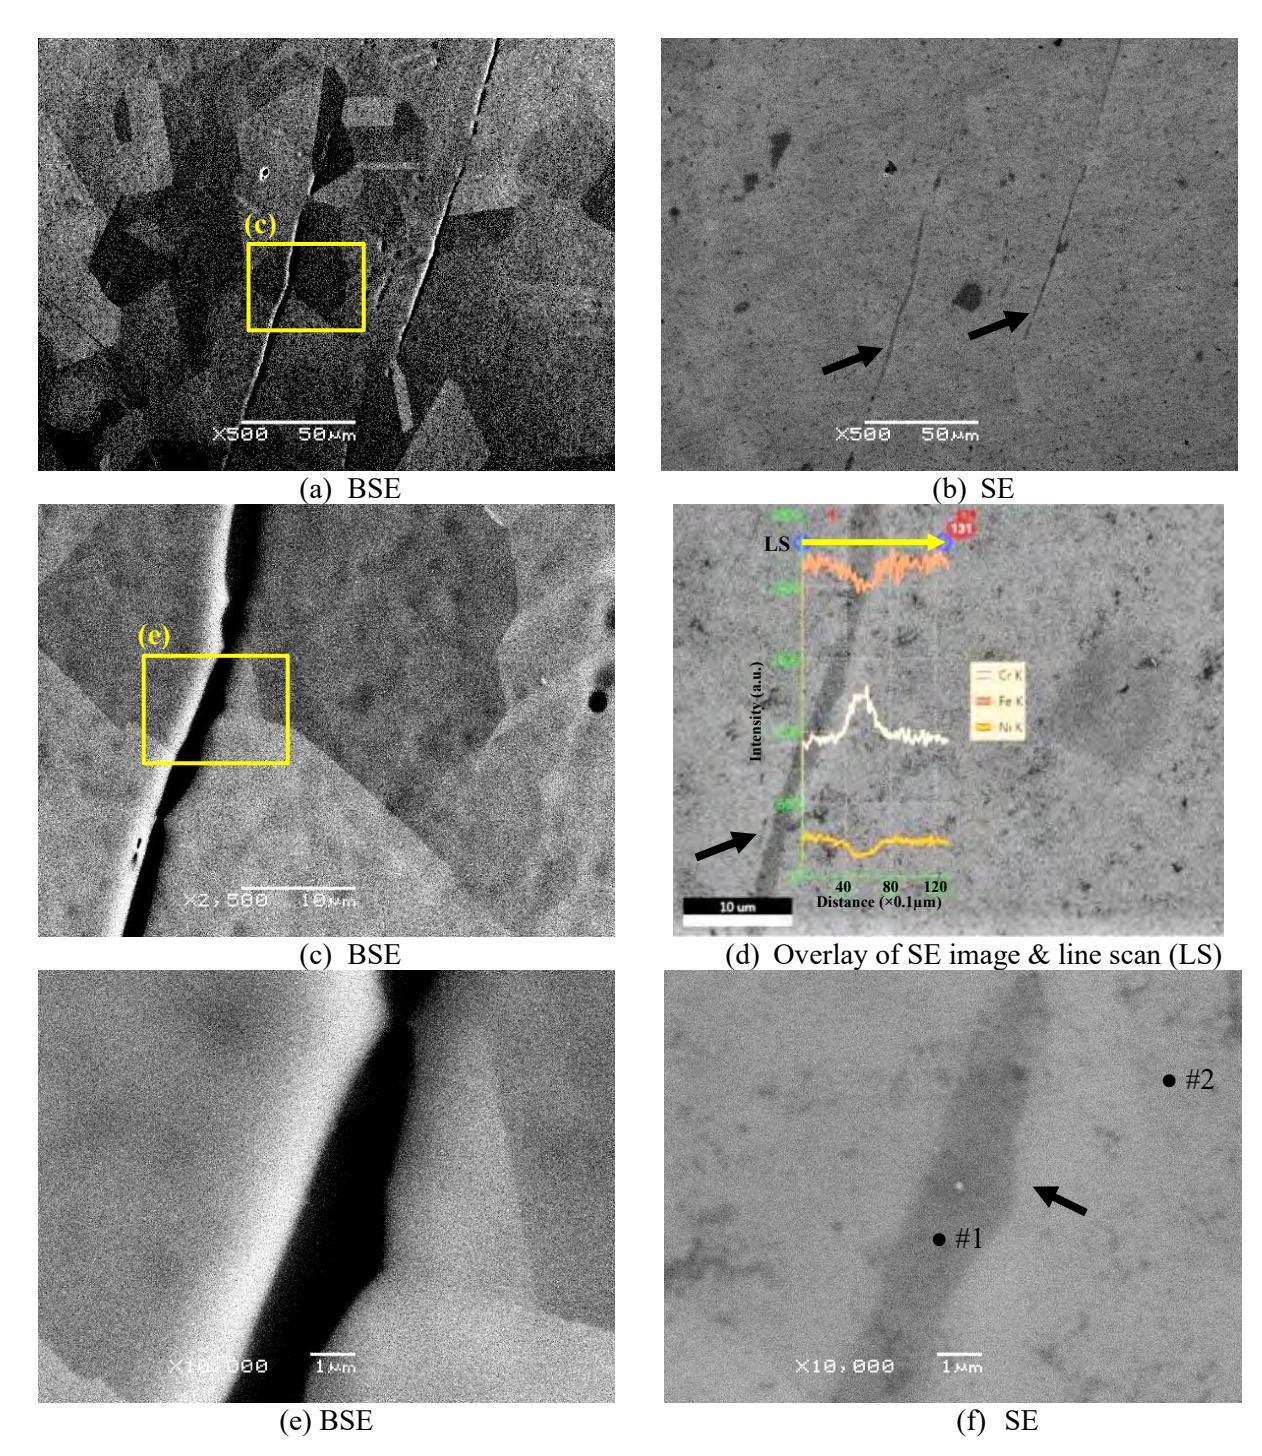
Figure 9. BSE (a, c and e) and the corresponding SE images (b, d and f) with various magnifications showing the elongated band-shaped ferrite phase in the austenite matrix of as-received A84-4 (5.4 dpa; SA304 SS) sample. An An overlay of SE image and the obtained line scan (LS; distance from left to right is 13.1  $\mu$ m) across the ferrite phase is shown in Fig. (d). The quantification results of EDS point spectra collected at spot #1 and #2 in Fig. (f), are listed in Table 4. Yellow box in BSE-image mark the location of respective high magnification BSE-image. The black arrows in SE-mode images (b, d and f) point to ferrite phase.

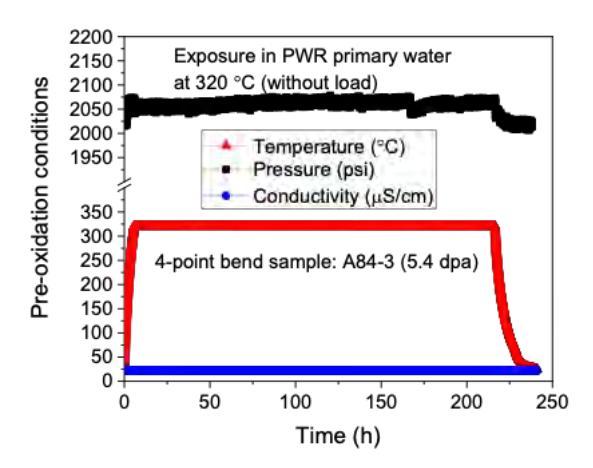
Figure 10. The thermal profile, pressure, and conductivity of simulated PWR primary water during pre-oxidation of a bend sample A84-3 (5.4 dpa) in high temperature water at 320 °C for 210 h, without application of stress.

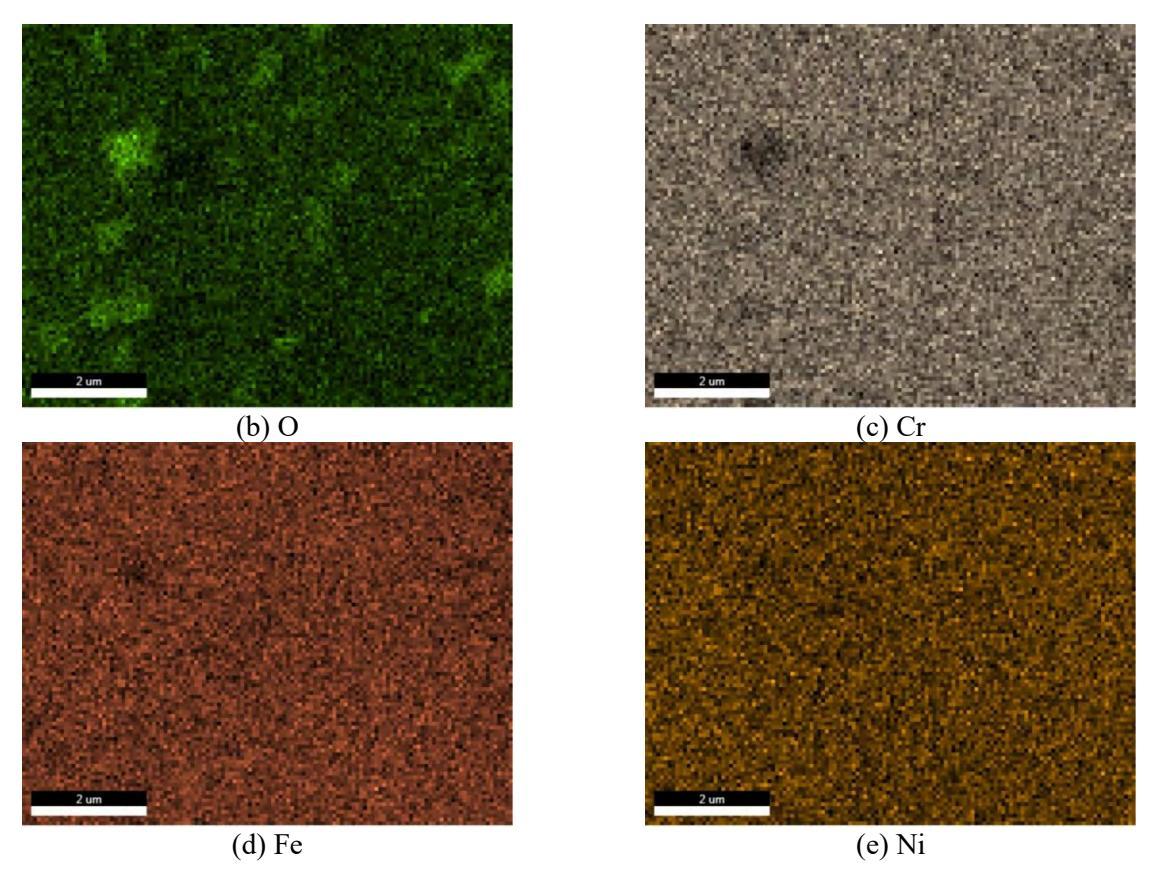
Figure 12. The SEM-EDS analysis of a bend sample A84-3 (SA304 SS; 5.4 dpa) after 210 h of oxidation at 320°C in simulated PWR primary water, (a) plan view SE image, and (b-e) the corresponding EDS-maps.

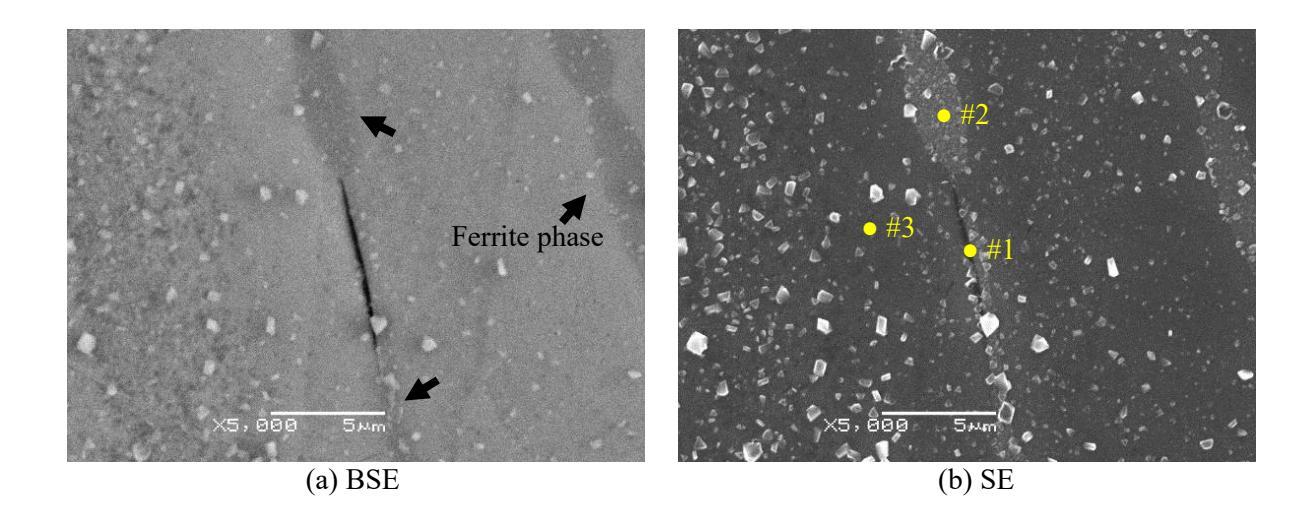
Figure 13. The SEM-EDS analysis of ferrite phase site in 210 h - pre-oxidized sample A84-3 (SA304 SS; 5.4 dpa) in high temperature water without application of load, (a) plan view BSE image, and (b) the corresponding SE image. The EDS spectra were acquired on the three spots marked in SE image. Ferrite phases were identified with black arrows in BSE image.

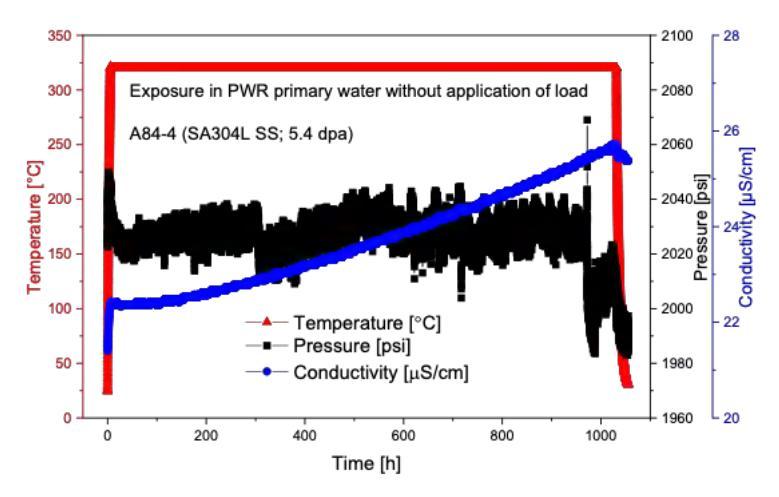
Figure 14. The thermal profile, pressure, and conductivity of simulated PWR primary water during pre-oxidation of a bend sample A84-4 (5.4 dpa) in high temperature water at 320 °C for 1010 h, without application of stress.

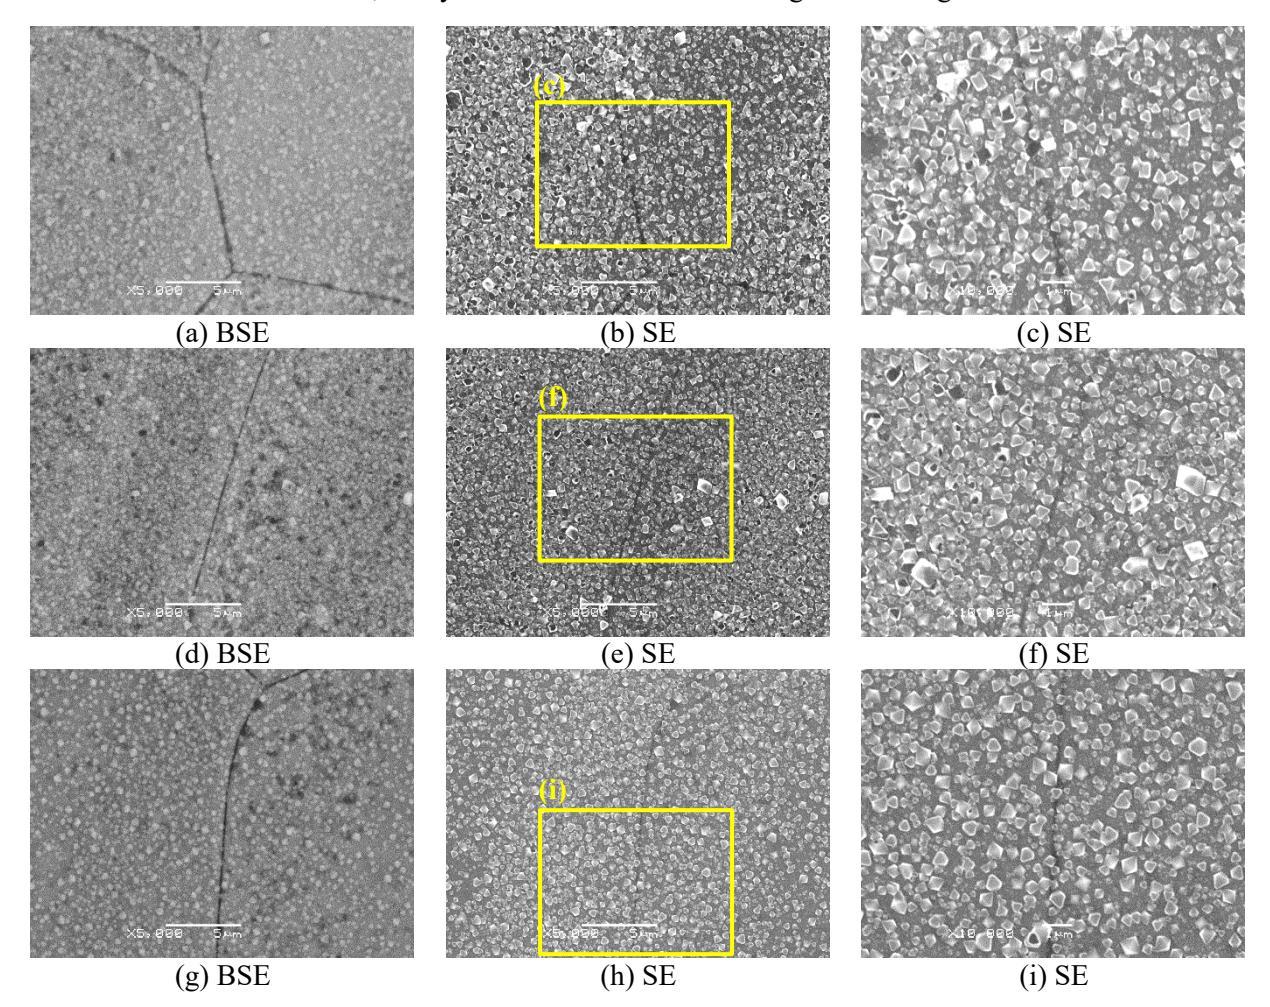
Figure 15. The plan view BSE images (a, d and g) and the corresponding SE images of a bend sample A84-4 (SA304 SS; 5.4 dpa) after 1010 h of oxidation at 320 °C in simulated PWR primary water. The morphology reveals that long-term exposure leads to increase in surface coverage of Fe-rich oxide crystallites, and various degrees of GB oxidation. Yellow box in 5000x SE-image mark the location of 10000x SE-image.
The 2000x magnification BSE image in Figure 16(a) shows the range of GB oxidation severity in A84-4 (5.4 dpa) upon long-term exposure (1010 h) in PW, and three GBs (#1-3) from this site were marked and further imaged with higher magnifications (i.e. 5000x and 15000x), as shown in Figure 16. As can be seen in Figures 16d, 16g and 16j, GBs #1 and 2 are oxidized to a greater extent than GB #3. Overall, the Fe-rich oxide crystallite coverage is quite high after such a long-term exposure in PW.

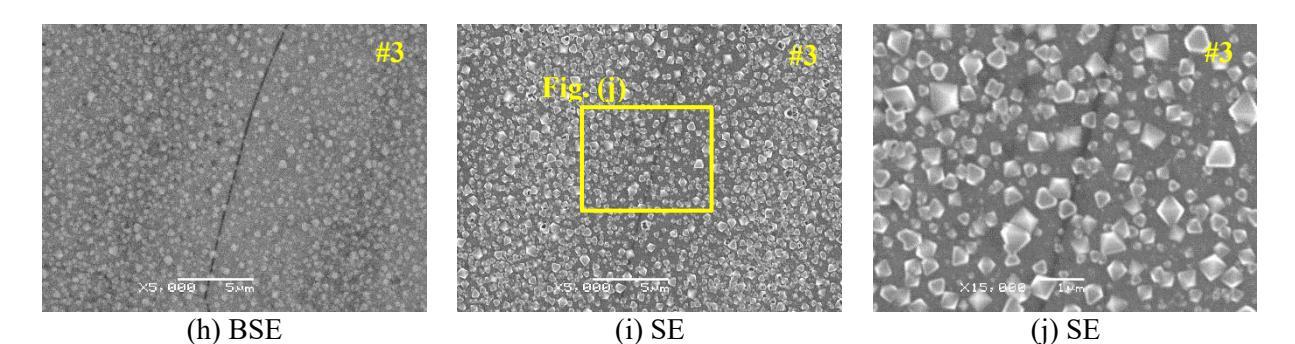
Figure 16. The SEM analyses (BSE and SE micrographs at different magnifications) of 1010 h - pre-oxidized sample A84-4 (SA304 SS; 5.4 dpa) in high temperature water without application of stress, showing the oxidation of grain boundaries with different degrees.

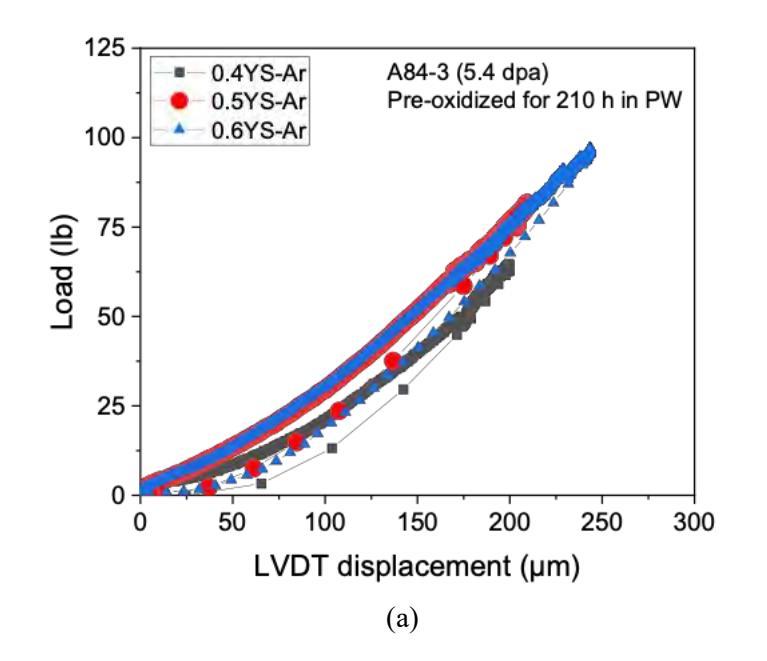
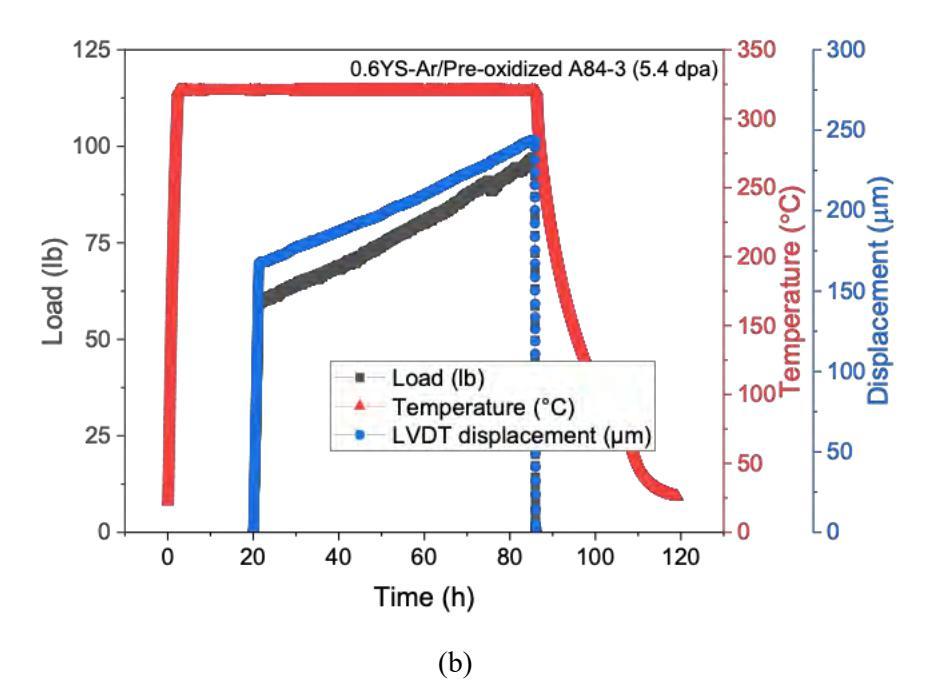
Figure 17. (a) Load versus LVDT displacement curves of 210 h pre-oxidized A84-3 (5.4 dpa; SA304 SS) sample during interrupted straining (0.4YS, 0.5YS and 0.6YS) in Ar at 320 °C, (b) the thermal profile, load and LVDT displacement data during straining of a pre-oxidized sample A84-3 (SA304 SS; 5.4 dpa) to 0.6YS in Ar (0.215 l/min). Initial strain rate was  $4.3 \times 10^{-6}$ /s, then lowered to  $4.3 \times 10^{-8}$ /s.

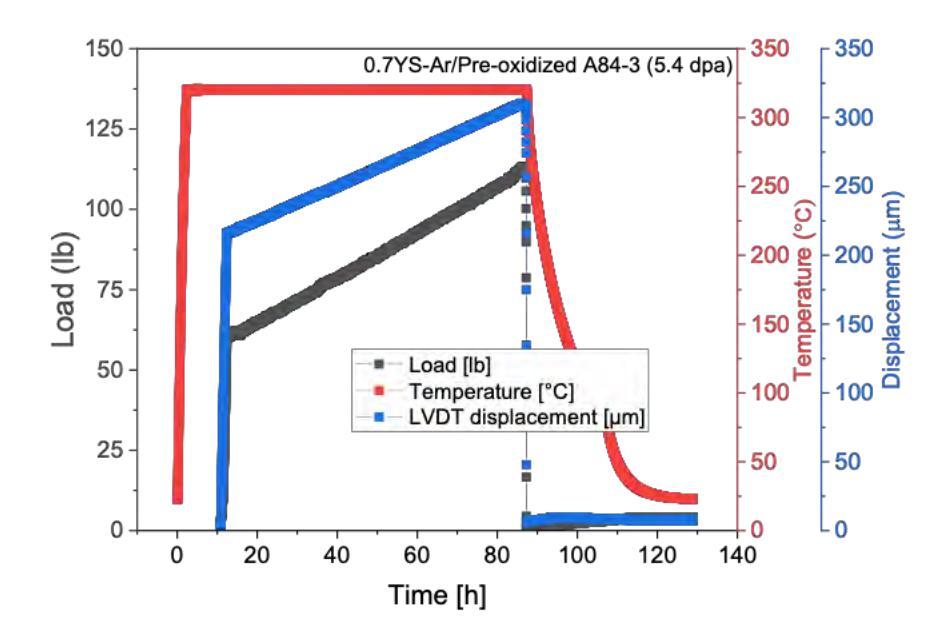
Figure 18. The thermal profile, load and LVDT displacement data during straining of a pre-oxidized sample A84-3 (SA304 SS; 5.4 dpa) to 0.7YS in Ar (0.215 l/min).

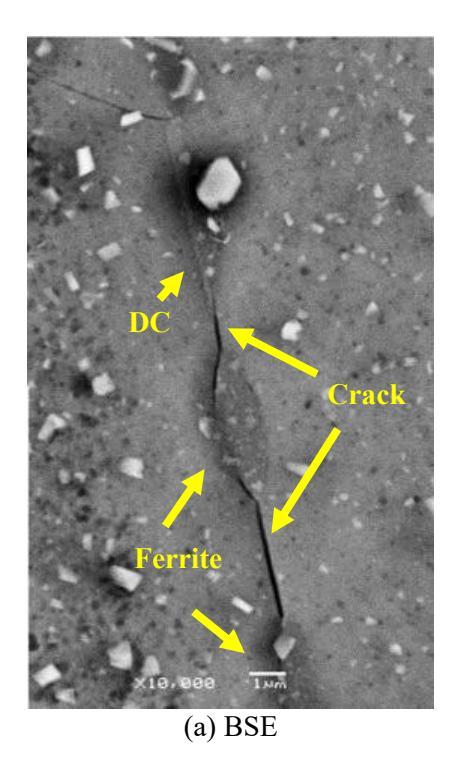
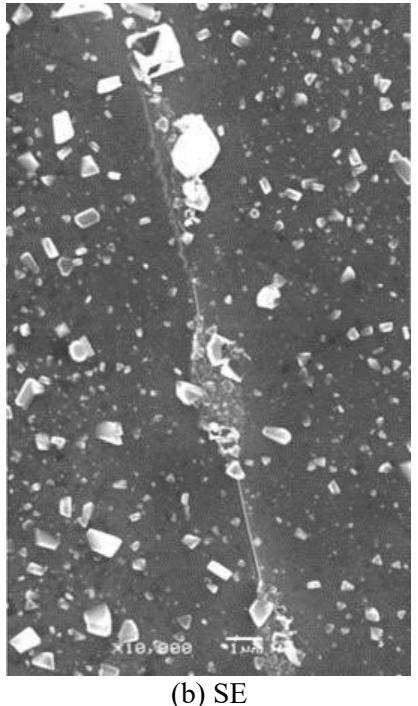
Figure 19. Photomontage of the plan view SEM micrographs showing the initiated cracks at the DC-GB intersection (interface of retained ferrite phase and the boundary adjacent to it) in 210 h - preoxidized A84-3 (SA304 SS; 5.4 dpa) followed by interrupted straining to 0.6YS in high temperature Ar, (a) BSE and (b) SE.

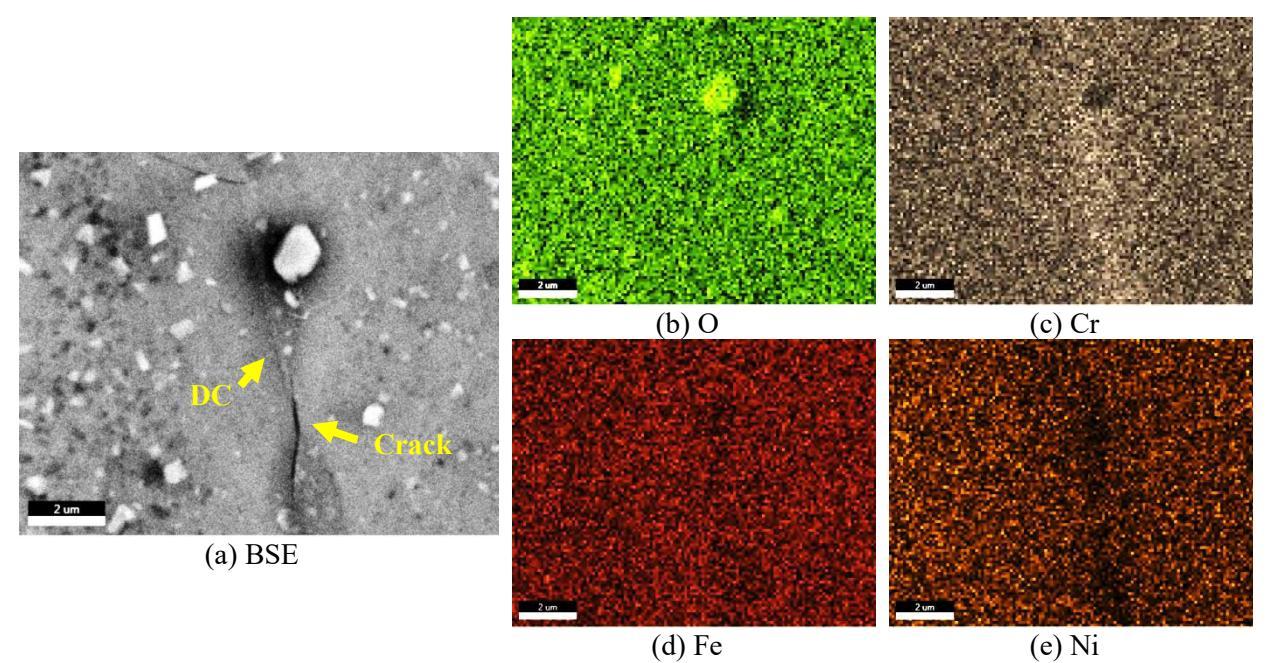
Figure 20. The SEM-EDS mapping of a crack initiated at the DC-GB intersection in 210 h - preoxidized A84-3 (SA304 SS; 5.4 dpa) followed by interrupted straining to 0.6YS in high temperature Ar, (a) BSE, (b-e) EDS mappings of O, Cr, Fe and Ni.

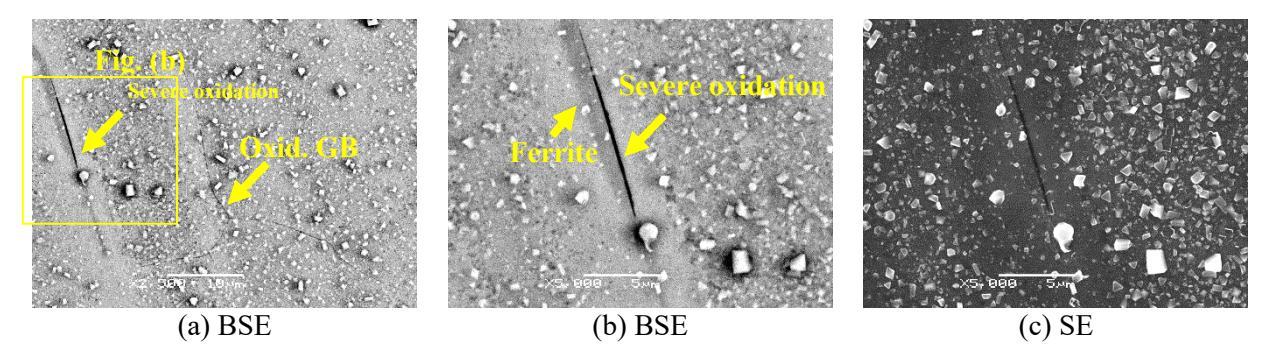
Figure 22. The BSE and SE micrographs showing the severe oxidation at the retained ferriteaustenite matrix interface in 210 h - pre-oxidized A84-3 (5.4 dpa) sample that was dynamically strained to 0.6YS in Ar.

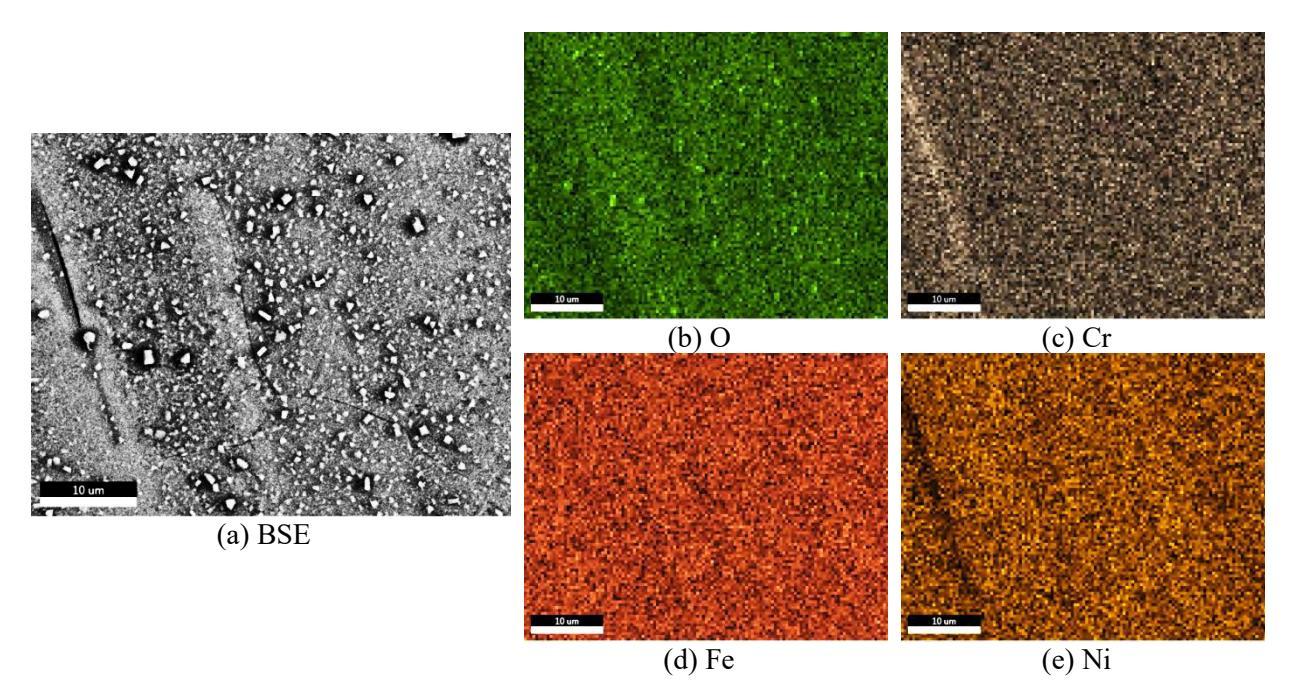
Figure 23. The BSE image and the corresponding EDS mapping showing the Cr-rich oxide at the retained ferrite and austenite matrix interface in 210 h - pre-oxidized A84-3 (5.4 dpa) sample that was dynamically strained to 0.6YS in Ar.

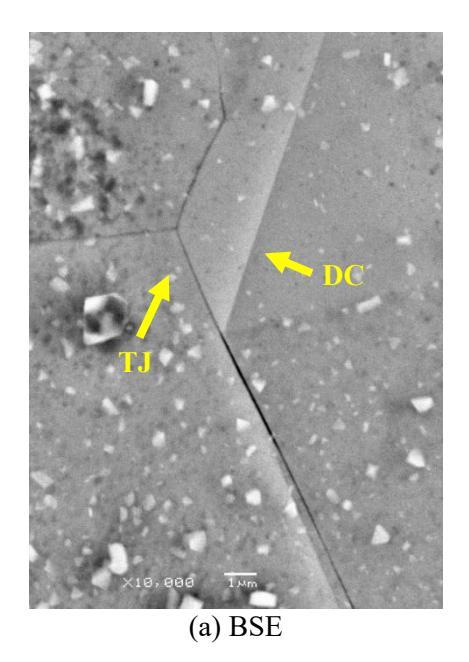
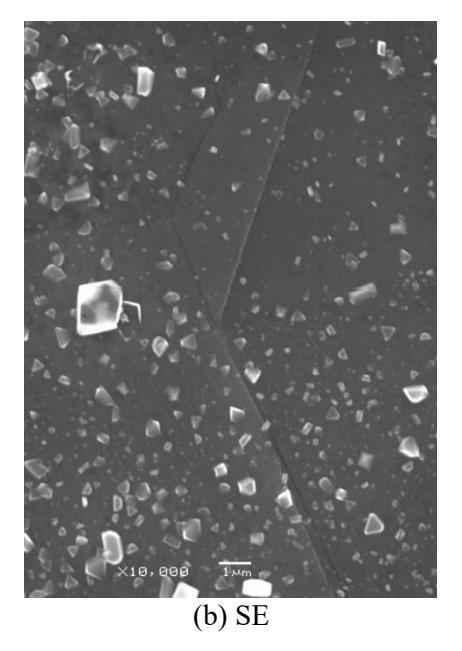
Figure 24. The BSE and SE image obtained after straining to 0.6YS in Ar showing the uncracked intersection of DC-GB in A84-3 (5.4 dpa).

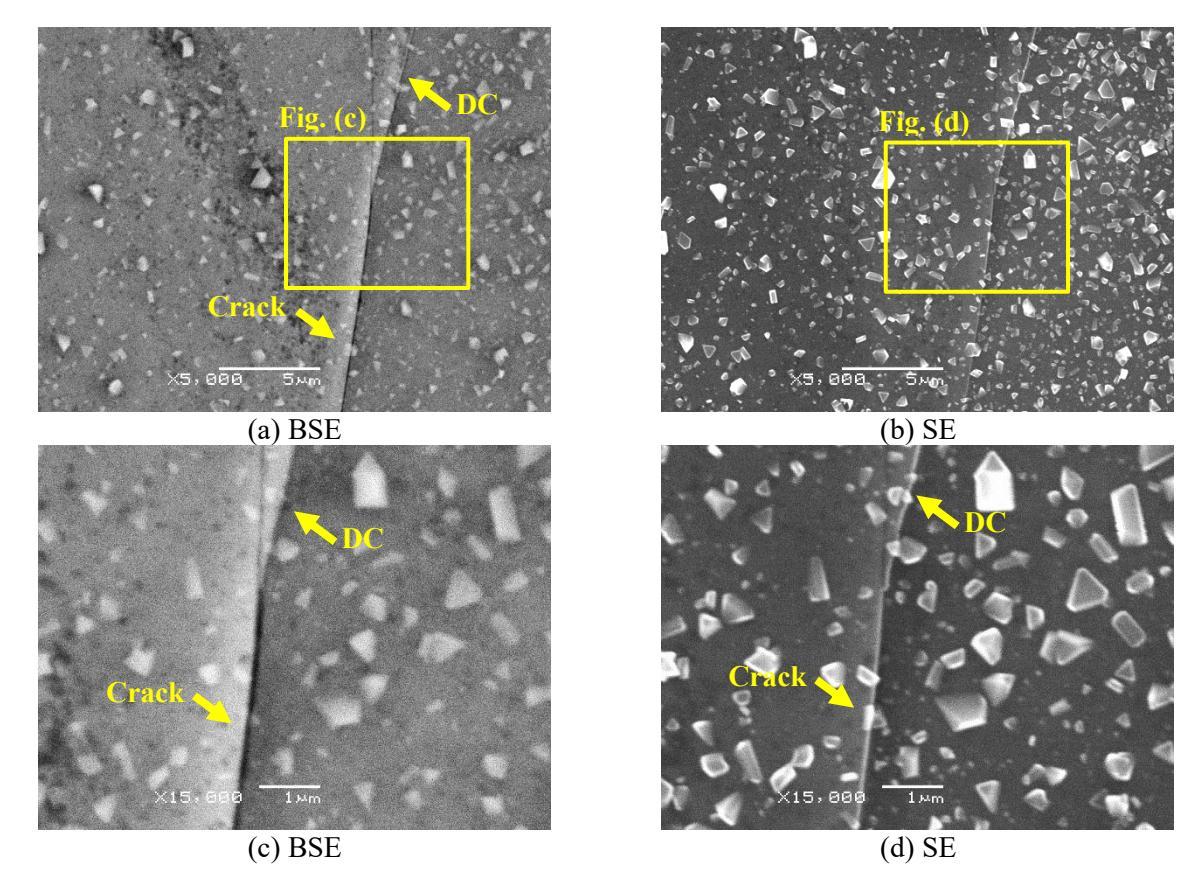
Figure 26. The high magnification BSE and the corresponding SE micrographs showing a narrow crack at the DC-GB intersection after straining 210 h - pre-oxidized A84-3 (5.4 dpa) bend sample to 0.7YS in high temperature Ar.

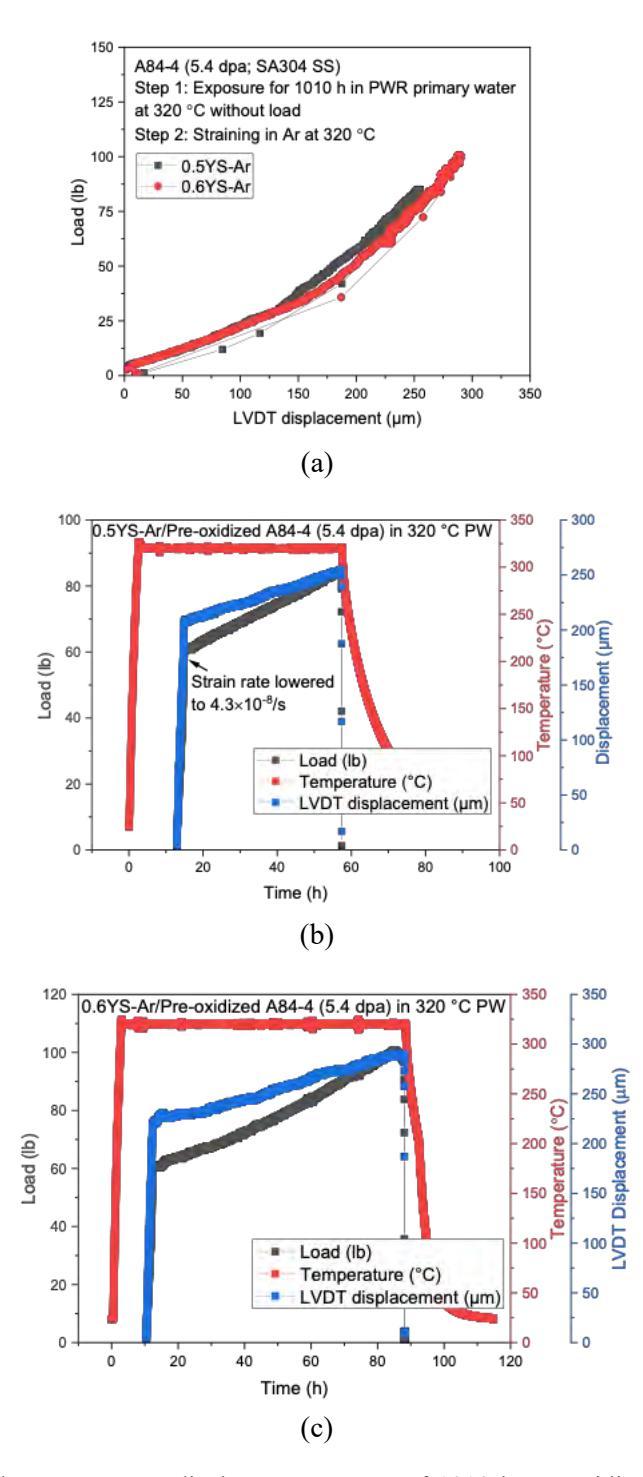
Figure 28. (a) Load versus LVDT displacement curves of 1010 h pre-oxidized A84-4 (5.4 dpa; SA304 SS) sample during interrupted straining (0.5YS and 0.6YS) in Ar at 320 °C, (b and c) the thermal profile, load and LVDT displacement data during four-point bend testing at 0.5YS and 0.6YS in flowing Ar (0.215 l/min). Initial strain rate was  $4.3 \times 10^{-6}$ /s, then lowered to  $4.3 \times 10^{-8}$ /s.
