# Light Water Reactor Sustainability Program

The role of grain boundary oxides in the susceptibility to irradiation assisted stress corrosion cracking for high dose 304 stainless steel under pressurized water reactor relevant conditions

Gary S. Was (Principal Investigator) Srinivasan Swaminathan Kai Sun

September 2022

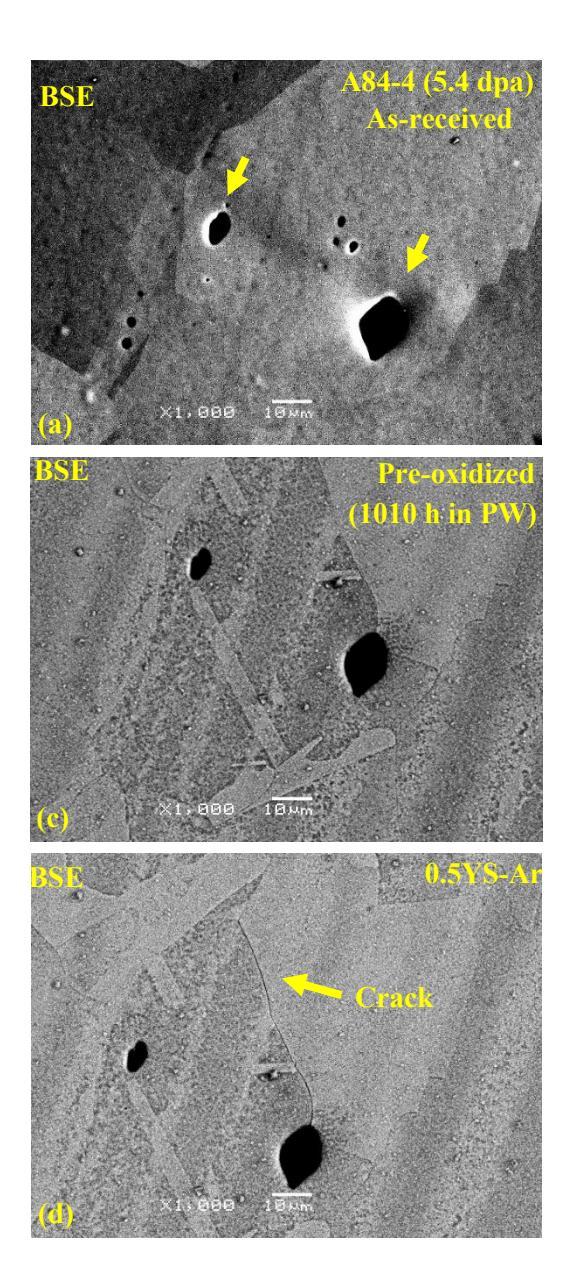
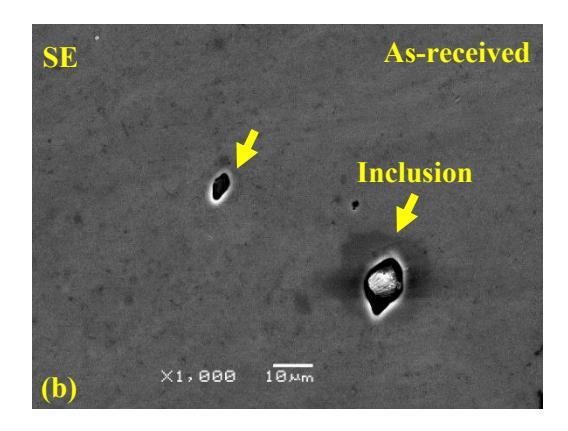
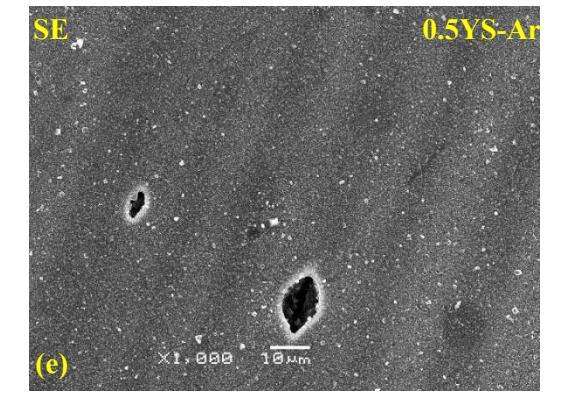
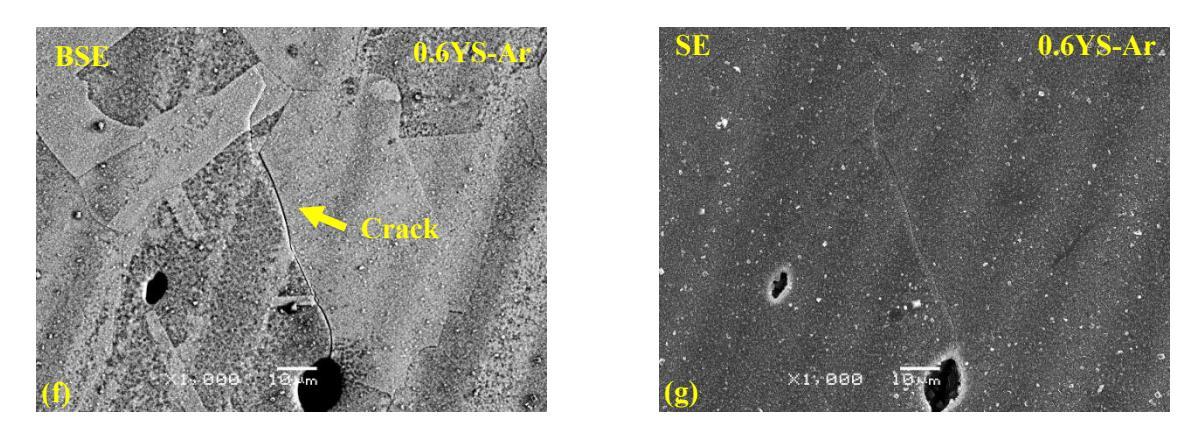
Figure 29. The SEM micrographs showing the crack initiation at an inclusion site of A84-4 sample pre-oxidized for 1010 h in PW followed by straining in Ar. Crack initiated at 0.5YS in Ar.

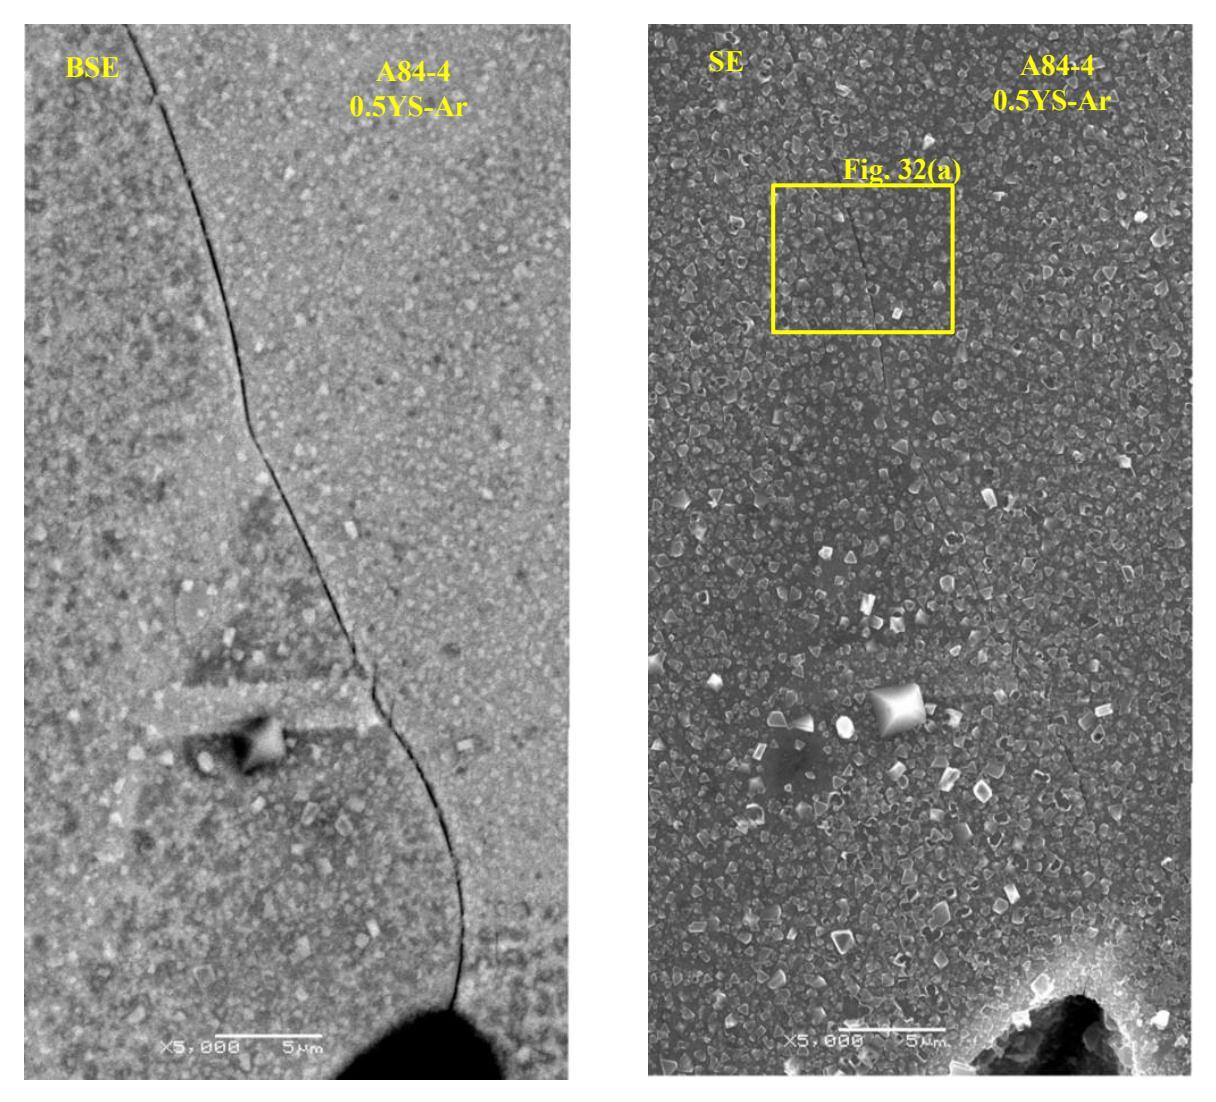
Figure 30. The BSE and SE image montage of a lengthy crack initiated in sample A84-4 (SA304 SS; 5.4 dpa) pre-oxidized for 1010 h in PW followed by straining to 0.5YS in high temperature Ar. Crack widening with stress increment is shown in Fig. 32.

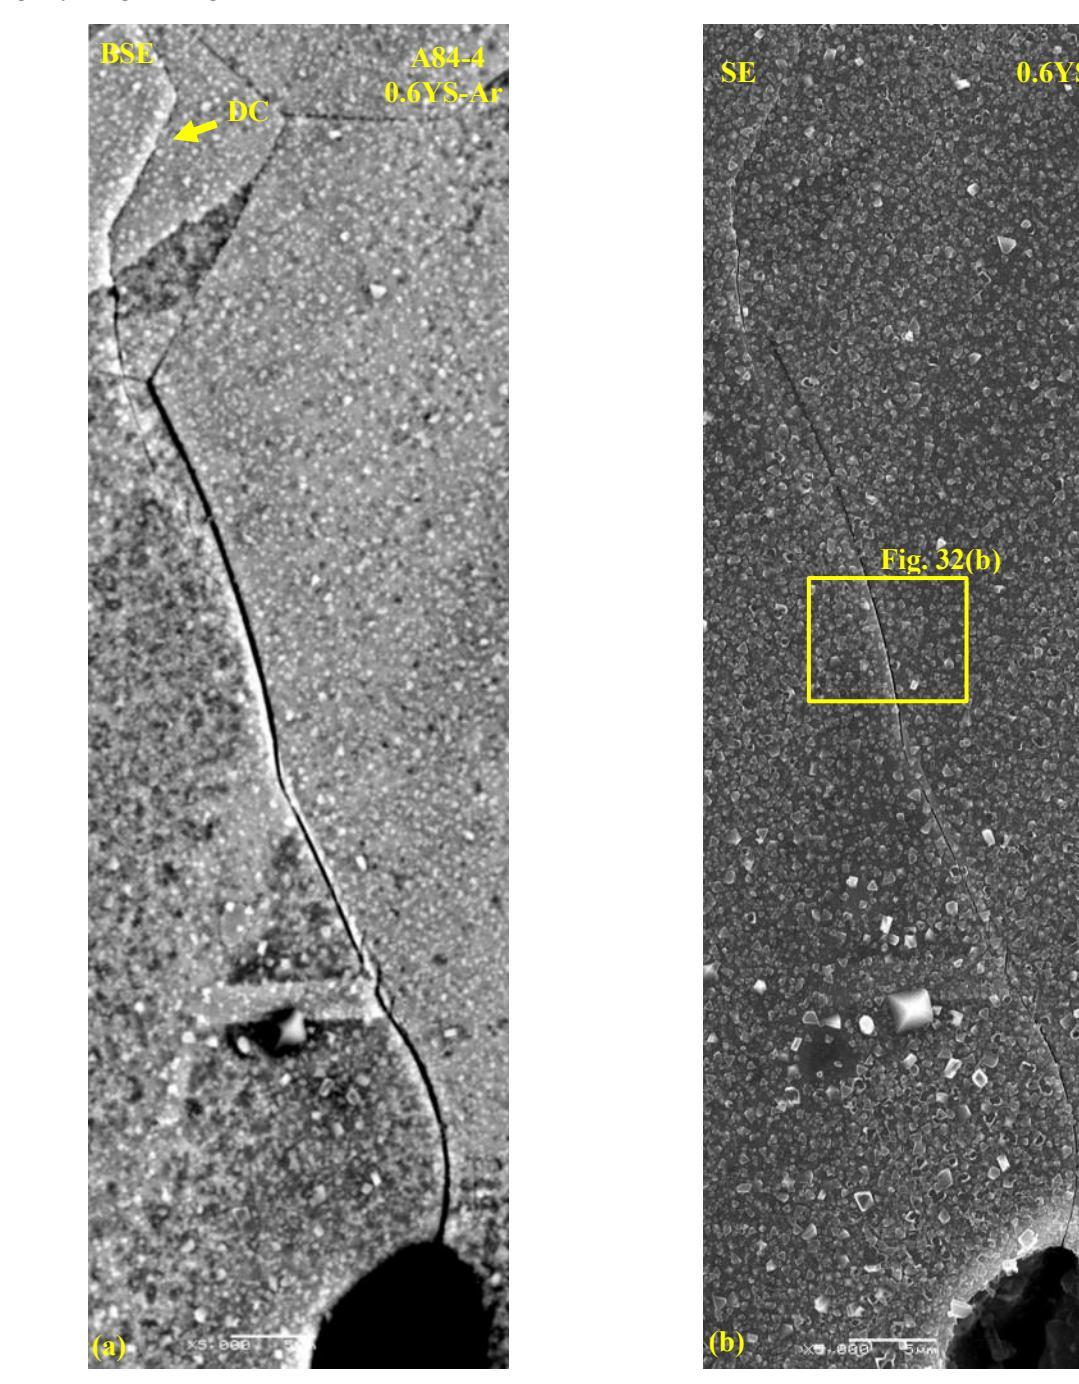
Figure 31. The SEM micrograph montage of lengthy crack in sample A84-4 (SA304 SS; 5.4 dpa) pre-oxidized for 1010 h in PW followed by interrupted straining until 0.6YS in high temperature Ar. This crack was initiated already in previous straining step (i.e. 0.5YS-Ar), further straining to 0.6YS widened (see, Fig. 32) as well as slightly lengthened the crack.

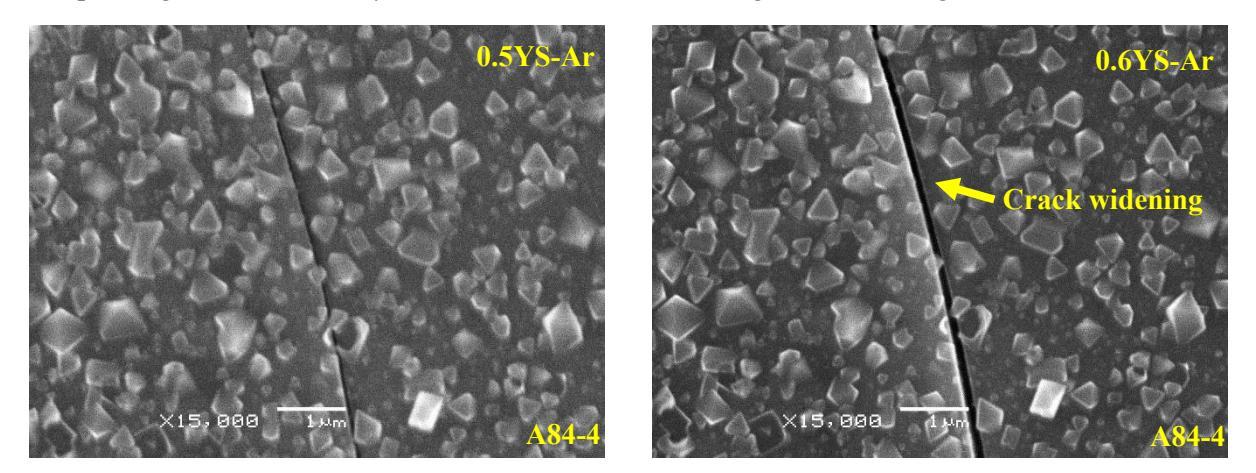
Figure 32. The SE images showing crack widening in A84-4 (5.4 dpa) sample with stress increment from 0.5YS to 0.6YS in Ar at 320  $\circ$ C. The sample A84-4 was pre-oxidized in primary water for 1010 h and then strained in Ar.

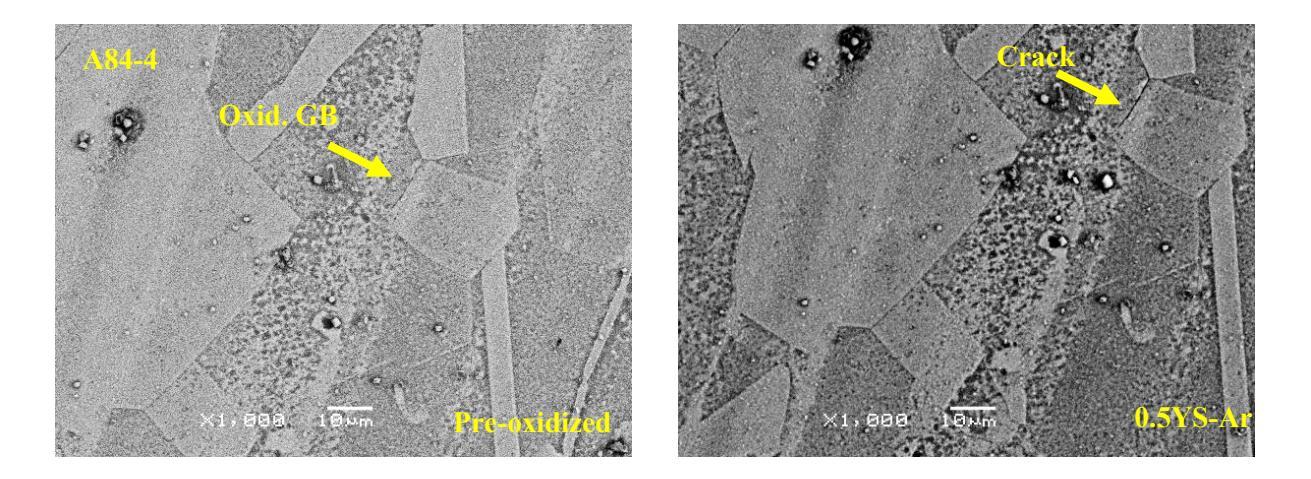
Figure 33. The BSE images showing the cracked GB in 1010 h pre-oxidized A84-4 (5.4 dpa) sample subjected to 0.5YS in Ar at 320 °C.

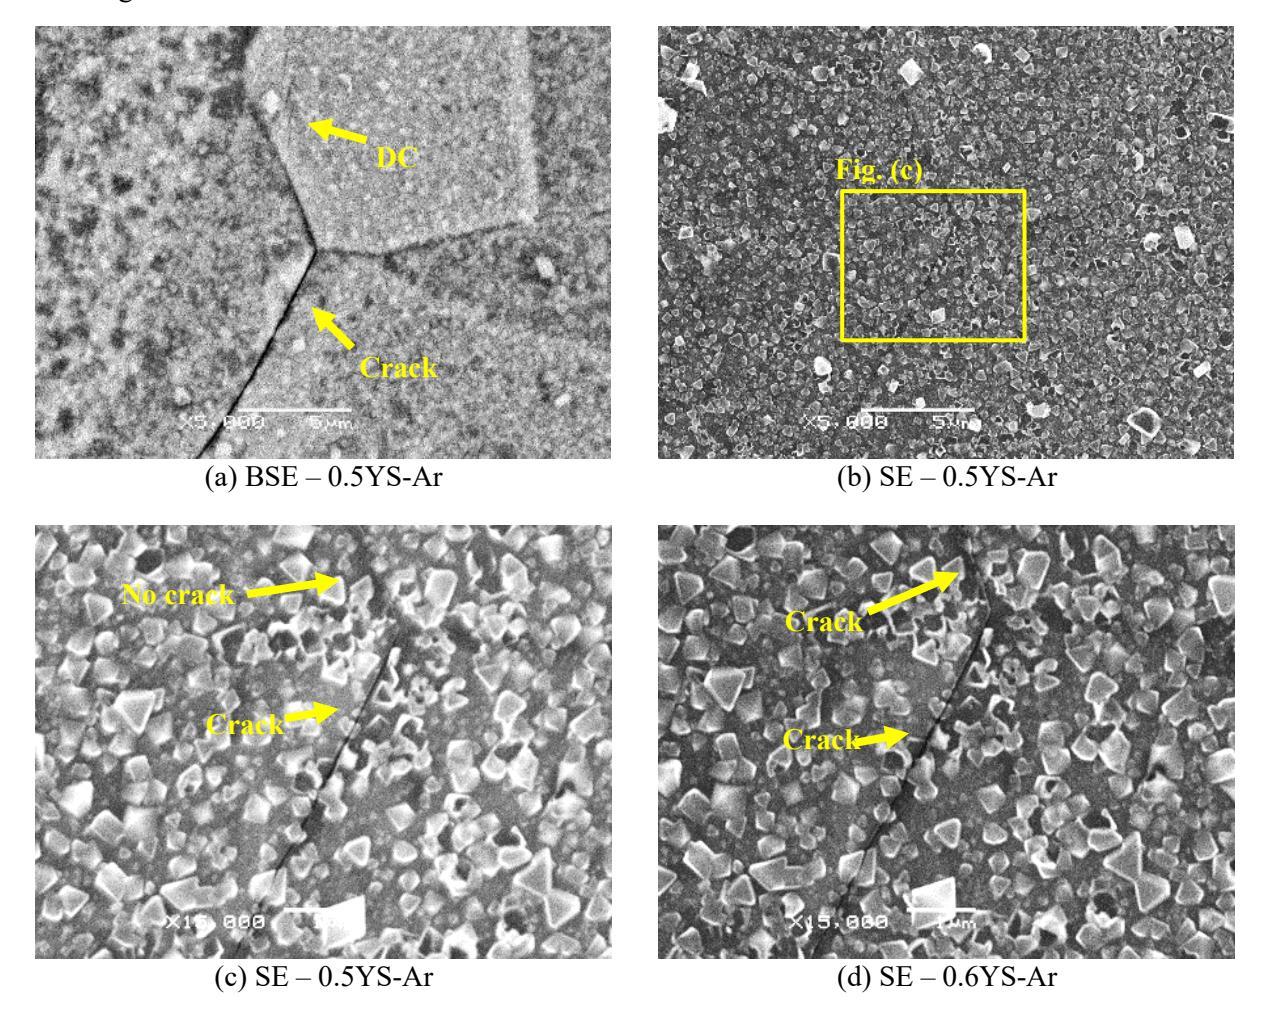
Figure 34. (a-c) The SEM images showing the cracked GB at triple junction in A84-4 (5.4 dpa; 1010 h pre-oxidized in PW) followed by straining to 0.5YS in Ar, (d) SE image showing the lengthening of the crack upon straining to 0.6YS in Ar.

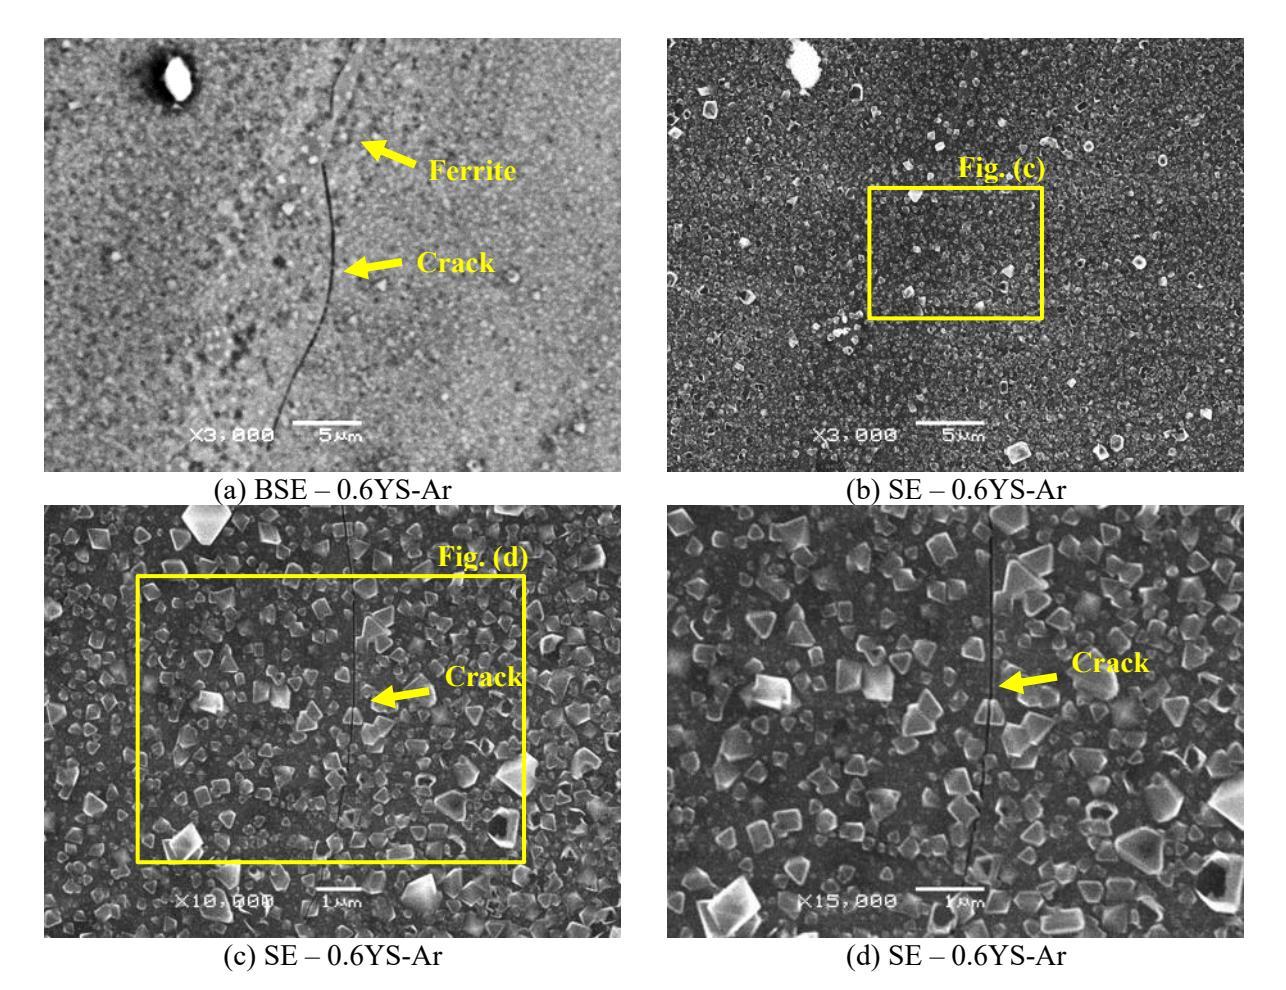
Figure 36. The SEM micrographs showing the cracked GB in 1010 h - pre-oxidized A84-4 (5.4 dpa) bend sample upon straining to 0.6YS in Ar.

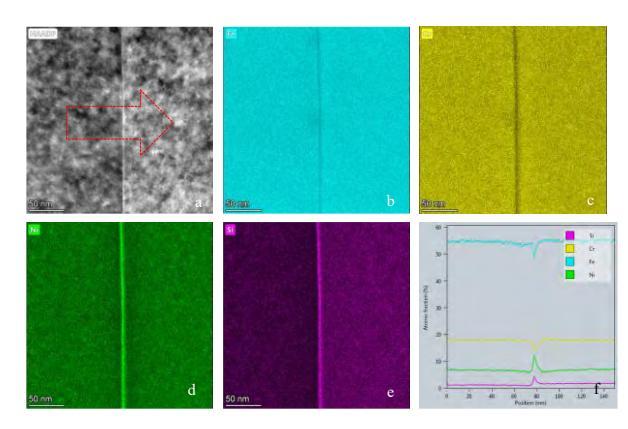
Figure 37. (a) is a STEM-HAADF image taken from the A98-1-1 sample far away from the surface; (b)- (e) are corresponding Fe-, Cr-, Ni- and Si-maps, respectively; (f) shows element profiles along the outlined region in (a).

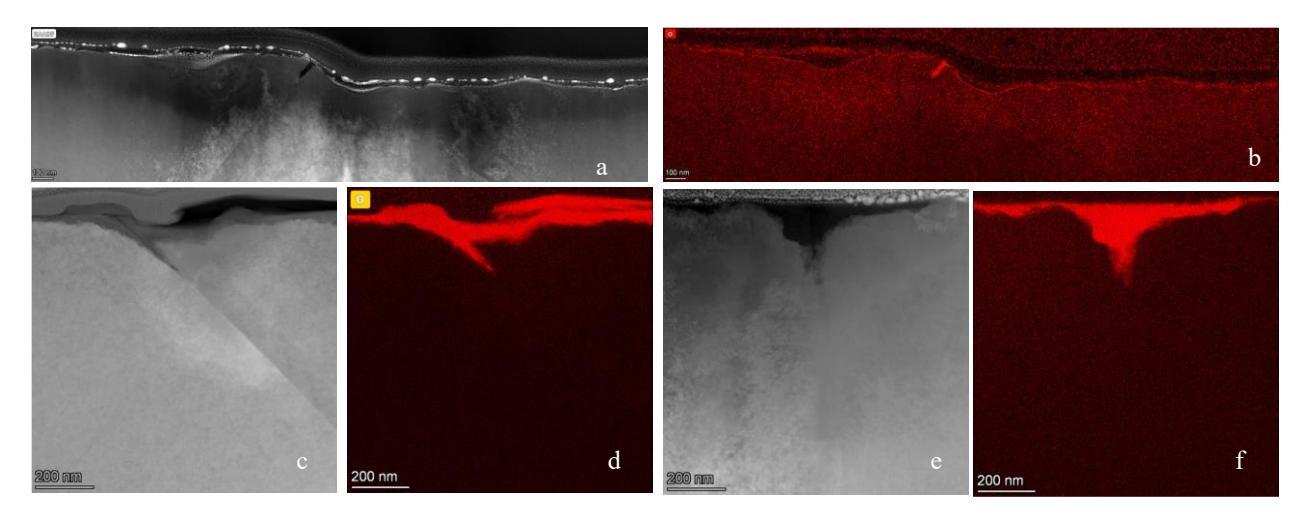
Figure 38. (a), (c), and (e) are STEM-HAADF images taken from the A98-1-1-A, -B and -C samples, respectively, showing three attacked GBs; (b), (d) and (f) are corresponding O-maps, respectively.

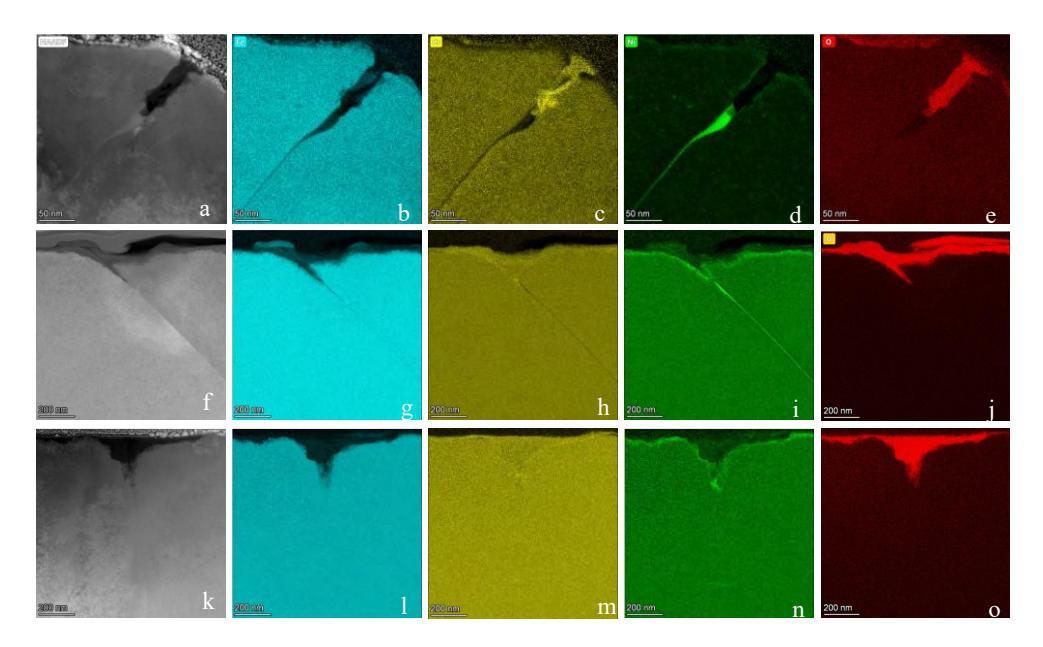
Figure 39. (a), (f) and (k) are STEM-HAADF images showing the three attacked GBs in the A98-1-1-A, -B and -C samples shown in Fig. 38; (b-e), (g-j) and (l-o) are corresponding Fe-, Cr-, Ni-, and O-maps, respectively.

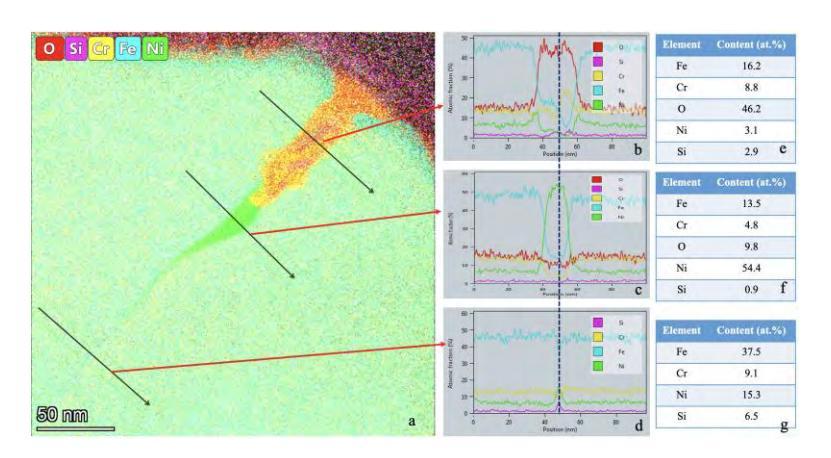
Figure 40. (a) a mixed element map showing O, Si, Cr, Fe and Ni distributions along the attacked GB in the A98-1-1-A sample. (b), (c) and (d) showing element profiles along the three outlined region marked in (a), respectively; (e), (f) and (g) are tables showing the element contents along the vertical dotted line across (b) to (d).

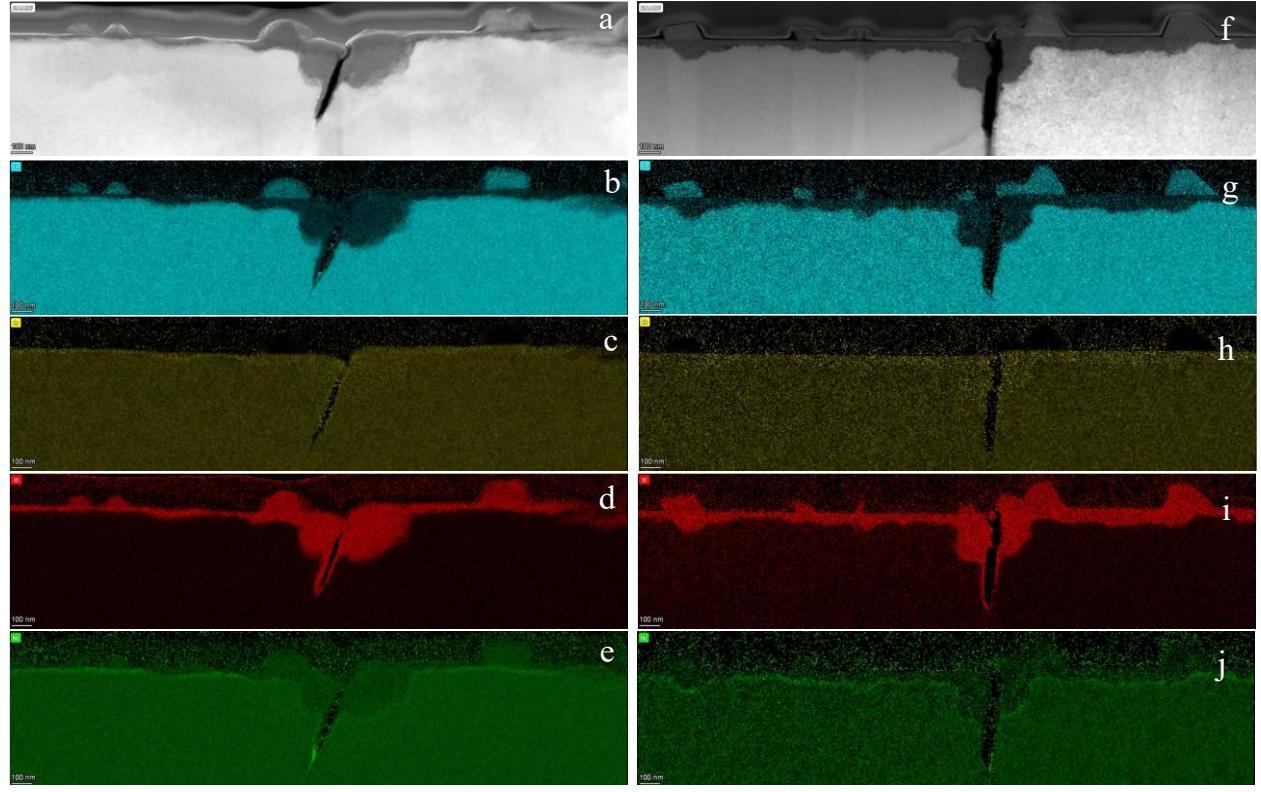
Figure 41. (a) and (f) are two STEM-HAADF images showing two cracked GBs in the A98-1-1-D and -E samples, respectively; (b)-(e) and (g)-(j) are corresponding Fe-, Cr-, O-, and Ni-maps, respectively, showing the element distributions in the cracked GB regions.

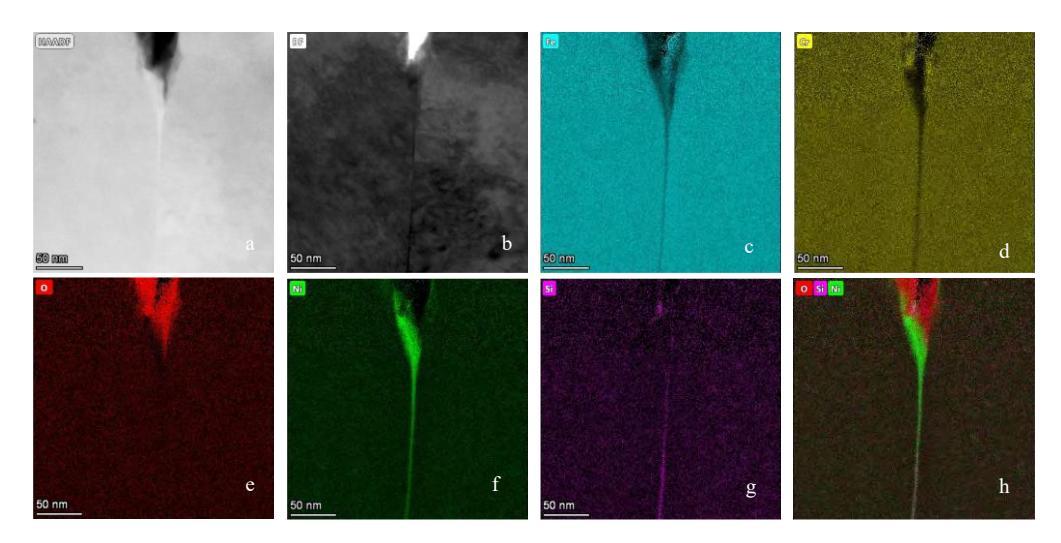
Figure 42. (a) and (b) are STEM-HAADF and BF images showing the crack tip region of the cracked GB in the A98-1-1-D sample as also shown in Fig. 41a; (c)-(g) are corresponding Fe-, Cr-, O-, Niand Si maps, respectively; (h) is a mixed element map showing distributions of O, Si and Ni in different colors.

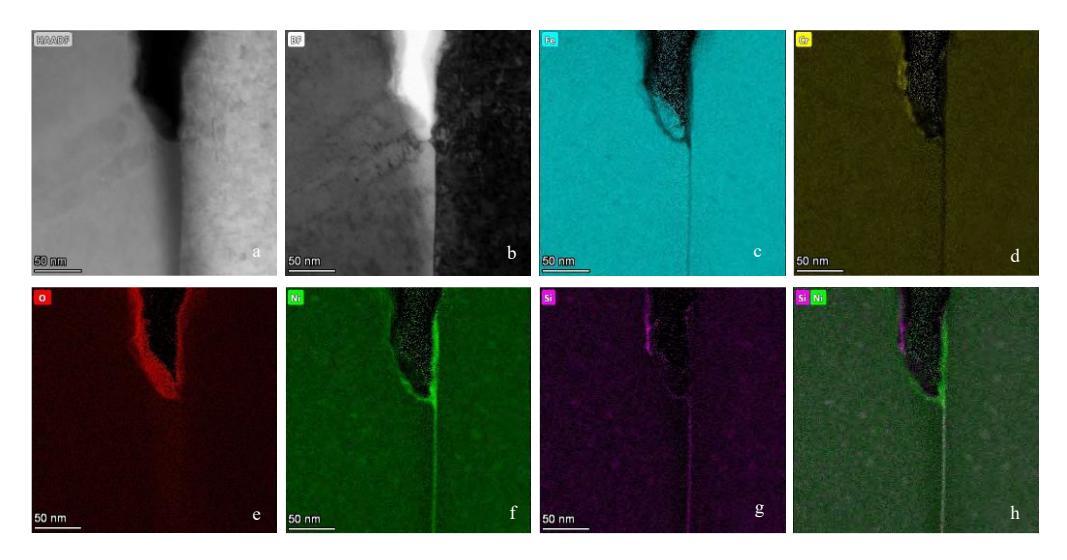
Figure 43. (a) and (b) are STEM-HAADF and BF images showing the crack tip region of the cracked GB in the A98-1-1-E sample as also shown in Fig. 41f; (c)-(g) are corresponding Fe-, Cr-, O-, Niand Si maps, respectively; (h) is a mixed element map showing distributions of Si and Ni in different colors.

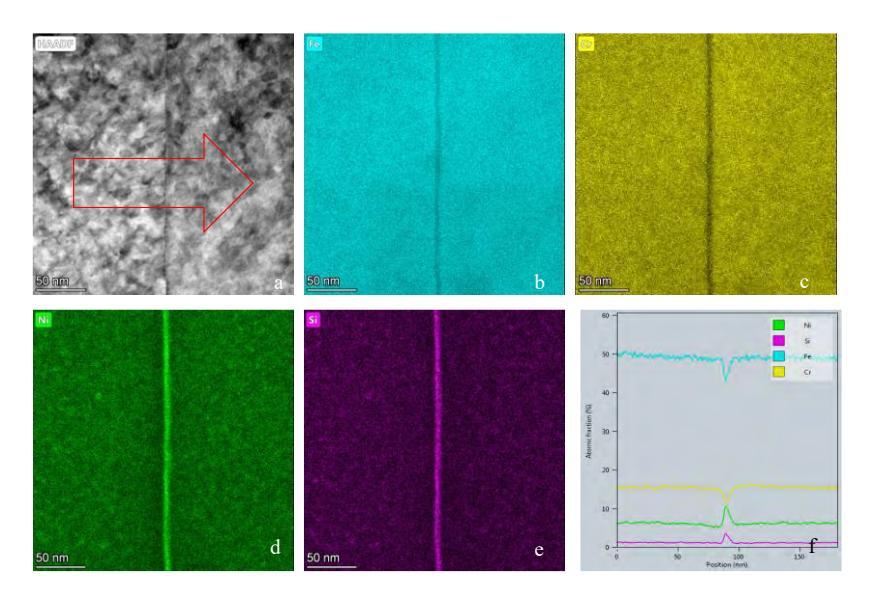
Figure 44. (a) is a STEM-HAADF image taken from the A98-1-1 sample far away from the surface; (b)- (e) are corresponding Fe-, Cr-, Ni and Si-maps, respectively; (f) shows element profiles along the outlined region in (a).

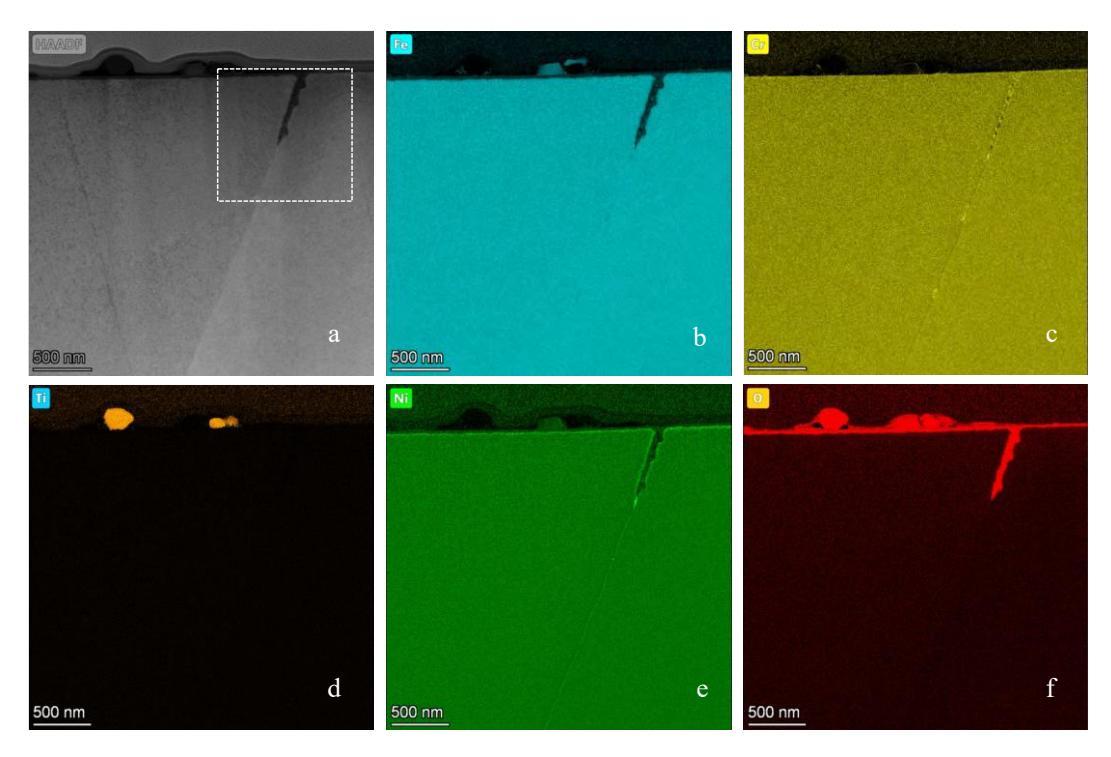
Figure 45. (a) is a STEM-HAADF image of an attacked GB in the A98-1-2-A sample; (b)-(f) are corresponding Fe-, Cr-, Ti-, Ni-, and O-maps, respectively.

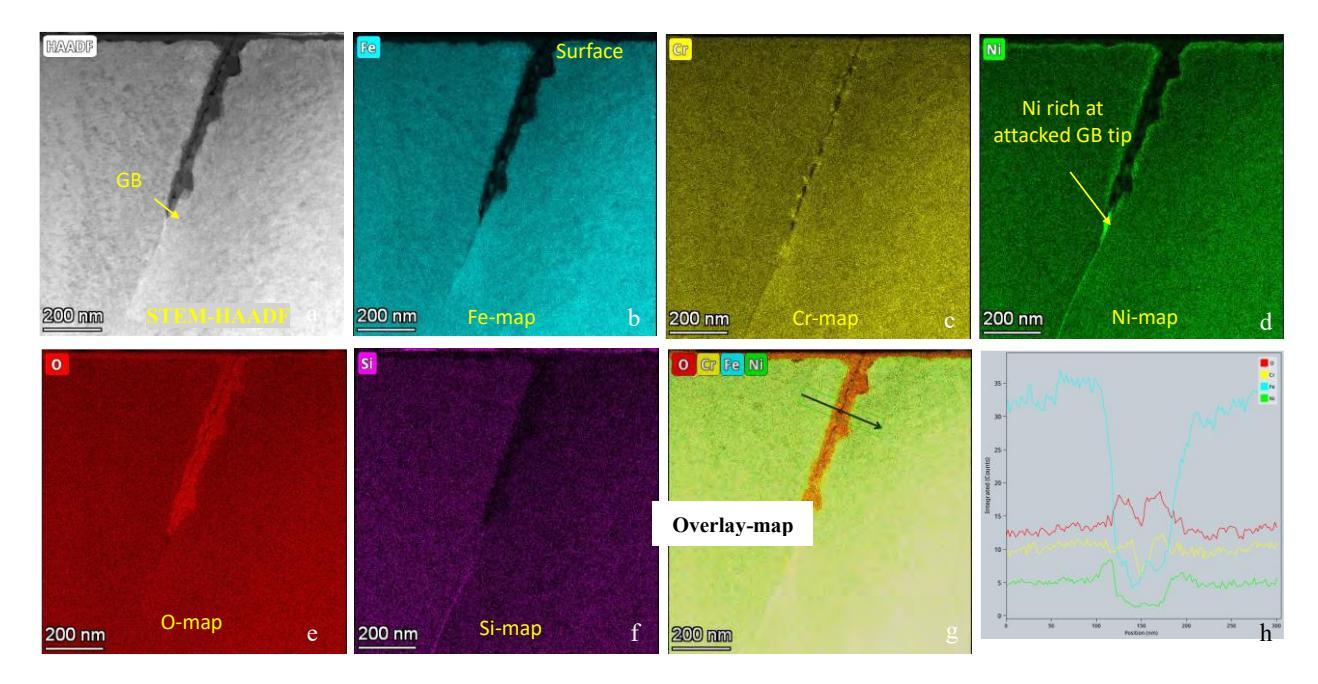
Figure 46. (a) is STEM-HAADF image of the attacked GB in the A98-1-2-A sample as also shown in Figure 45a; (b)-(f) are corresponding Fe-, Cr-, Ni-, O-maps, and Si-maps, respectively; (g) is a mixed element map with O, Cr, Fe and Ni in different colors and (h) shows element profiles along the outlined region in (g).

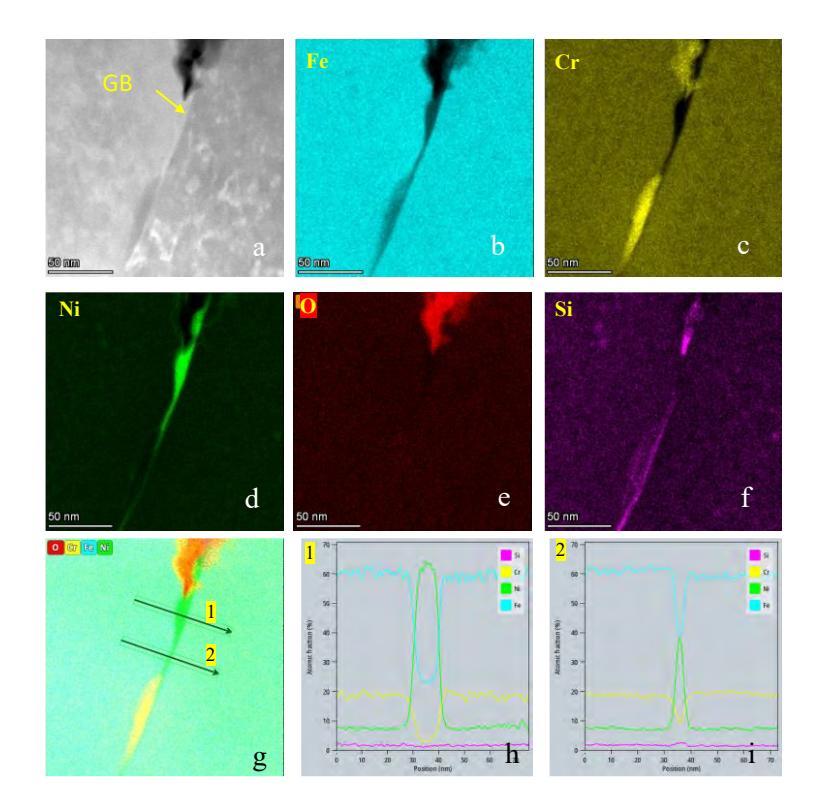
Figure 47. (a) is a STEM-HAADF image of the attacked tip region of the attacked GB in the A98-1-2-A sample as shown also in Figures 45a and 46a; (b)-(f) are corresponding Fe-, Cr-, Ni-, O- and Si-maps, respectively; (g) is a mixed element map with O, Cr, Fe and Ni in different colors and (h) and (i) display element profiles along the outlined regions, 1 and 2 in (g), respectively.

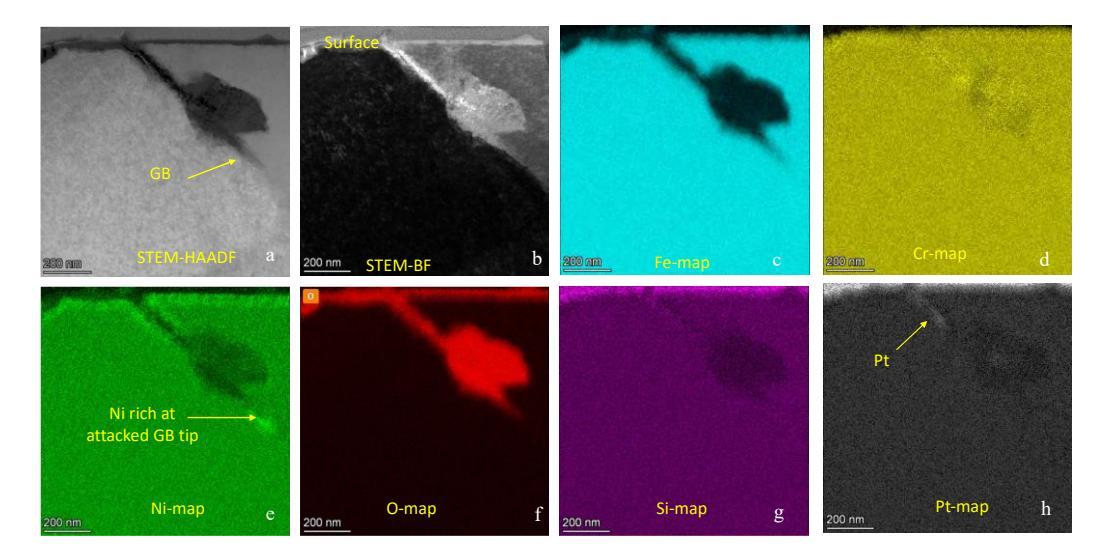
Figure 48. (a) and (b) are STEM-HAADF and BF images of a short-cracked GB in the A98-1-2-B sample; (c)-(h) are corresponding Fe-, Cr-, Ni-, O-maps, Si- and Pt-maps, respectively.

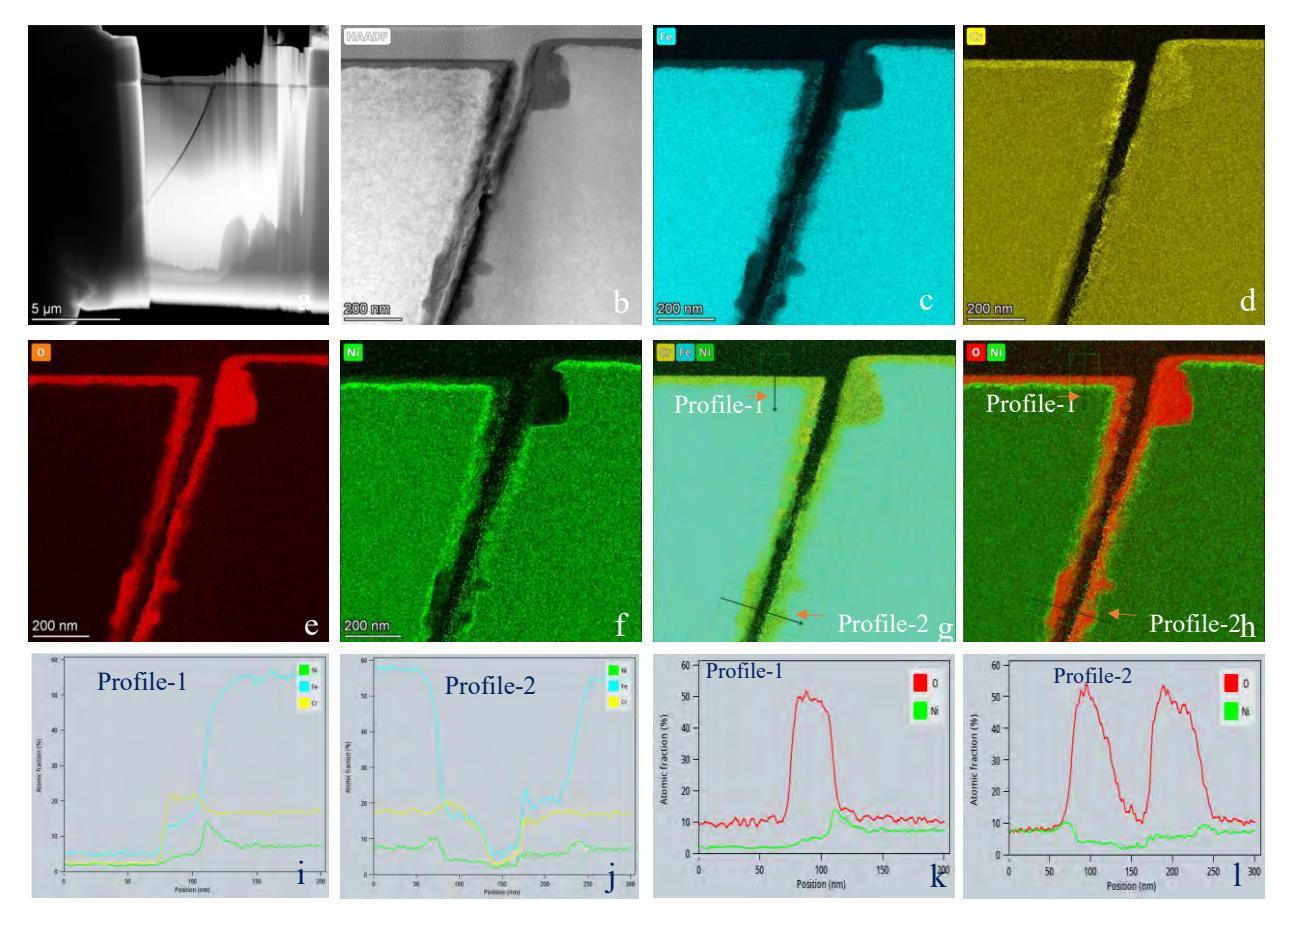
Figure 49. (a) and (b) are BF and STEM-HAADF images of a long-cracked GB in the A98-1-2-C sample, (c)-(f) are corresponding Fe, Cr, O and Ni maps, respectively, (g) and (h) are mixed elemental maps with two line profiles displayed as insets.

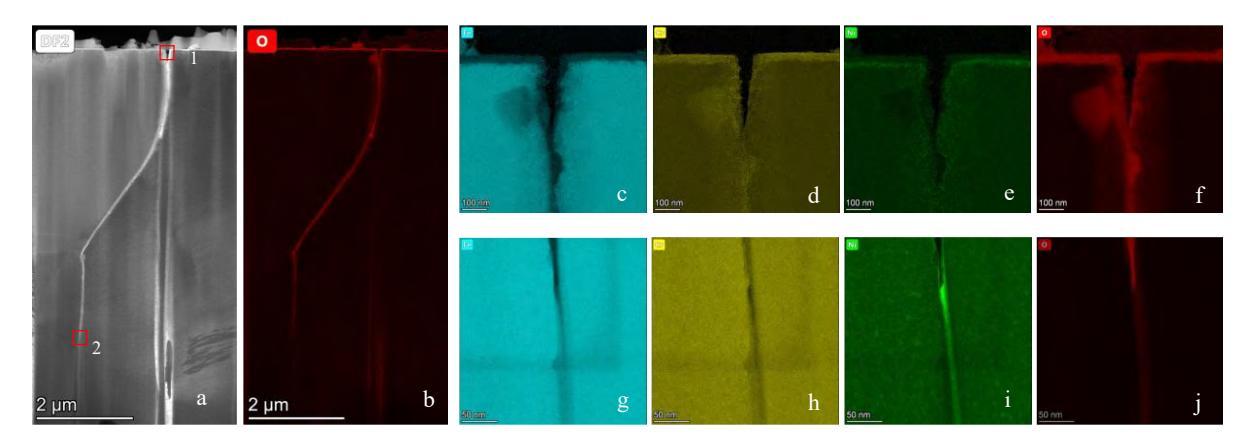
Figure 50. (a) is a STEM-HAADF images taken from a region with a long-cracked GB in the A98-1-2-D sample and (b) is its corresponding O-map; (c)-(f) and (g)-(j) are Fe-, Cr-, Ni- and O-maps from the outlined region 1 and 2 in (a), respectively.

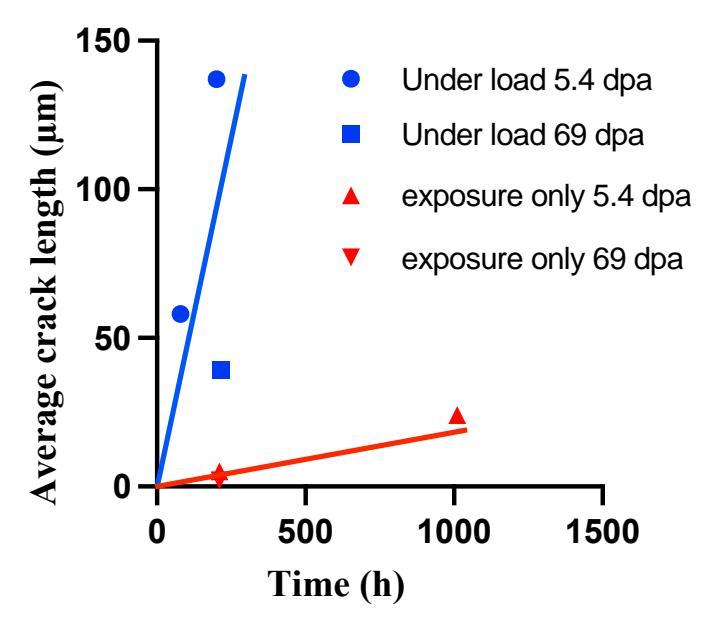
Figure 52. Effect of the time over which the sample was under stress during oxidation on average IASCC crack length compared that for samples exposed without load and subsequently strained in purified UHP Ar gas.

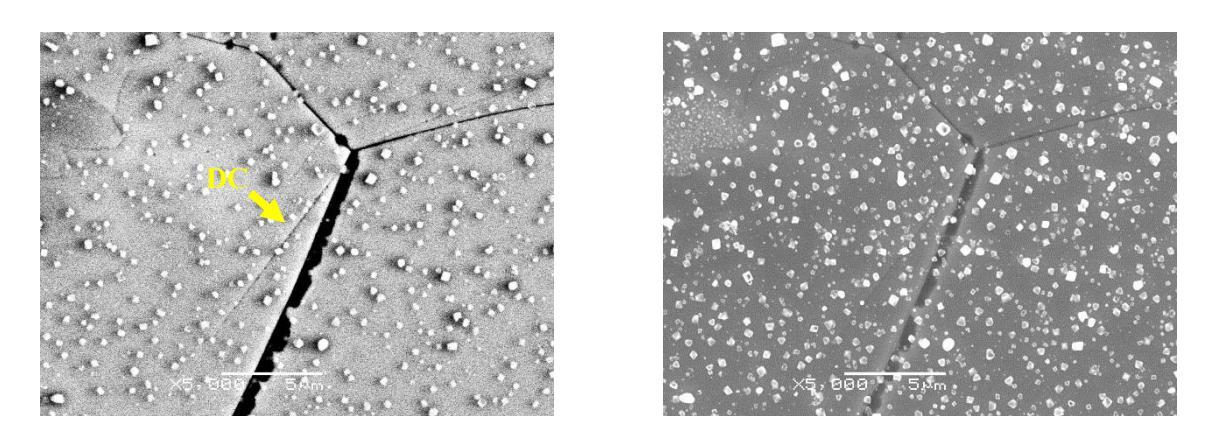
Figure 54. The BSE and SE images obtained from the surface of A84-1-2 (5.4 dpa) sample upon constant load bend test at 0.5YS for 200 h in PW at 320 °C, showing accelerated oxidation at GB triple junction.

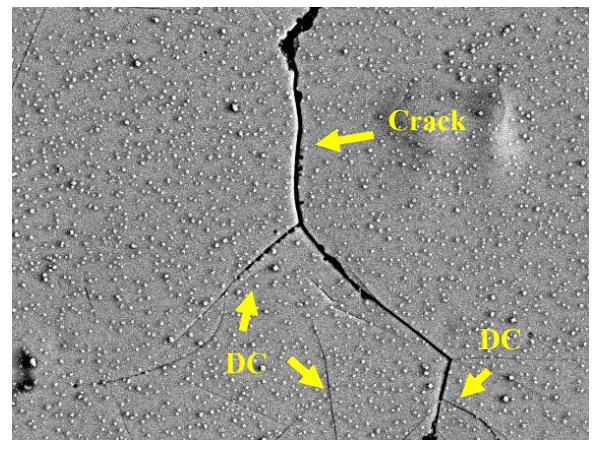
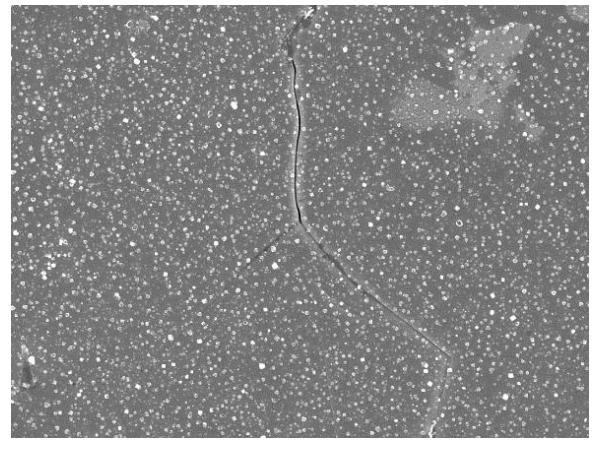
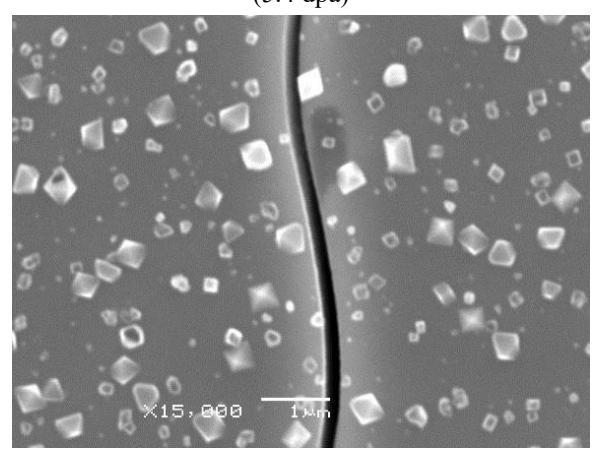
(a) BSE – 0.5YS-PW – 200 h – Constant load A84-1-2 (5.4 dpa)

(b) SE – 0.5YS-PW – 200 h – Constant load A84-1-2 (5.4 dpa)

(c) SE – 0.5YS-PW – 200 h – Constant load A84-1-2 (5.4 dpa)
