Light Water Reactor Sustainability Program Casting of Reinforced Concrete Beam: Project Progress

**Casting of Reinforced Concrete Beam: Project
Progress**

Casting of Reinforced Concrete Beam: Project Progress

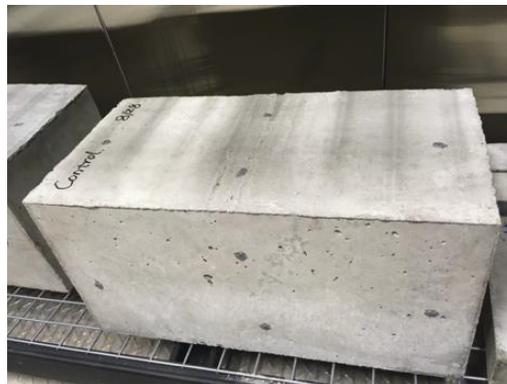
Figure 3. Non-reactive aggregate reinforced concrete sample (control sample).

Subtasks 1 and 2 will be performed by University of Nebraska, Lincoln (UNL), under the direction of Prof. Jinying Zhu. Four reinforced concrete specimens will be cast and cured under aggressive conditions. The four samples are all of dimension 1 ft. x 1 ft. x 2 ft. and consist of one unreinforced control sample with non-reactive aggregate, one unreinforced sample with Gold Hill reactive aggregate, one transverse-reinforced sample with Gold Hill reactive aggregate, and one bidirectionally reinforced sample with Gold Hill reactive aggregate. Table 1 presents the casting date and Figures 3 and 4 are controlled sample and bidirectional reinforced sample in environmental chamber. Reinforced concrete samples with transverse direction confinement and reactive aggregate concrete sample without confinement will go into the environmental chamber in October.

The samples will be cured and conditioned in an environmental chamber at UNL at a temperature of 38°C and relative humidity > 95%. The UNL team will install stainless steel targets on sample surfaces to monitor concrete expansion during curing and conditioning using demountable mechanical strain gauge devices (150 mm and 500 mm gauge lengths). This expansion data will be shared with the Vanderbilt team. Once the conditioning is complete, the samples will be shipped to Vanderbilt University.

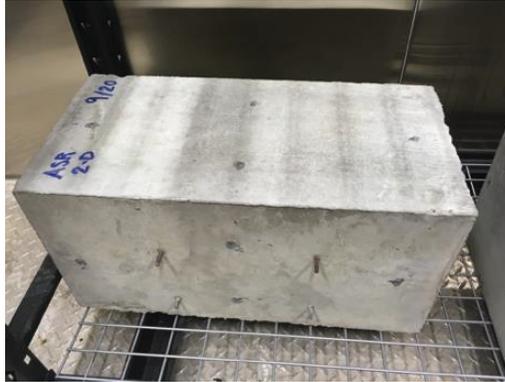
Figure 4. Reactive aggregate reinforced concrete sample with bidirectional confinement.
