# **EBSD Characterization of Tubular Cladding Plasticity after Bend Testing: A Feasibility Study**

Isabella J. van Rooyen

March 2013

**Prepared for the  
U.S. Department of Energy  
Office of Nuclear Energy  
Under DOE Idaho Operations Office  
Contract DE-AC07-05ID14517**

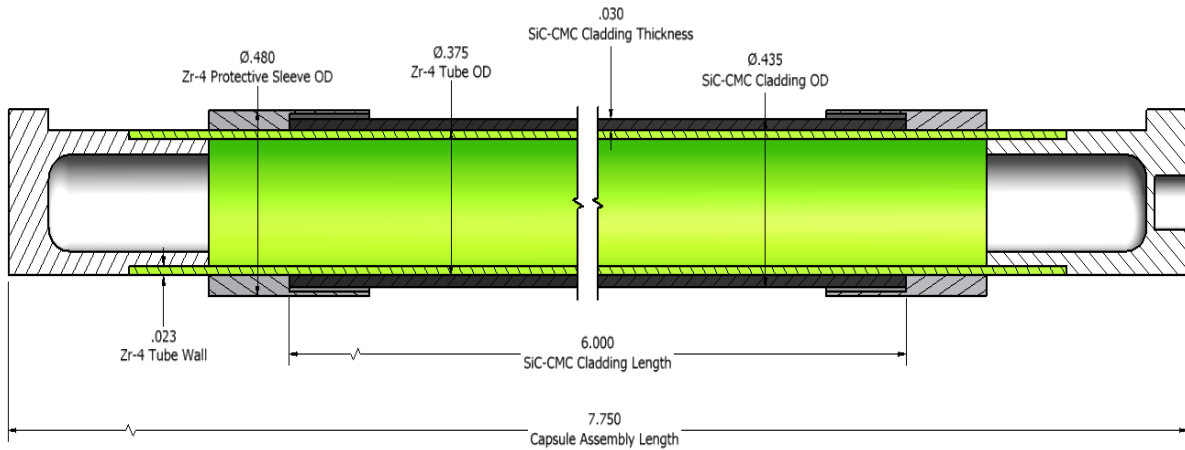
Figure 1. Geometry of the LWRS capsule assembly design for the Si-CMC hybrid Zr-4 cladding rodlet[1].

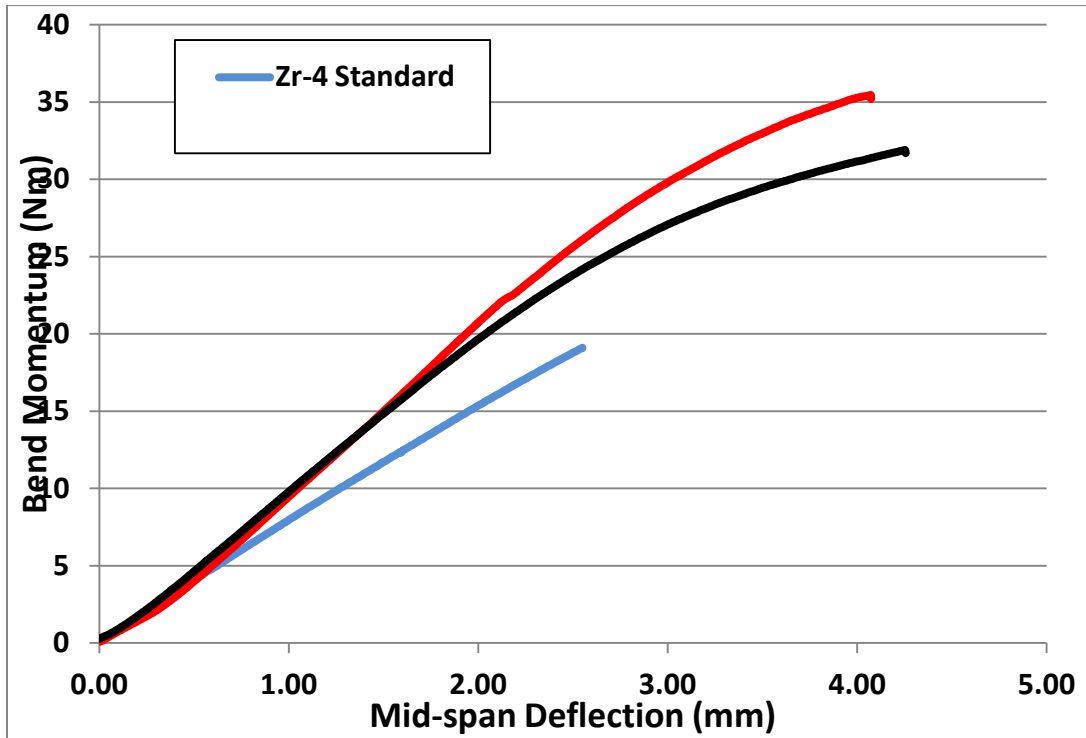
Figure 3. Bend test results of the mock-up samples showing bending momentum vs mid-span deflection. The 2 ply SiC-CMC hybrid mock-up sample exhibits the highest bend momentum.

The first test on the bare Zr-4 mock-up tube showed a shortfall in the initial test, as a maximum deflection value of 10% set on the Instron load cell prohibited the test to continue to a maximum load condition for Zr-4, as shown in Figure 3. This limit was corrected when the hybrid mock-up samples were tested. The deflectometer used in the test, shown in Figure 4, provided a more accurate measurement of the deflection up to 2% changes, allowing early detection of material changes. Additionally, the deflectometer provided verification for the built-in deflection measurement system of the Instron load cell. No differences between these two measurements were found for all three mock-up samples. (Graphs in Figure 4 show only the Instron measurements). Figures 4 to 6 show the bend test at the start and completion of all three mock-up samples. Slippage of the saddles was observed at the end of the testing of the hybrid mock up samples SiC-1 and SiC-2. This is not considered to have influenced the final results as the comparative nature of the test still showed sufficient differences between the bending momentum of the three samples. Figure 3 shows that the 2 ply SiC-CMC hybrid mock-up sample exhibited the highest bending moment while the Zr-4 mock-up sample exhibited the lowest. Cracking and bundling of the SiC-CMC fibers was observed for the 2 ply braided sleeve hybrid mock-up sample (SiC-1) in the mid section of maximum deflection, while no bundling or cracking was observed for the 1 ply braided hybrid mock-up sample (SiC-2).

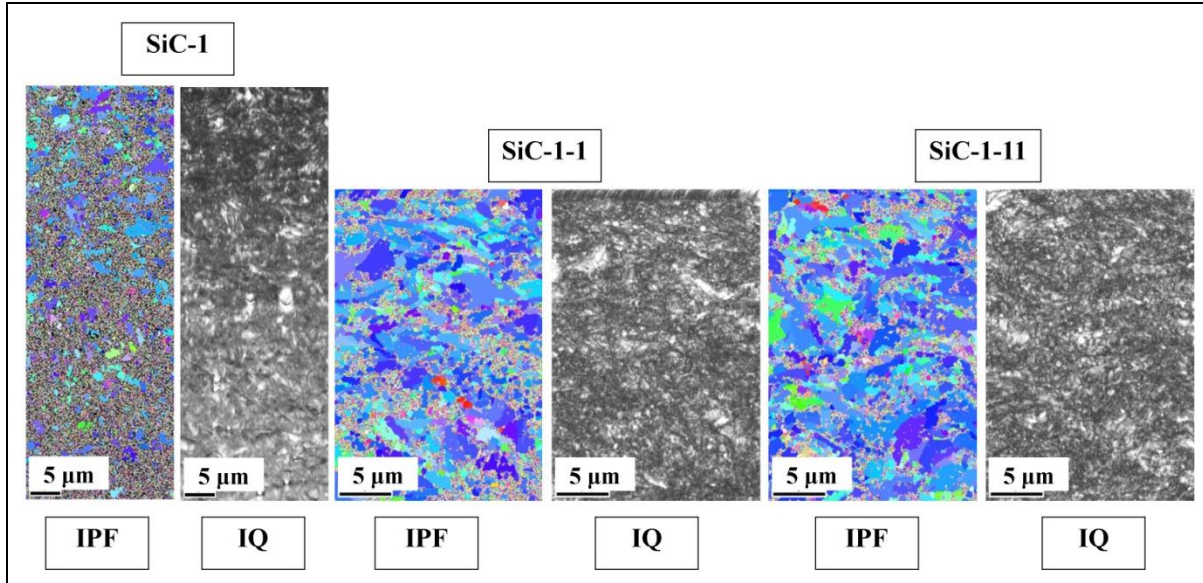
Figure 18. Micrographs showing the evolution of the EBSD measurements; IPF and IQ; of the SiC-1 sample after bend at the point of maximum deflection. The average CI improved with 76% from SiC-1 and SiC-1-11.

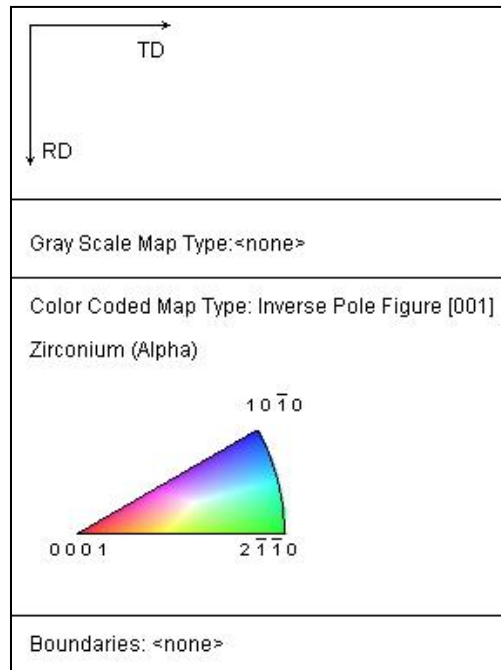
Figure 21. Pole figure color coded map for Zirconium (Alpha)
